CALAIS AT PELICAN BAY CONDOMINIUM ASSOCIATION, INC.

Subject: MILESTONE INSPECTION – PHASE 1
Calais at Pelican Bay – Building C
7048 Pelican Bay Boulevard
Naples, Collier County, Florida 34108
SOCOTEC Project Number 2775-002.01

Representative Photographs

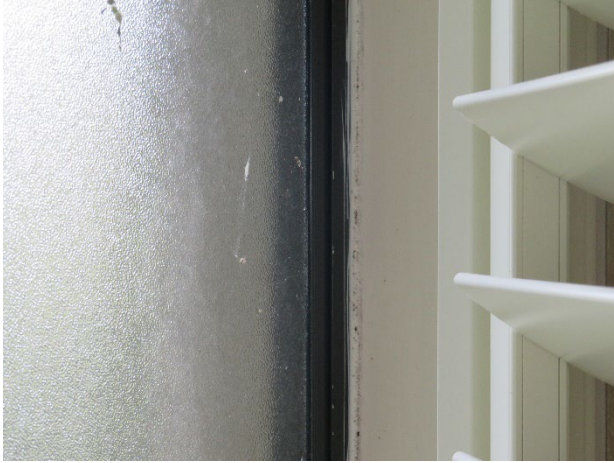
Water leak and staining in garage, Unit C204	Water intrusion, failed sealants, Unit C302

Water intrusion, efflorescence, Unit C201	Garage wall cracking, Unit C201

Apparent mold at window sealant, Unit C105
