SOCOTEC

July 18, 2023

Subject: MILESTONE INSPECTION – PHASE 1
Calais at Pelican Bay – Building D
7040 Pelican Bay Boulevard
Naples, Collier County, Florida 34108
SOCOTEC Project Number 2775-002.01

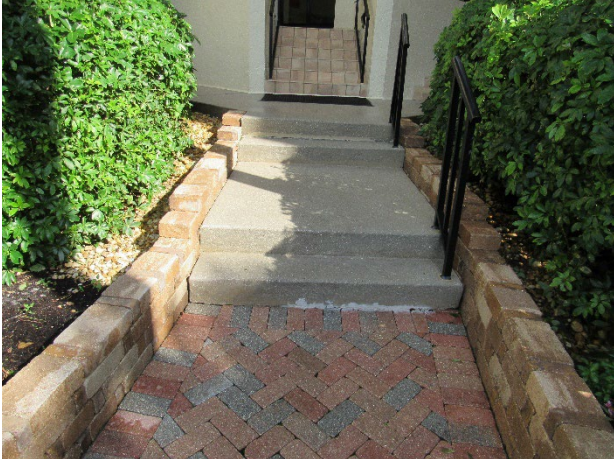
<p>Settlement at building D entry</p>	<p>Concrete spall at garage entry, building D</p>

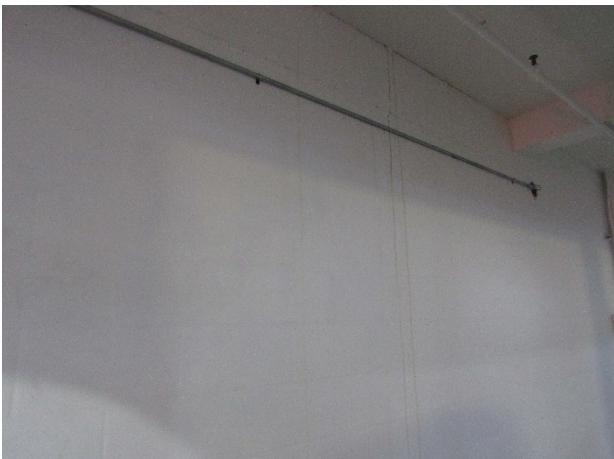
<p>Water intrusion, D garage</p>	<p>Floor settlement in elevator lobby in D garage</p>

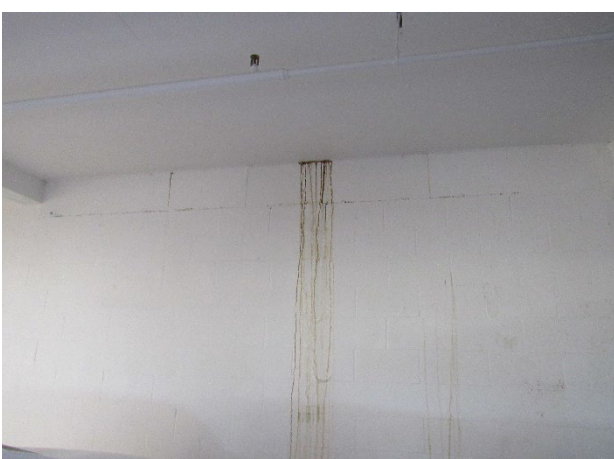
<p>Water intrusion, D garage</p>	<p>Water intrusion, Unit D303</p>

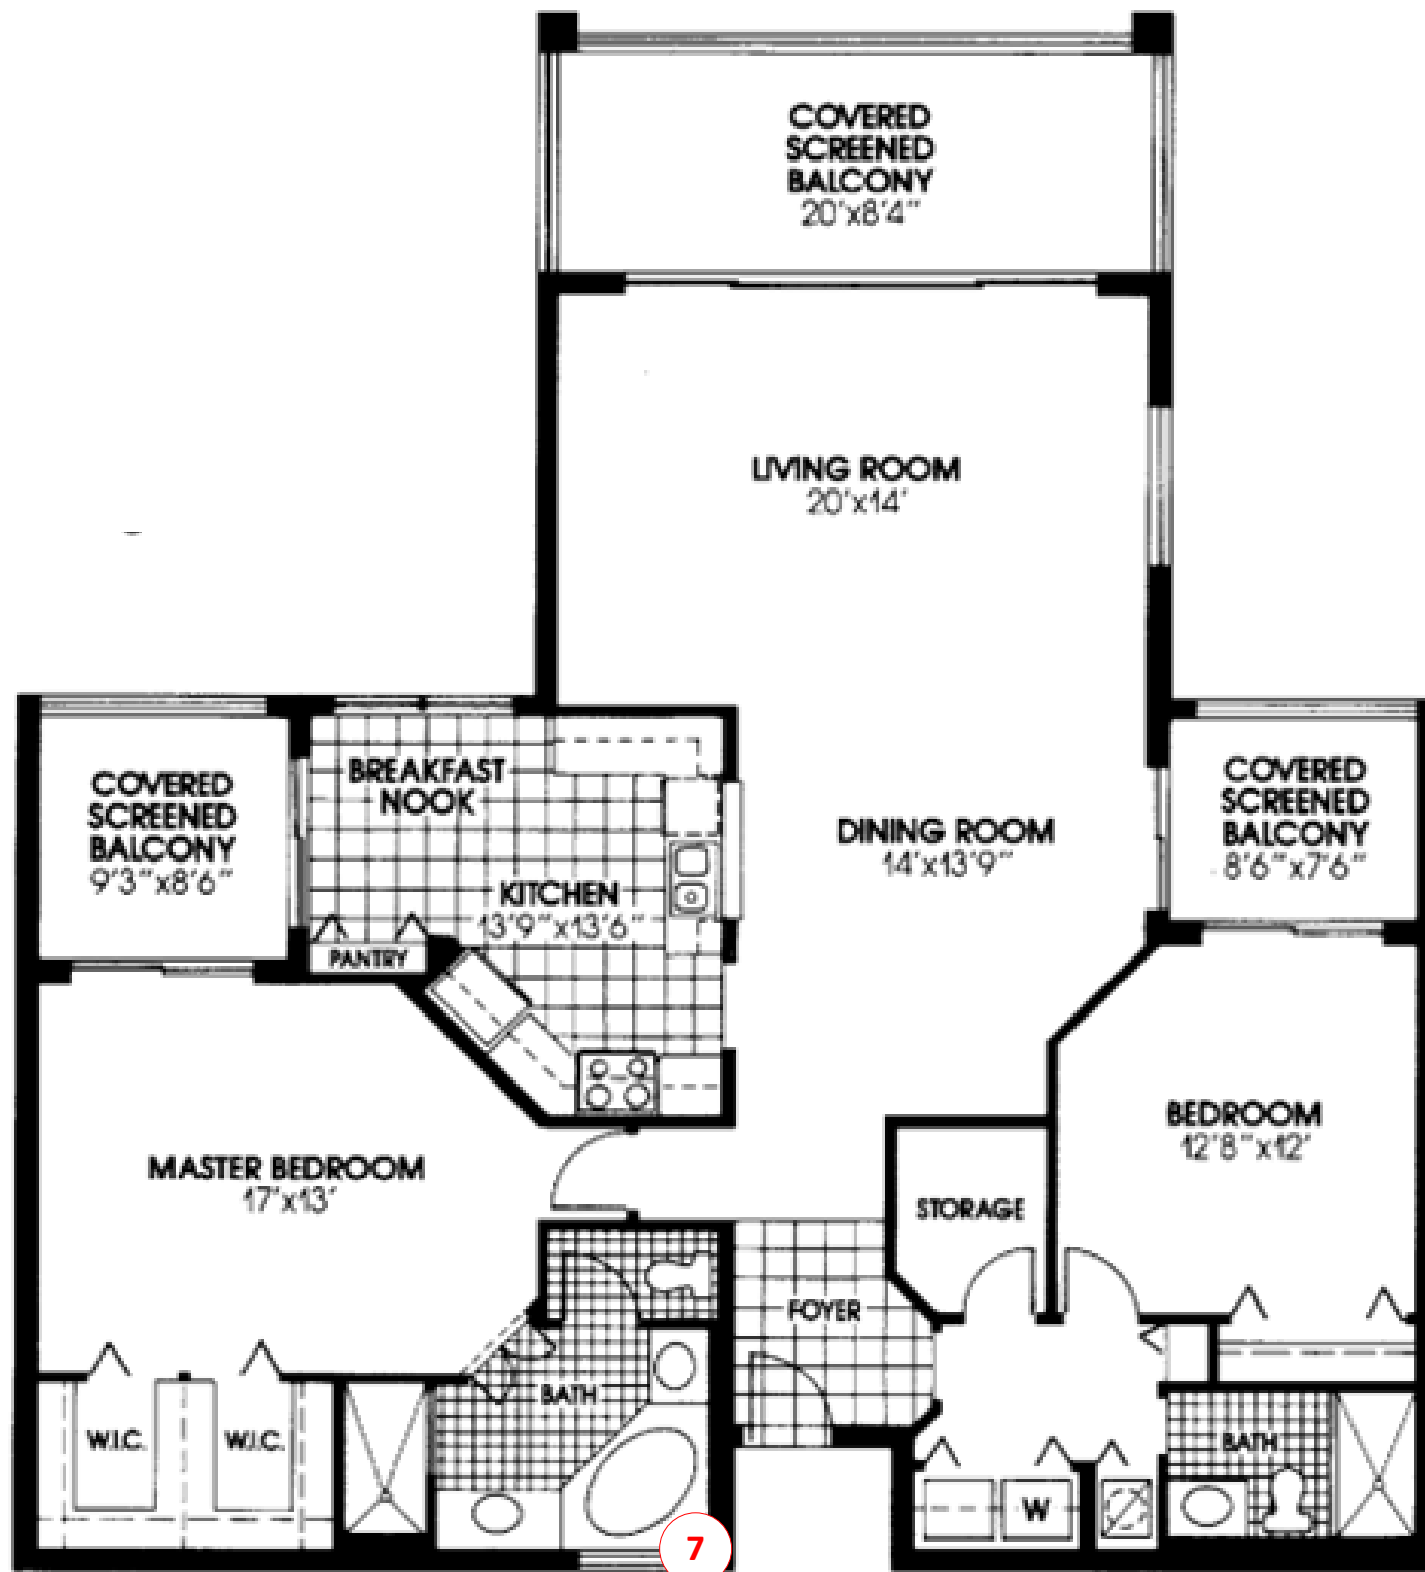
BUILDING D
UNIT 202

NOTHING TO BE NOTED

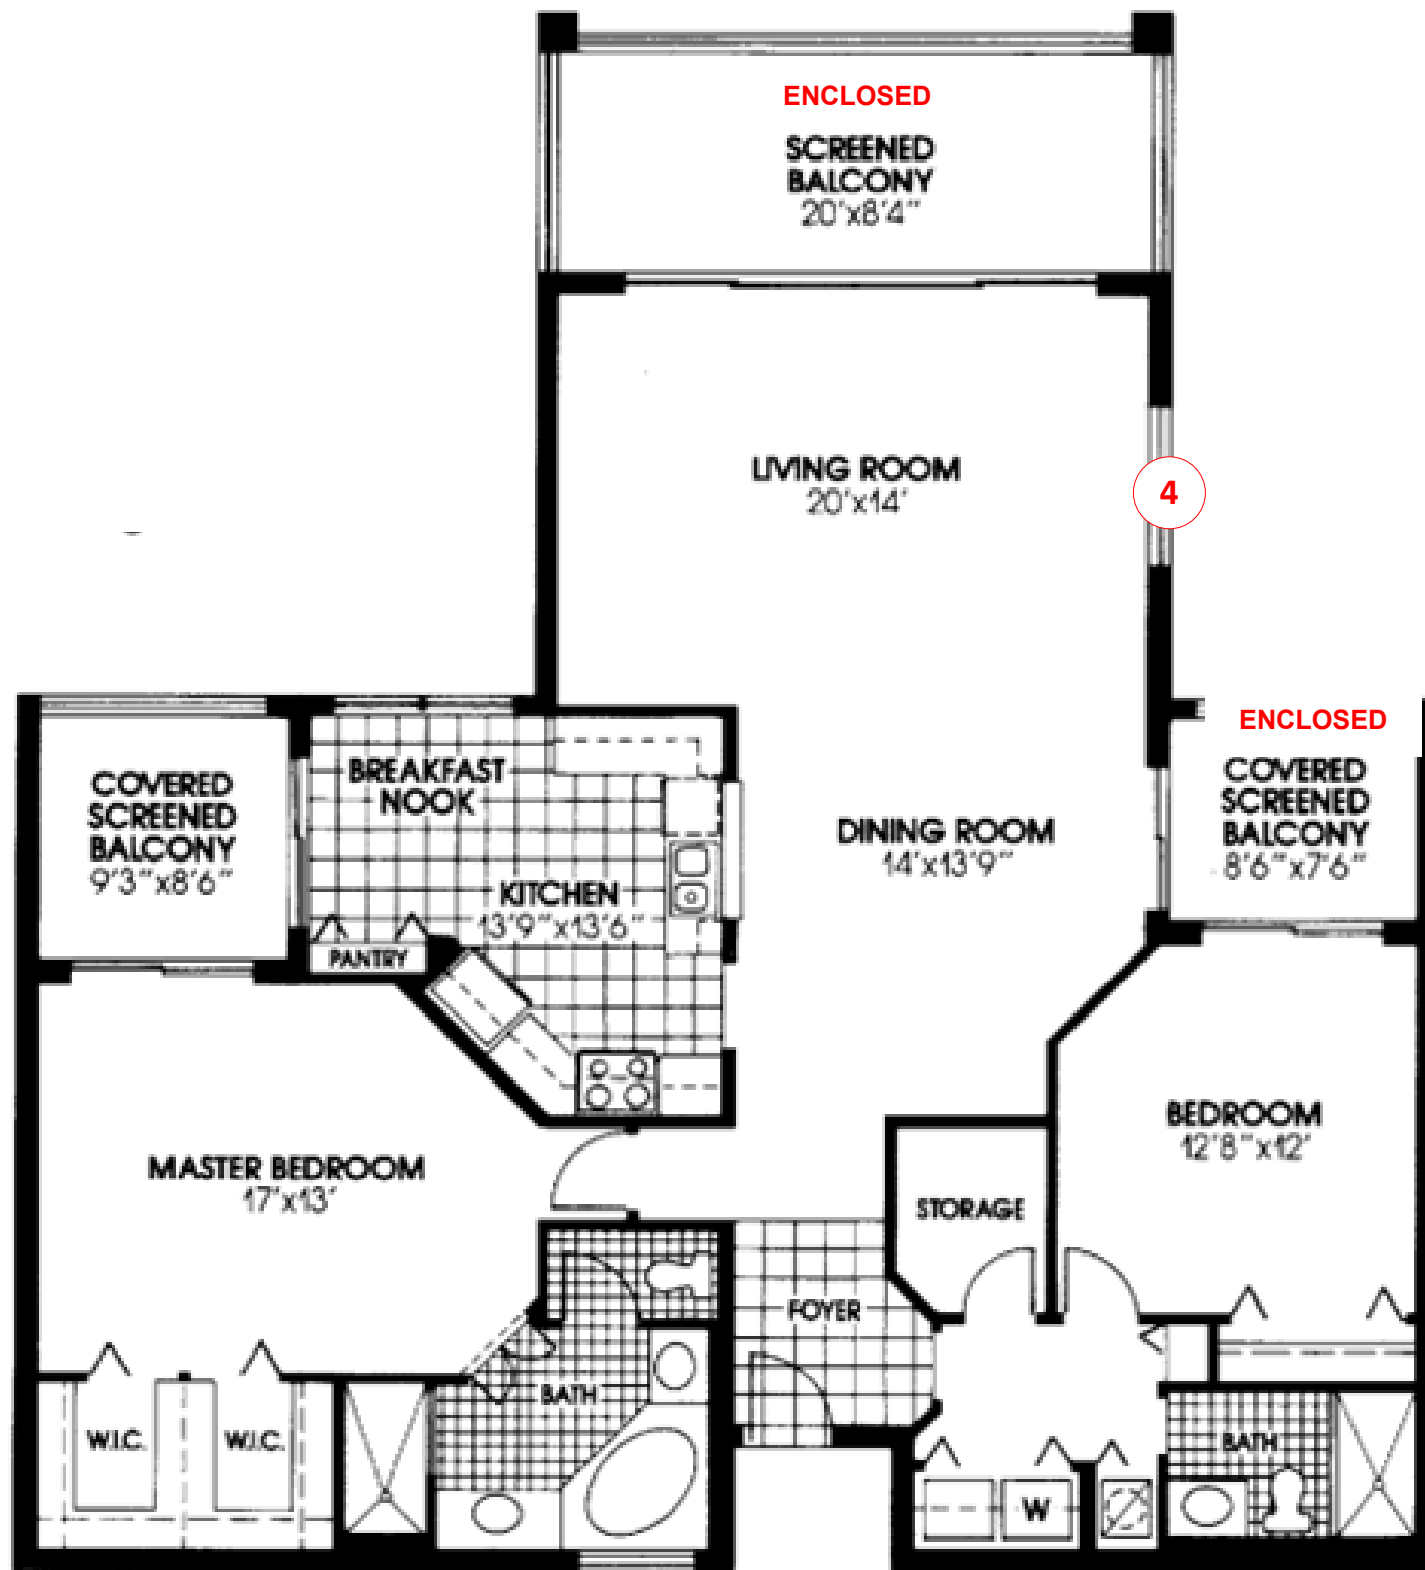
BUILDING D
UNIT 404

NOTHING TO BE NOTED
