SOCOTEC

CALAIS AT PELICAN BAY CONDOMINIUM ASSOCIATION, INC.

Subject: MILESTONE INSPECTION – PHASE 1
Calais at Pelican Bay – Building E
7032 Pelican Bay Boulevard
Naples, Collier County, Florida 34108
SOCOTEC Project Number 2775-002.01

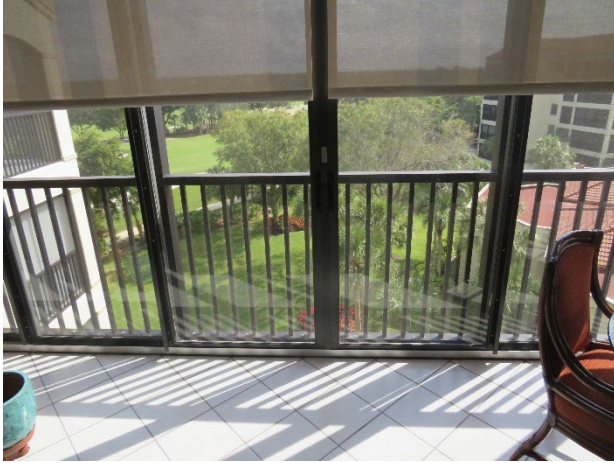
Enclosed balcony, delaminated tile, Units E501

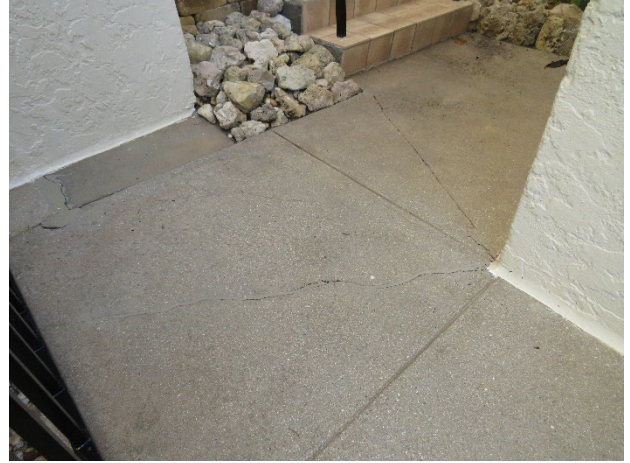
Settlement, slab cracking, building E

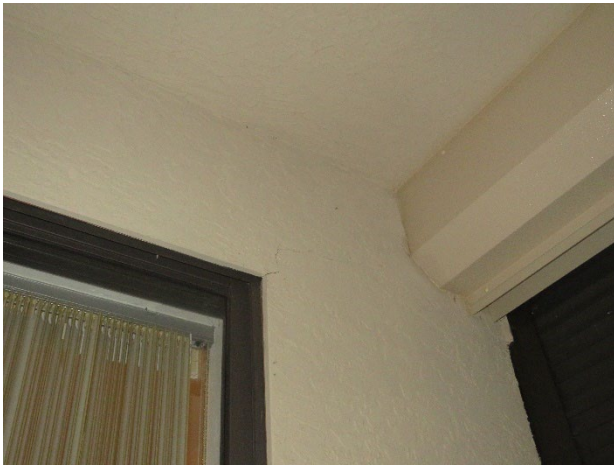
Balcony wall crack, Unit E105

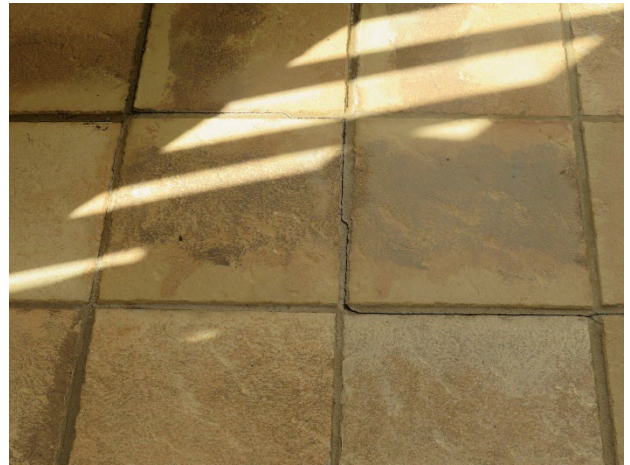
Delaminated tile in E corridor, 2nd floor

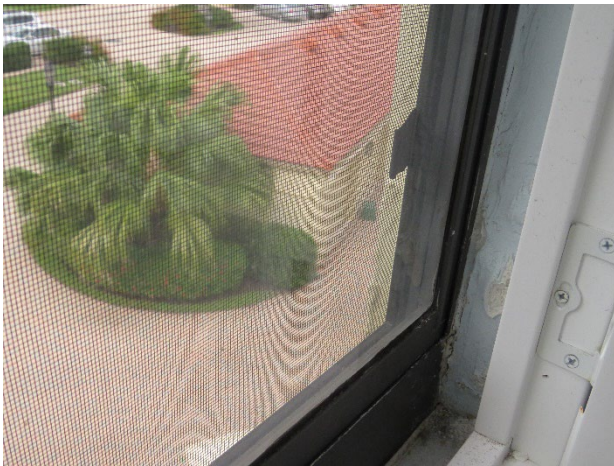
Water intrusion, Unit E301

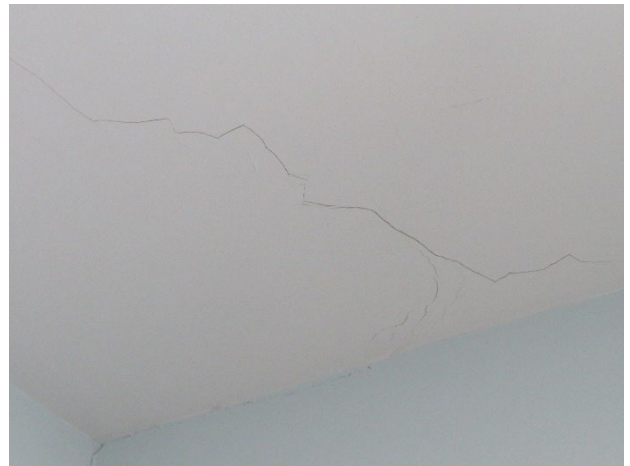
Ceiling crack, Unit E301
