**CALAIS AT PELICAN BAY CONDOMINIUM ASSOCIATION, INC.**

**Subject: MILESTONE INSPECTION – PHASE 1**  
Calais at Pelican Bay – Building F  
7024 Pelican Bay Boulevard  
Naples, Collier County, Florida 34108  
SOCOTEC Project Number 2775-002.01

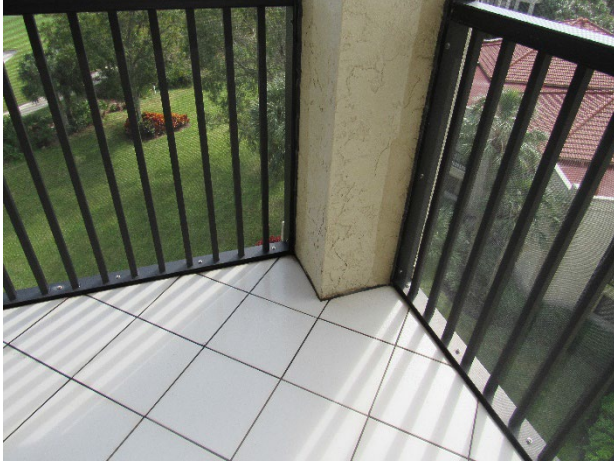
- Stucco spalling on columns in private units and in common areas should be investigated further to determine the condition of the underlying structural elements and then repaired as appropriate to preserve the structure.

Typical stucco spall at column, Unit F502

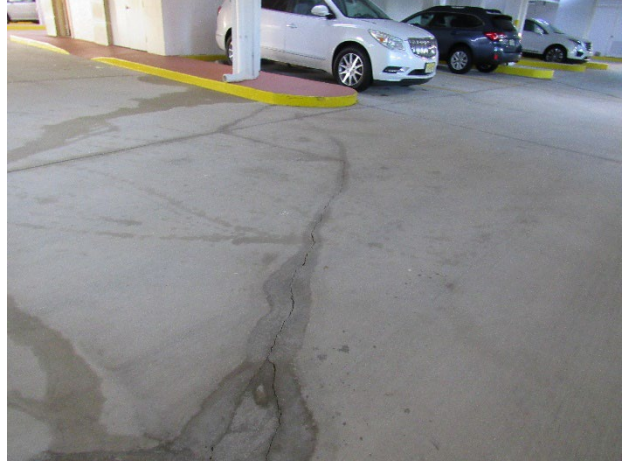
- Garage water intrusion and cracking warrants further investigation in the short term.
- See Appendix A diagrams as indicators of problem areas.

Garage slab crack, Building F

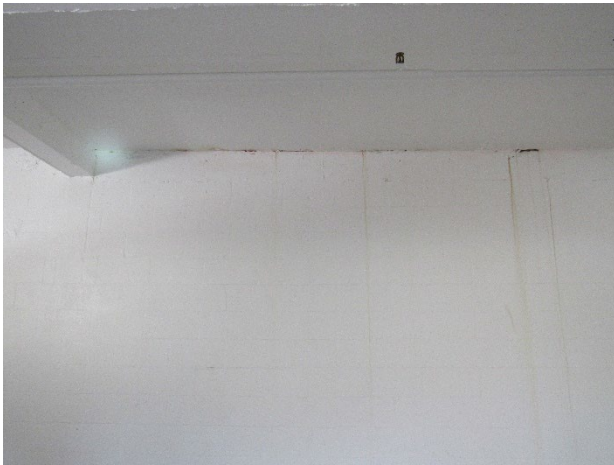
Active water intrusion, building F garage

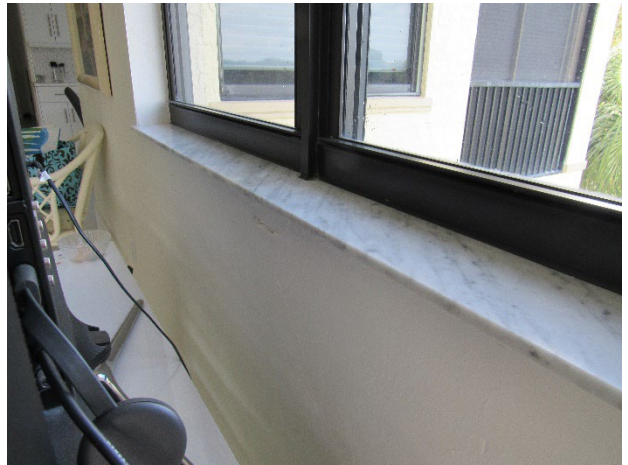
- Water intrusion at windows and many sliding glass doors appears to be a commonly occurring problem that should be addressed in a comprehensive way. The damage caused is both cosmetic and a threat to the structure if not repaired. Sealant repairs and replacements should be completed in the near term.

Water intrusion signs, Unit F303

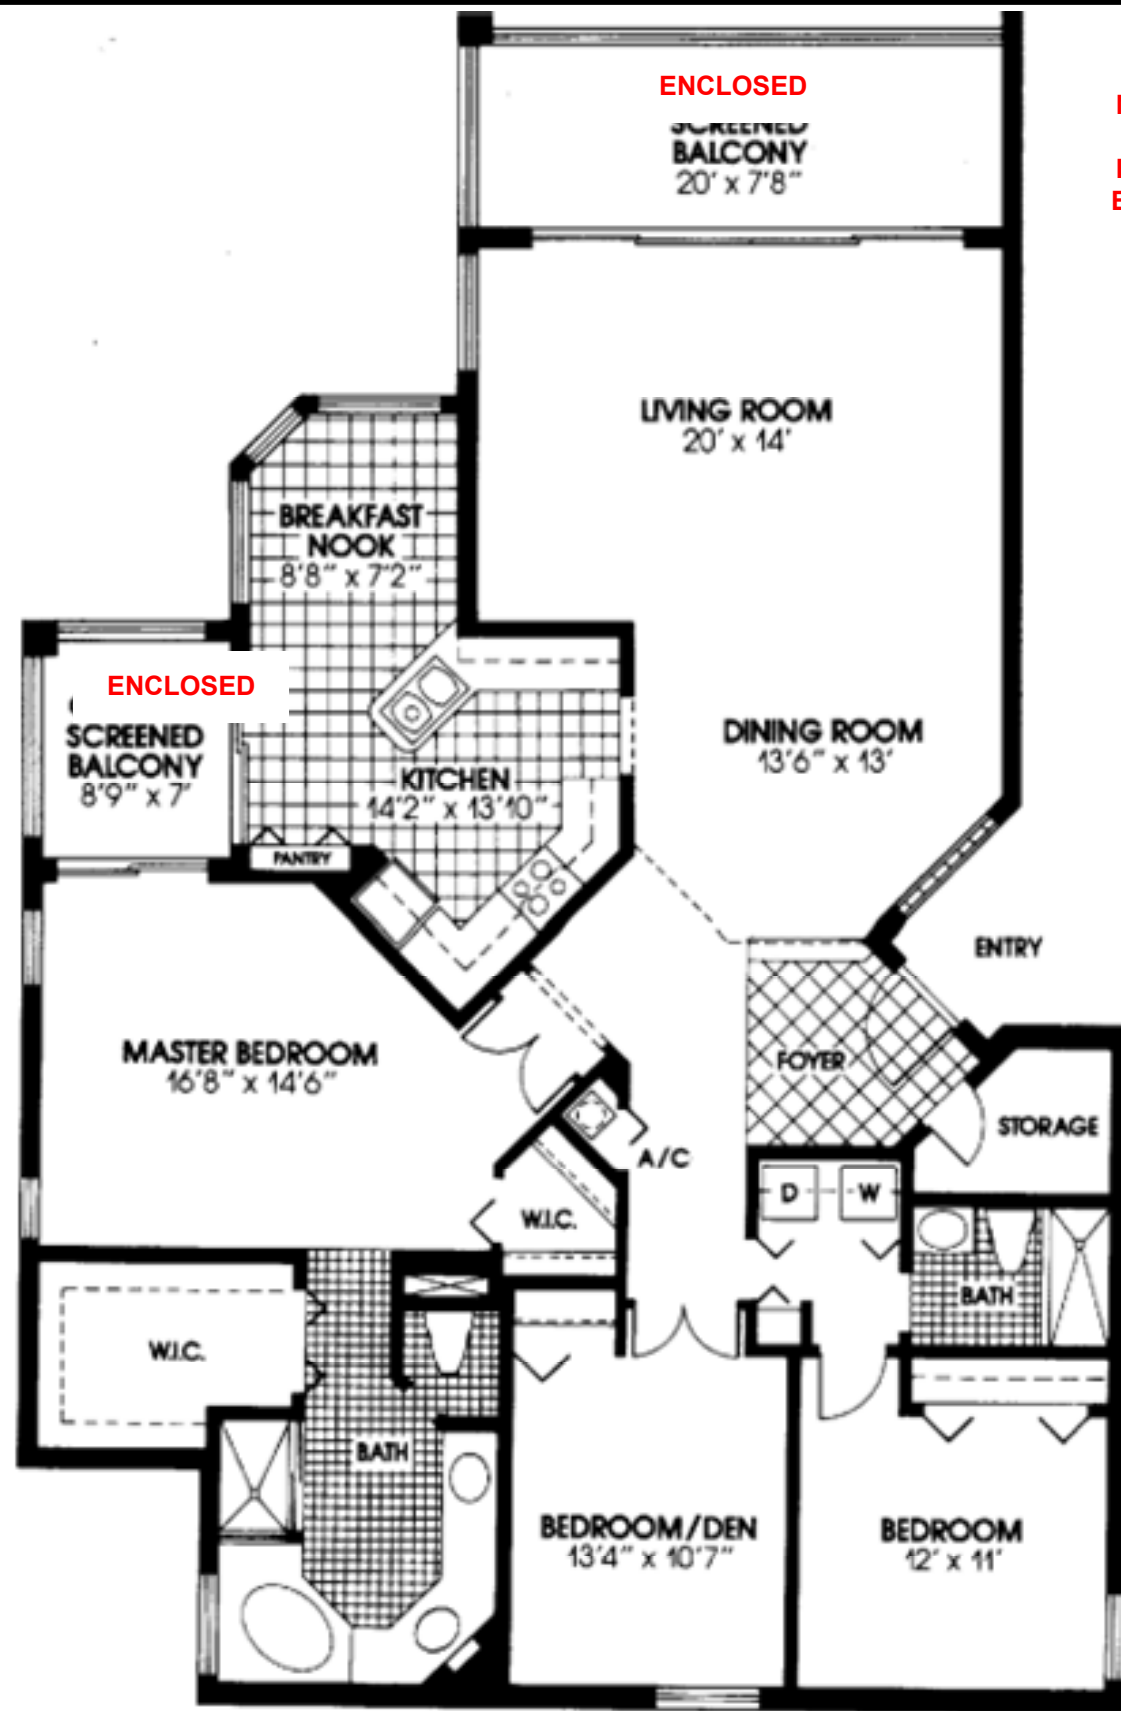
**BUILDING F  
UNIT 201**

NEW SLIDING GLASS  
DOORS APPEAR TO  
BE INSTALLED OVER  
EXIST TILE FLOOR AT  
LANAI
