July 18, 2023

CALAIS AT PELICAN BAY CONDOMINIUM ASSOCIATION, INC.

Subject: MILESTONE INSPECTION – PHASE 1
Calais at Pelican Bay – Building H
7008 Pelican Bay Boulevard
Naples, Collier County, Florida 34108
SOCOTEC Project Number 2775-002.01

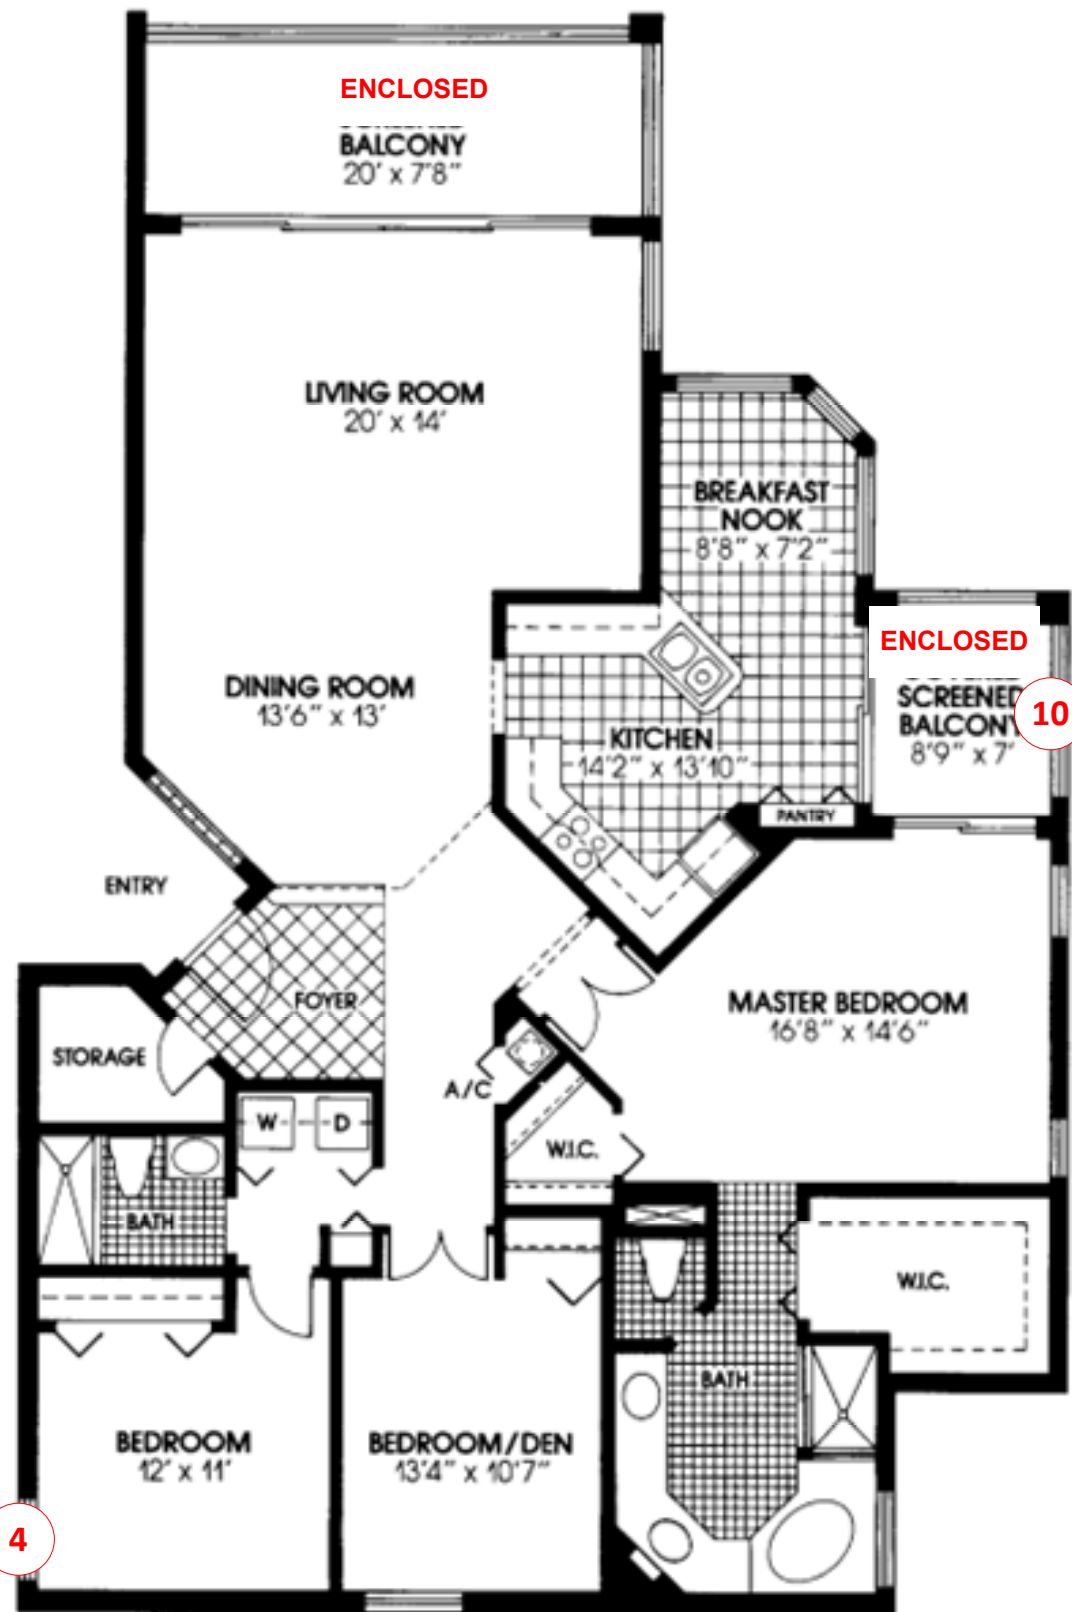
BUILDING H
UNIT 101

NEW SLIDING GLASS
DOORS APPEAR TO
BE INSTALLED OVER
EXIST TILE FLOOR AT
ENCLOSED KITCHEN
LANAI

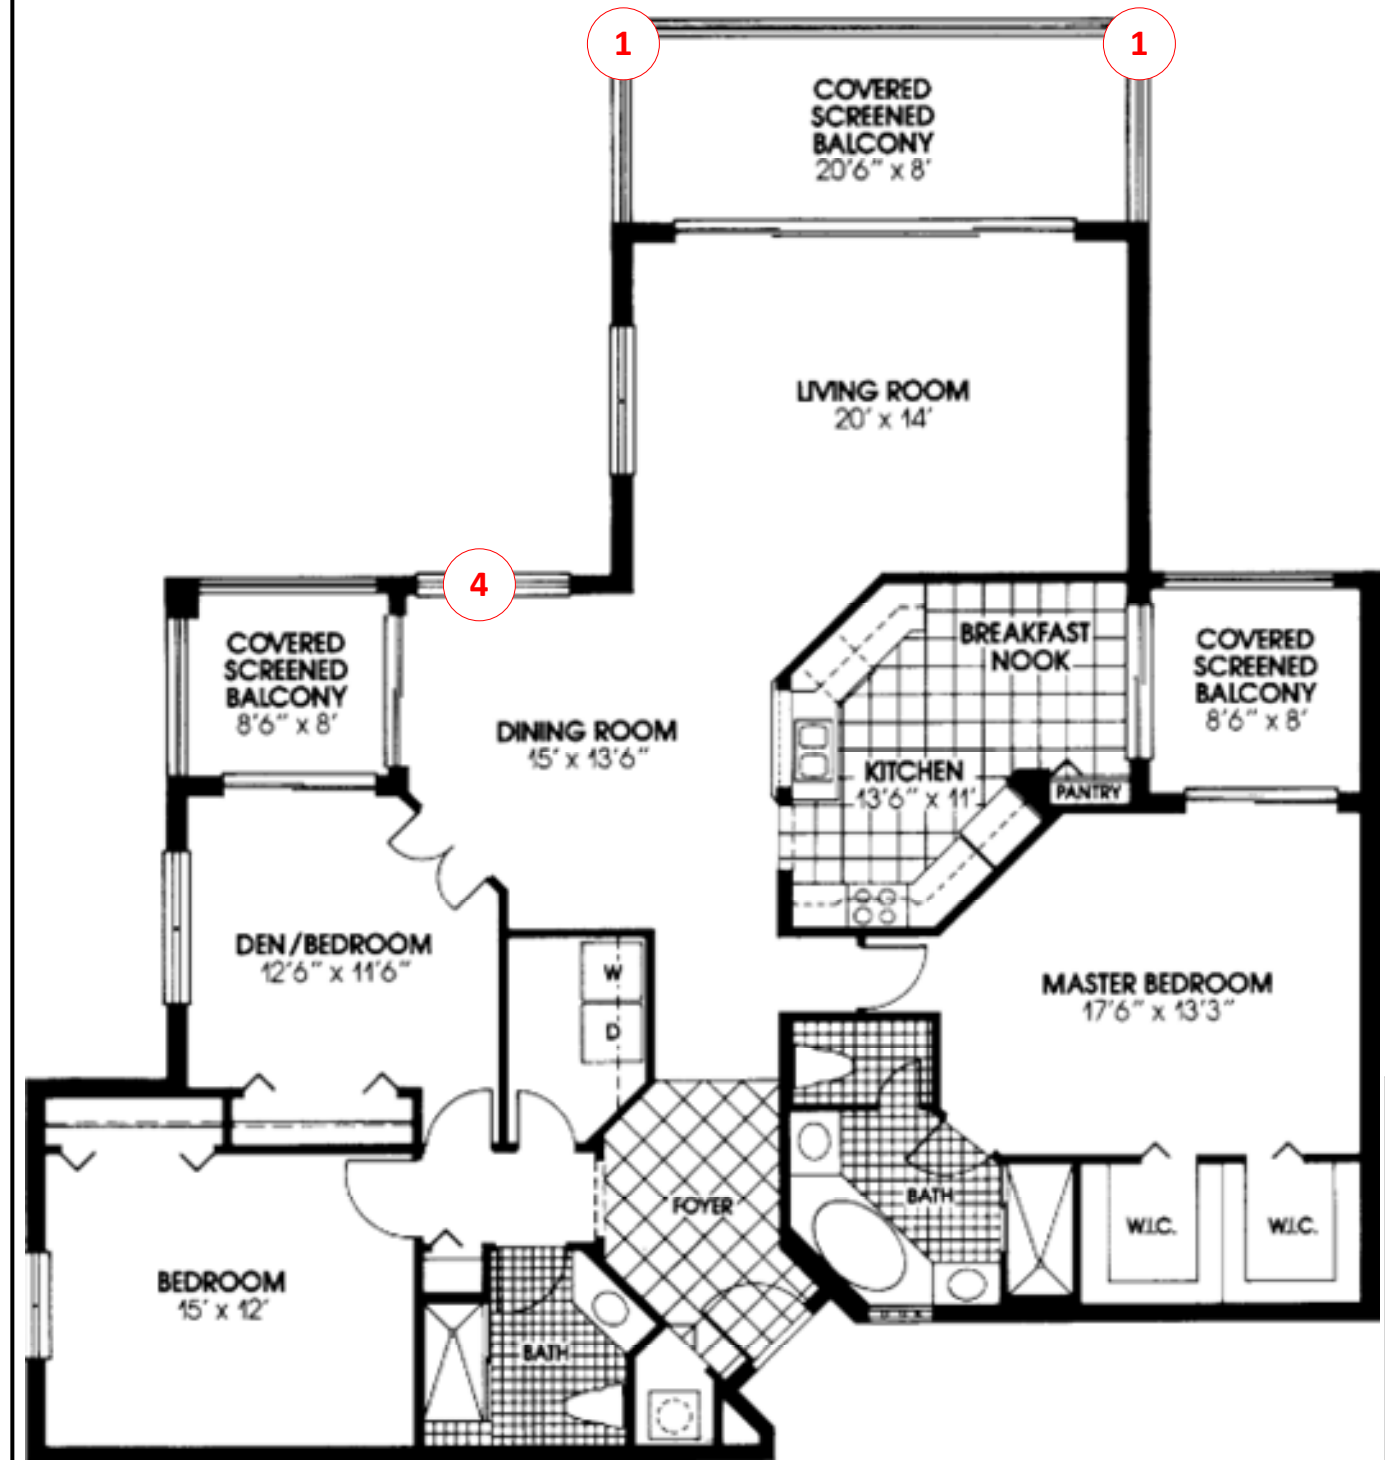
BUILDING H
UNIT 303

NOTHING TO BE NOTED

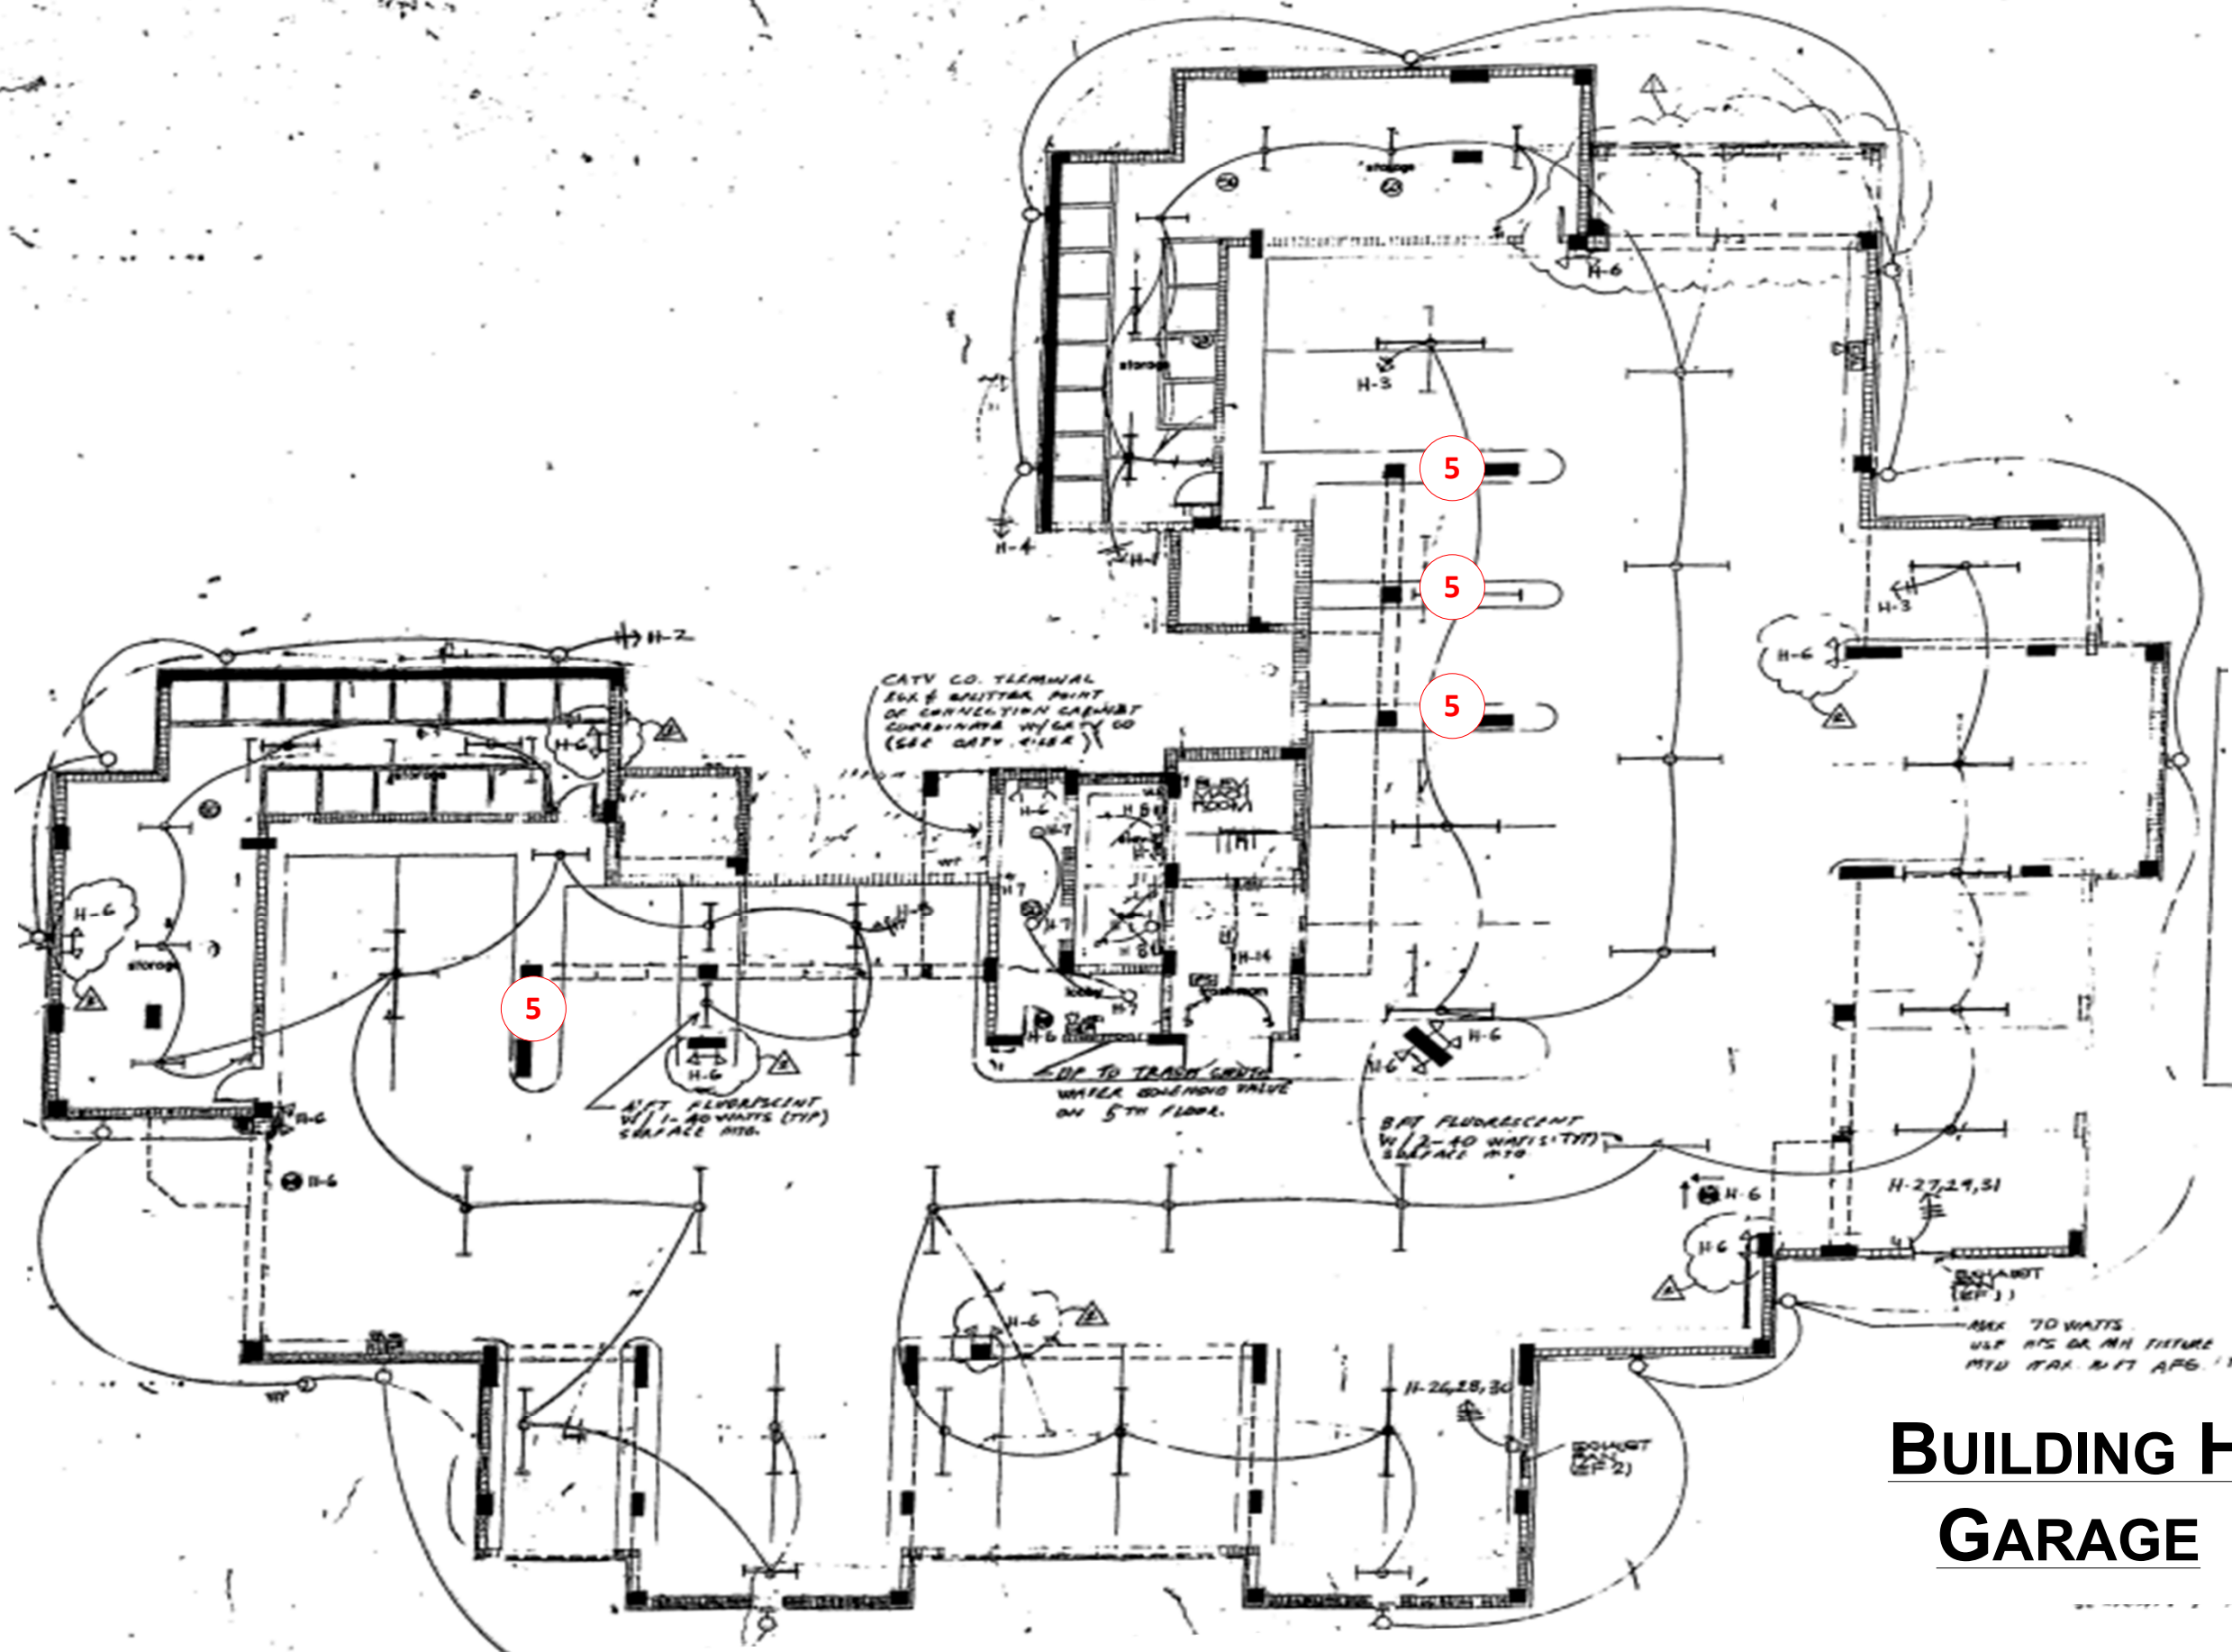
BUILDING H GARAGE

- Garage water intrusion and cracking warrants further investigation in the short term followed by a plan to address the multiple issues found during the field work. The multiple findings common to several of the garages should be further investigated and monitored.
