**CALAIS AT PELICAN BAY CONDOMINIUM ASSOCIATION, INC.**

**Subject:** Report of Engineering Consulting Services  
**STRUCTURAL EVALUATION AND REMEDIATION WORK SUMMARY**  
Calais at Pelican Bay  
Naples, Collier County, Florida 34108  
SOCOTEC Project Number VS232306

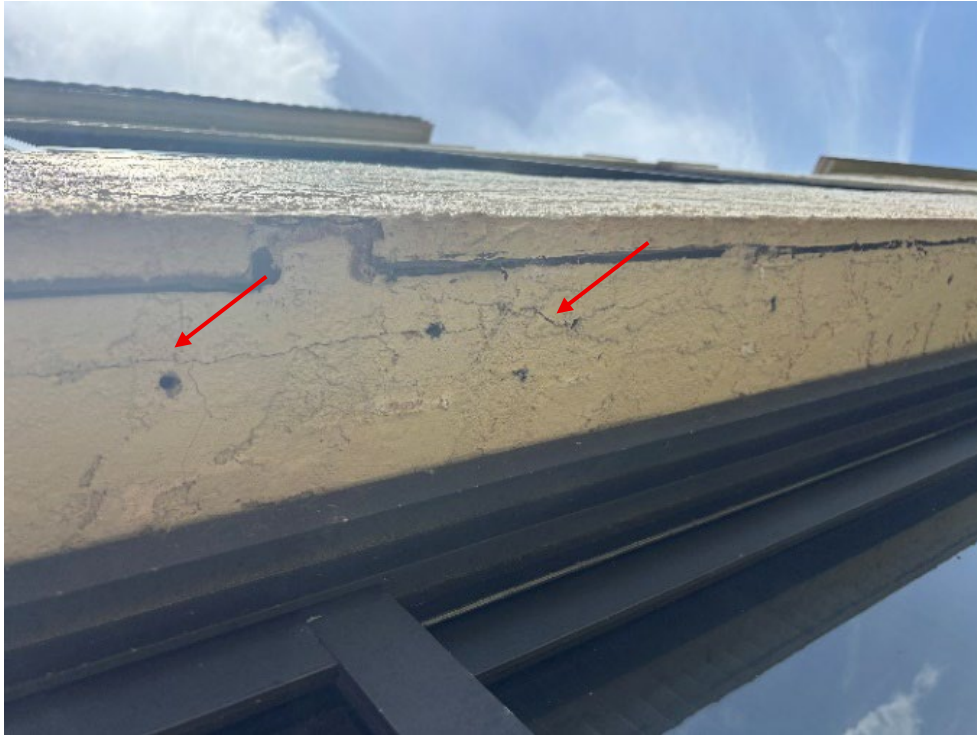
View of initial signs of distress on headers - stucco cracks along the fastener points.

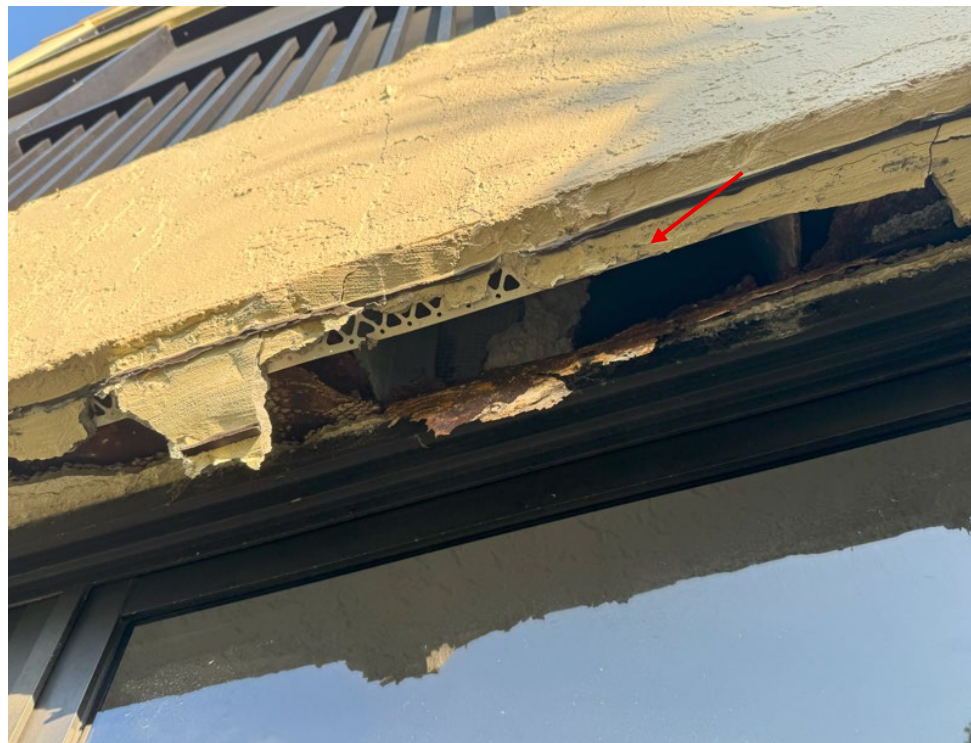
View of deterioration of header observed after further investigation.

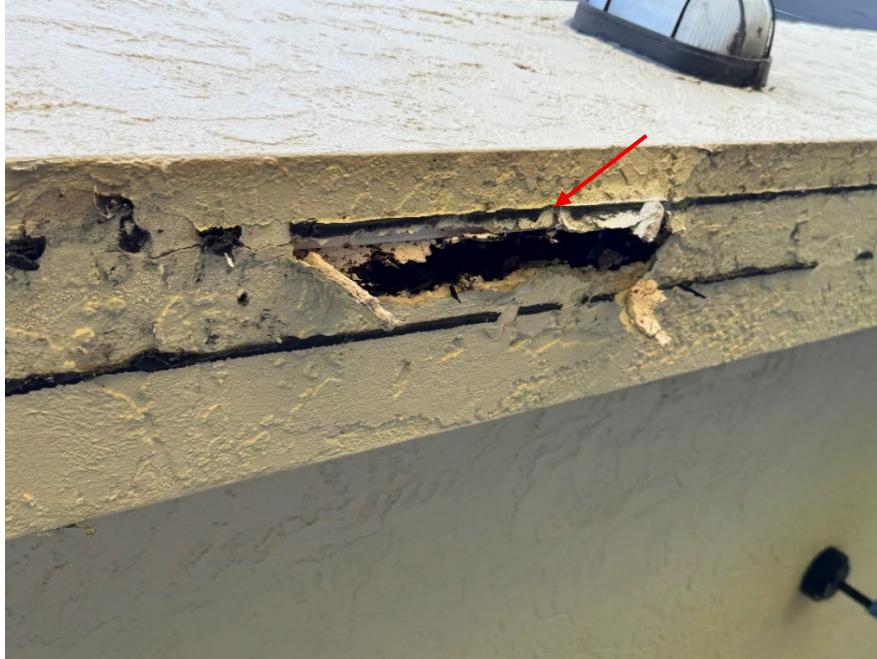
View of deterioration of header observed after further investigation.

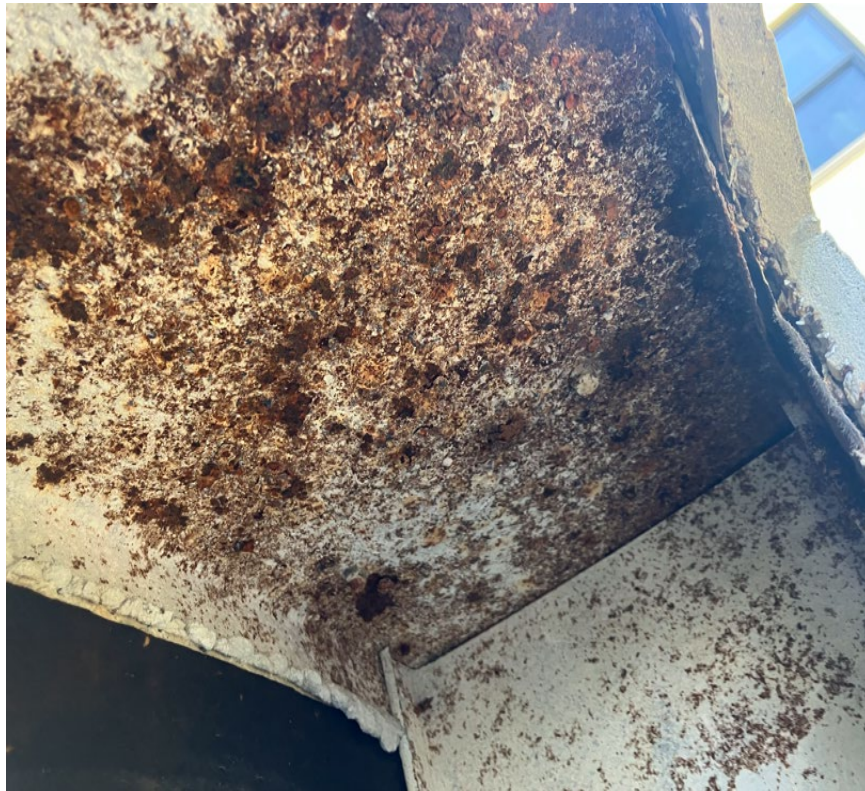
View of condition of header metal framing observed.

Additionally, we have previously identified several units with cracked stucco along the headers on the screened balconies. After further investigation, we found that this header is not a structural beam but rather a light gauge metal framing with stucco covering. Most of the headers observed contain severely corroded and deteriorated light gauge metal framing. Repairs to these headers have been made at multiple units in accordance with our previously provided repair details. The Association should anticipate that these findings are unlikely to be limited to a single unit, rather may be present throughout the property.

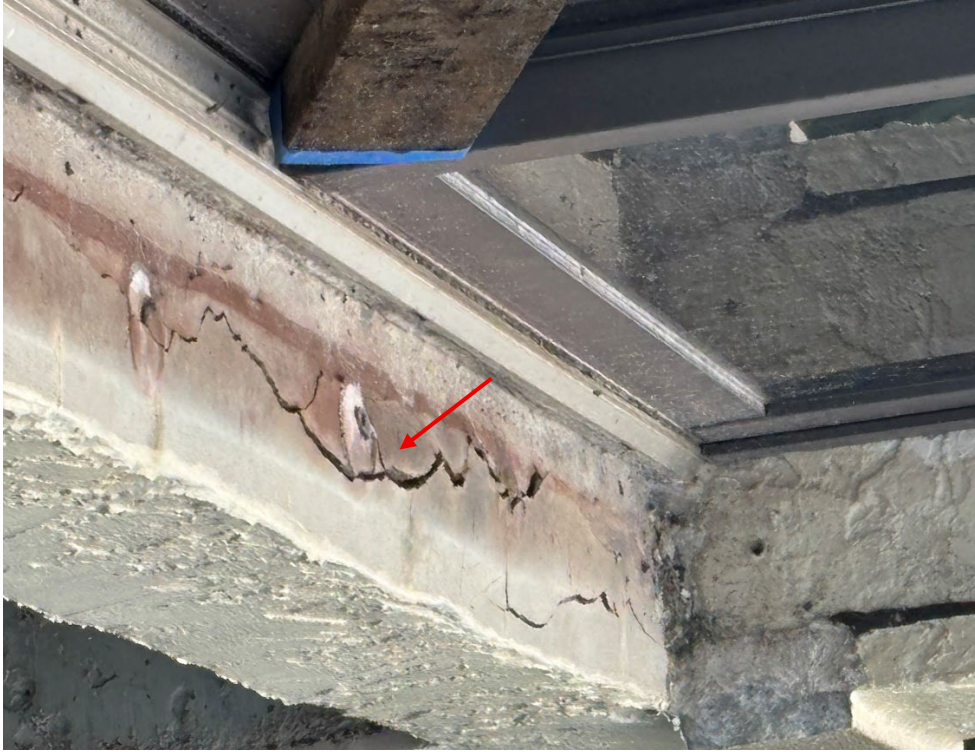
View of structural distress observed at balcony deck edge along fastener points.

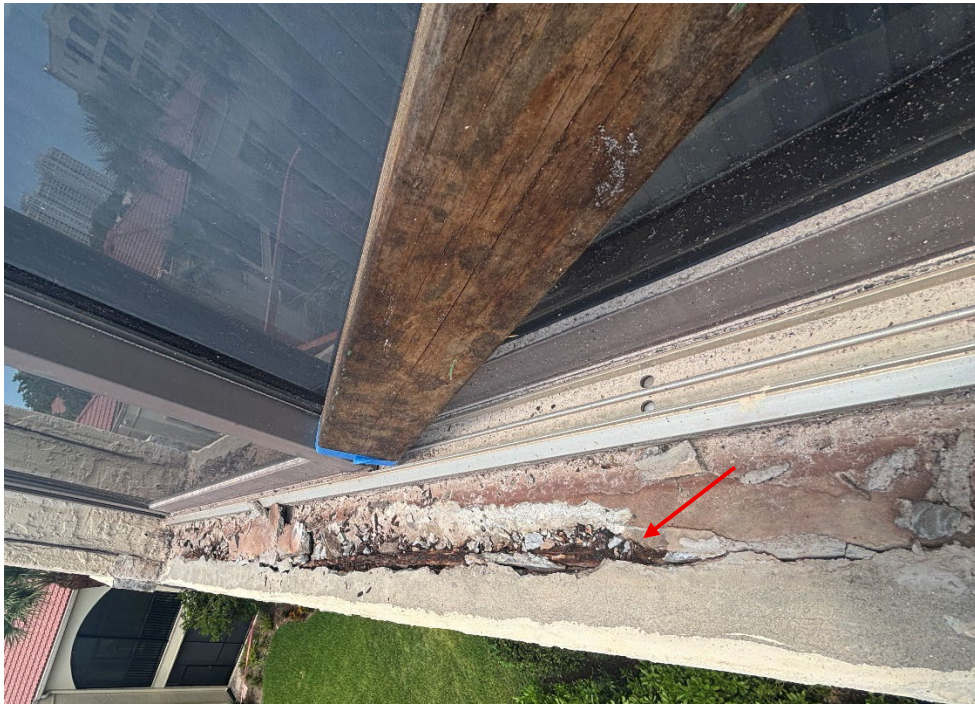
View of structural distress parallel to corroded steel reinforcement bar.

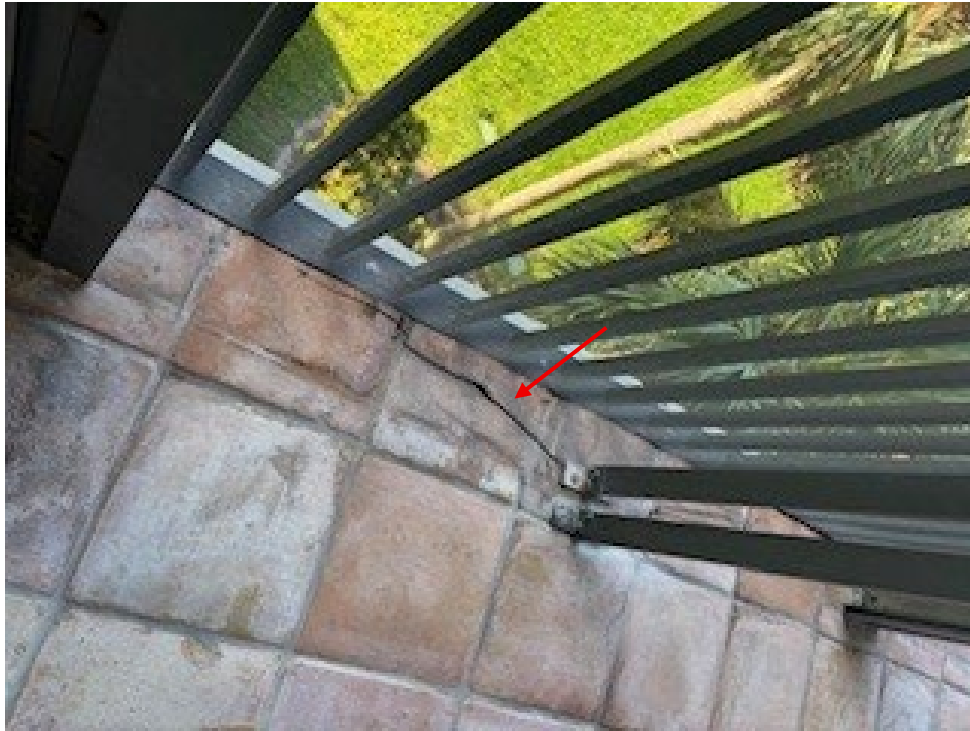
View of cracked/delaminated tiles stemming from shutter system fastener points.

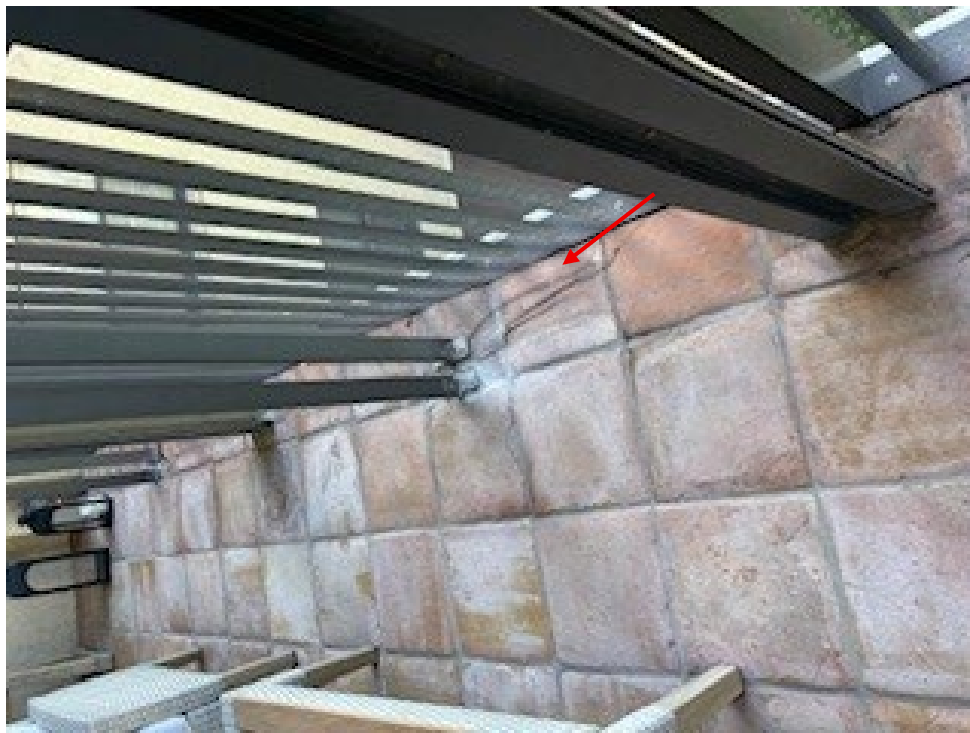
View of cracked/delaminated tiles stemming from shutter system fastener points.

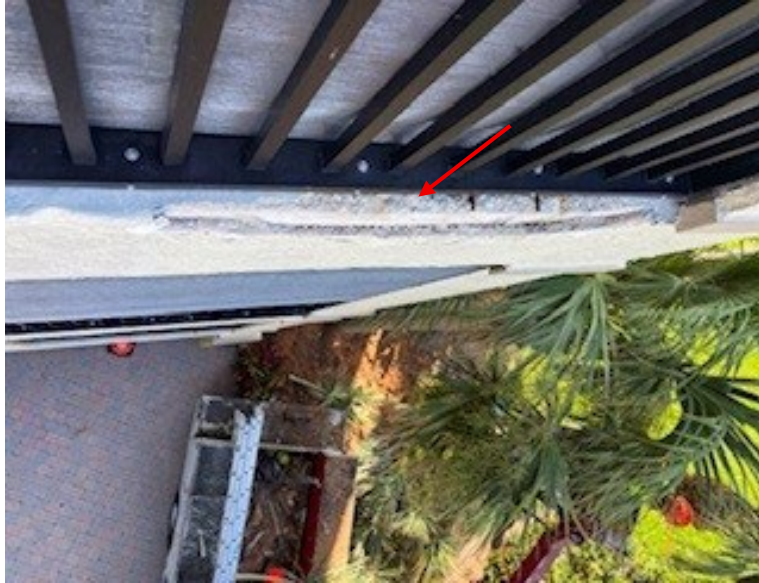
View of exposed balcony deck edge steel reinforcement bar and concrete spall.

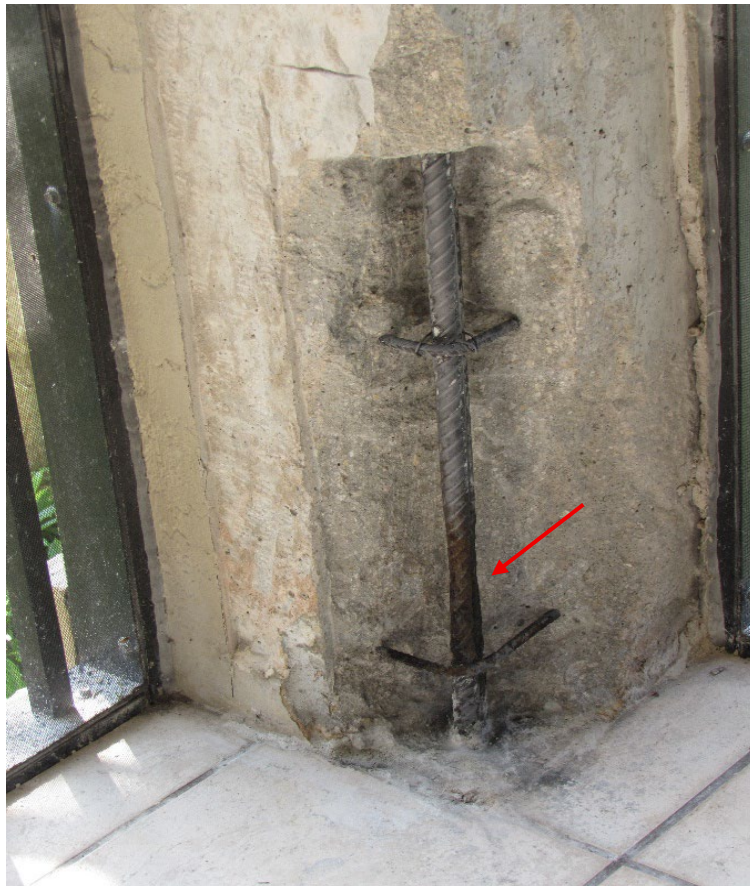
View of corroded steel reinforcement bar and distressed concrete at balcony column.

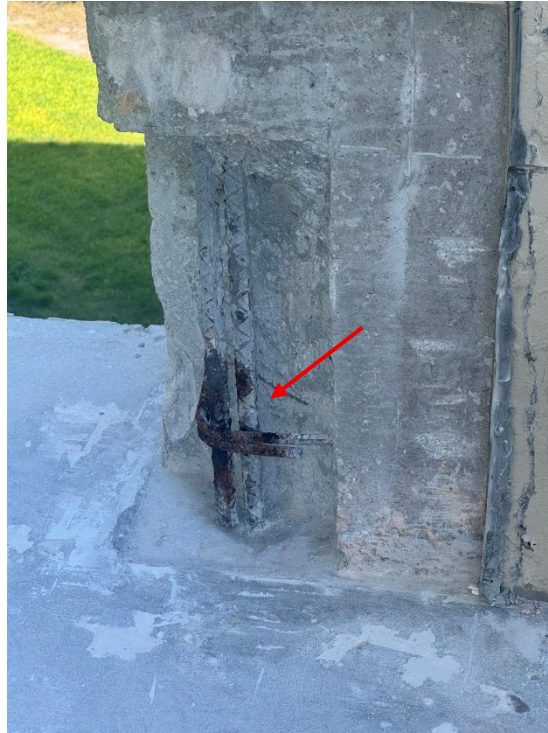
View of corroded steel reinforcement bar and distressed concrete at balcony column.

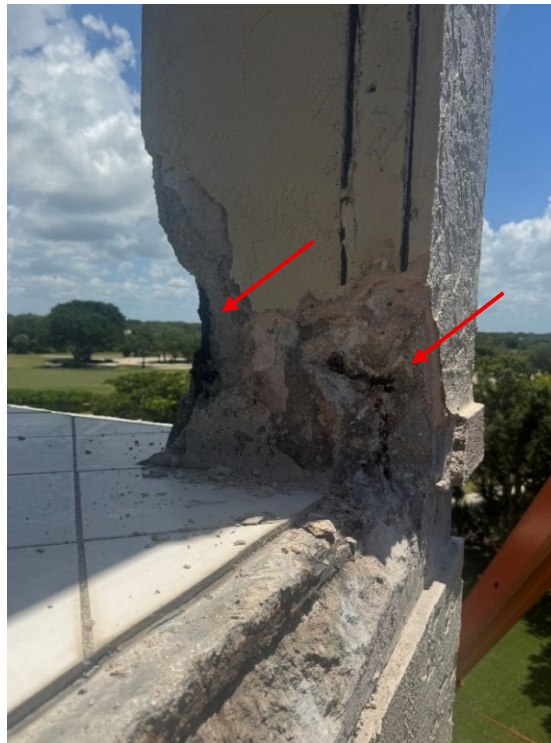
View of corroded steel reinforcement bar and distressed concrete at balcony column.

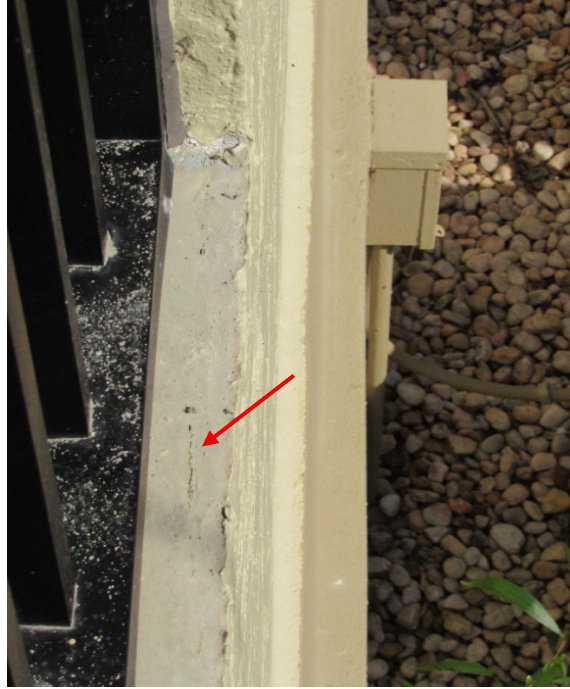
View of initial signs of distress at balcony deck edge – minor cracks.

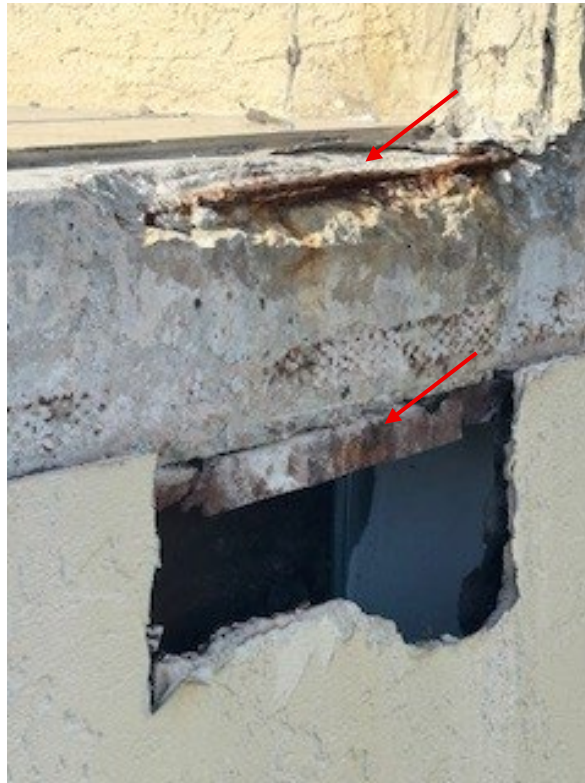
View of corroded steel reinforcement bar, deteriorated concrete, and header framing.

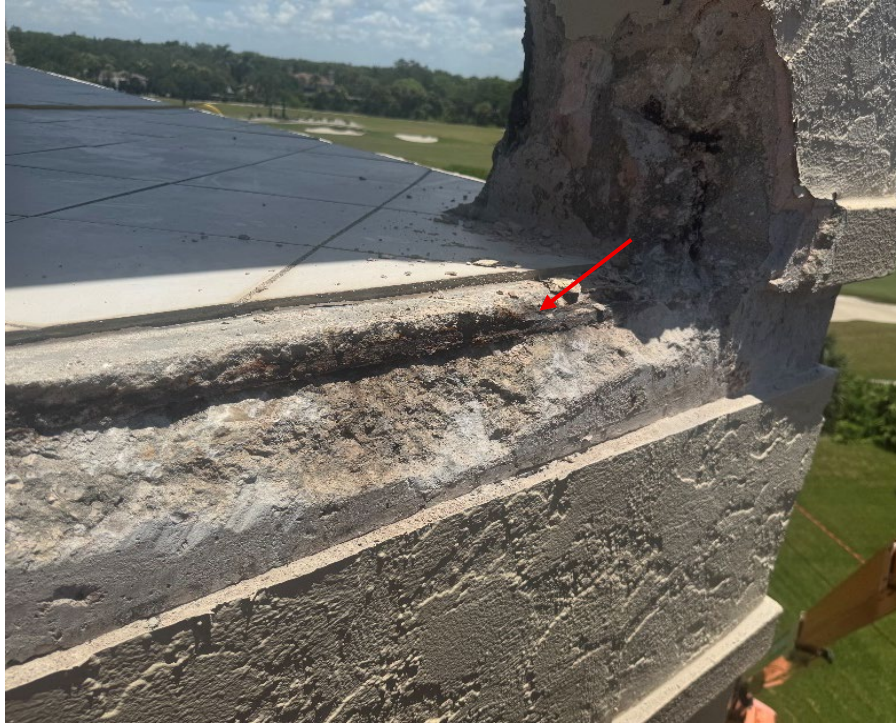
View of corroded steel reinforcement bar along balcony deck edge.

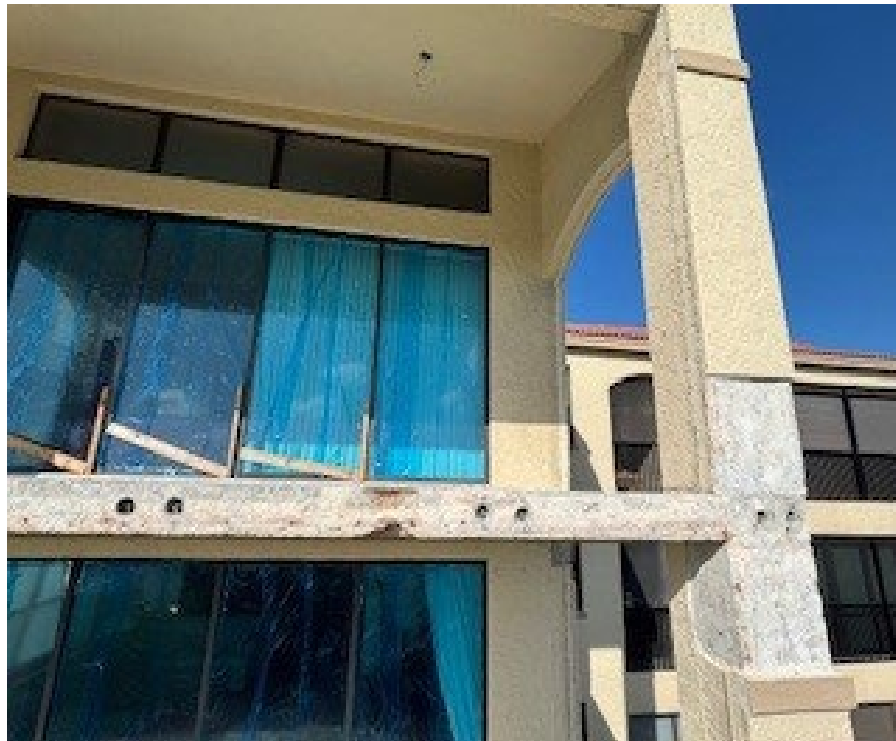
Typical view of compromised post-tension cables along balcony deck edge.

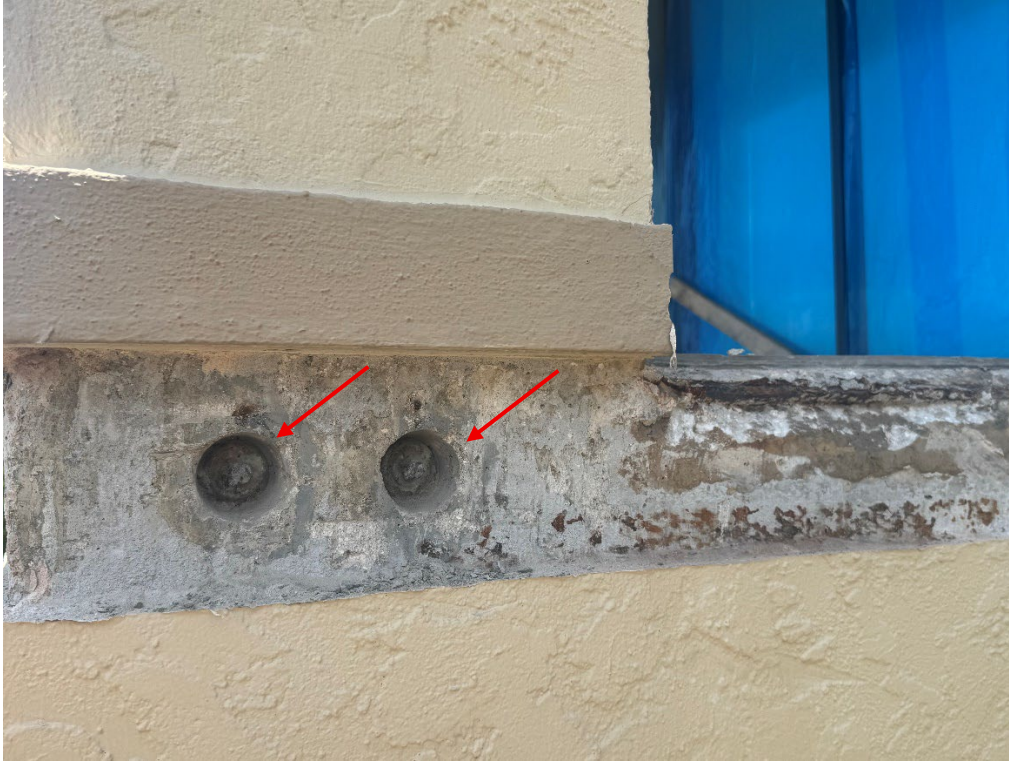
View of post-tension cable pockets with deteriorated cement and signs of corrosion.

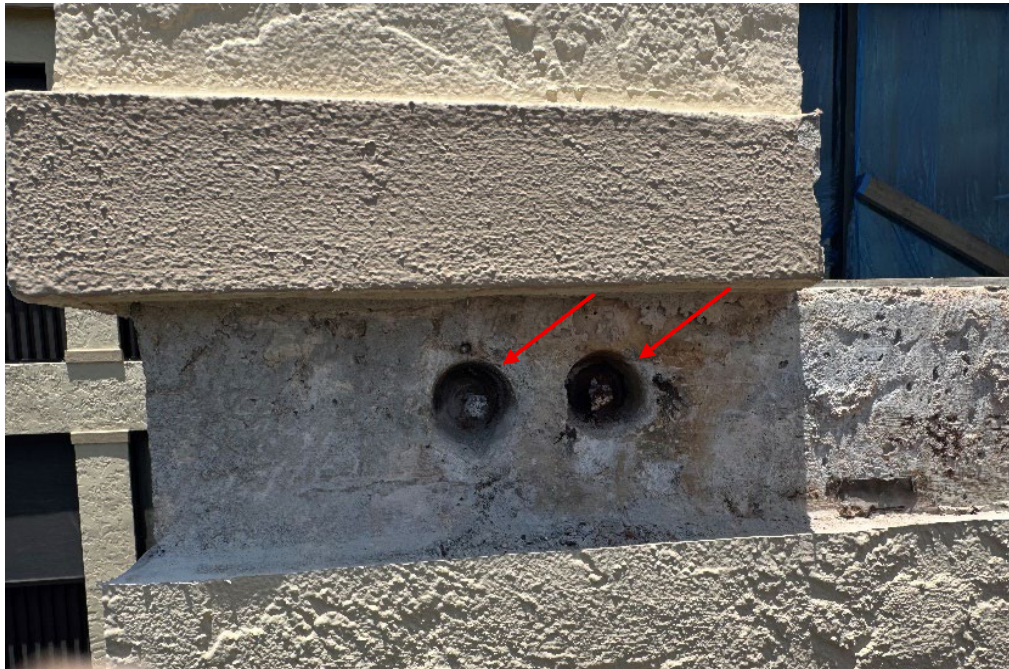
View of post-tension cable pockets with deteriorated cement with signs of corrosion.
