## Calais at Pelican Bay

### Project Management Report – Building D

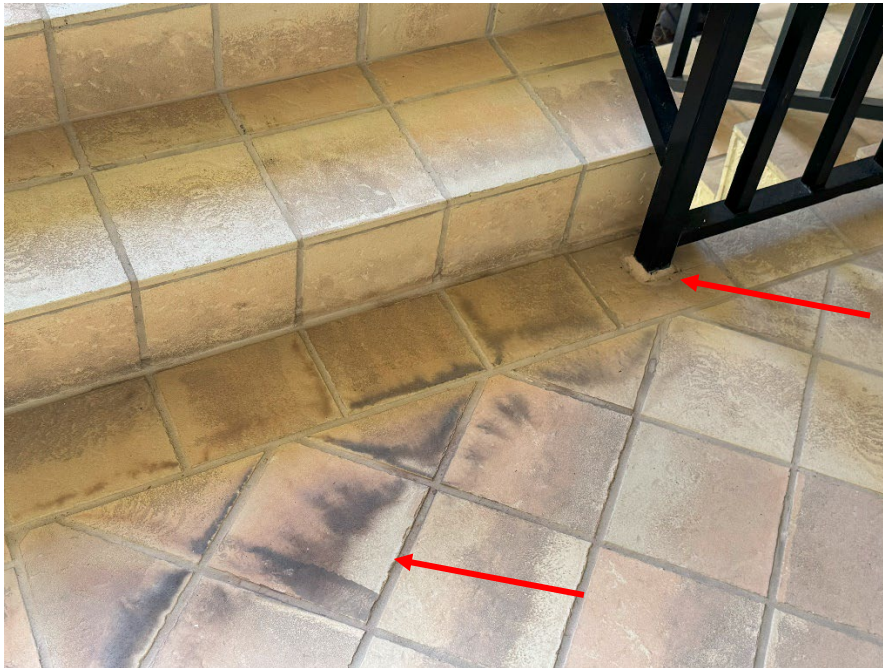
Our inspection revealed what appears to be minor stucco delamination in this area. This condition is likely due to signs of water ponding and possible water intrusion through the railing post. There is a possibility that water is penetrating behind the stucco surface. We recommend removing the stucco for further investigation of the underlying conditions.

Area Under Staircase: Signs of water ponding and possible water intrusion.

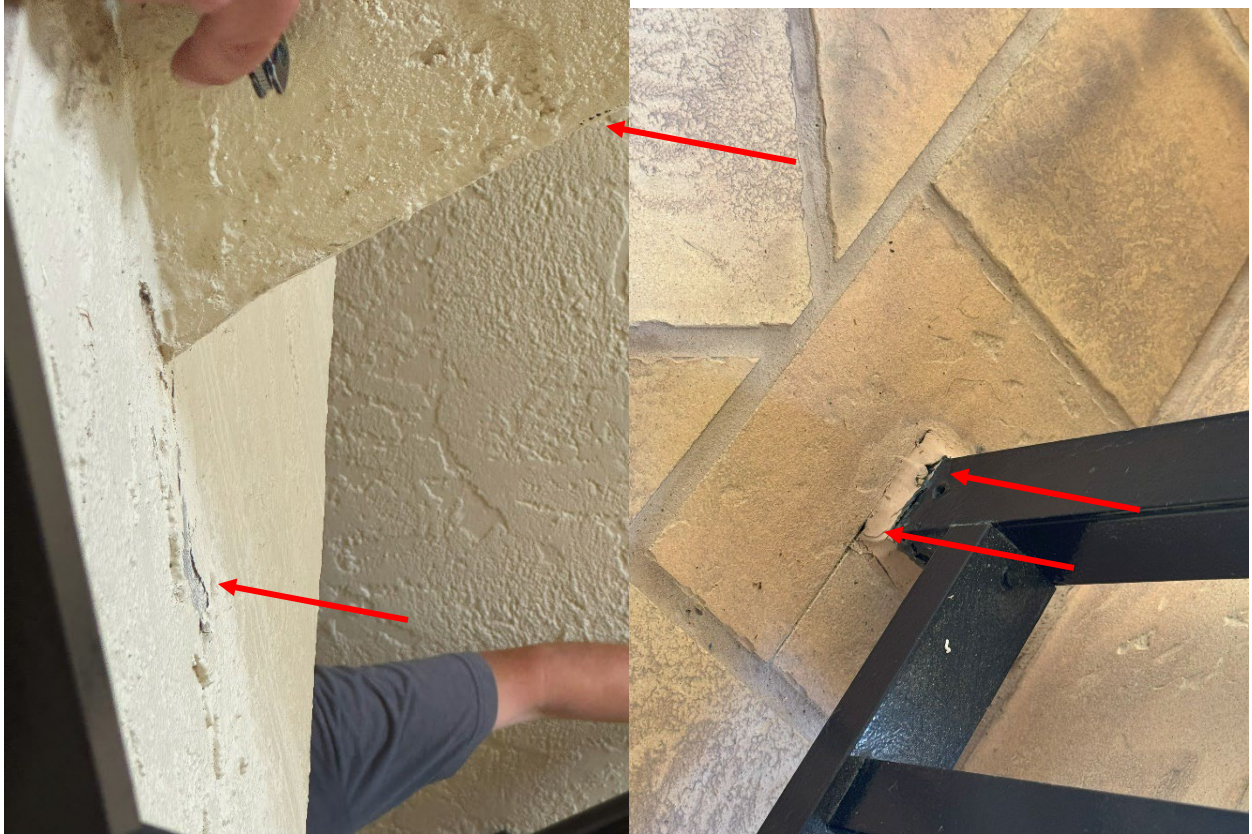
Area Under Staircase: Observed stucco delamination and possible water intrusion at railing post.

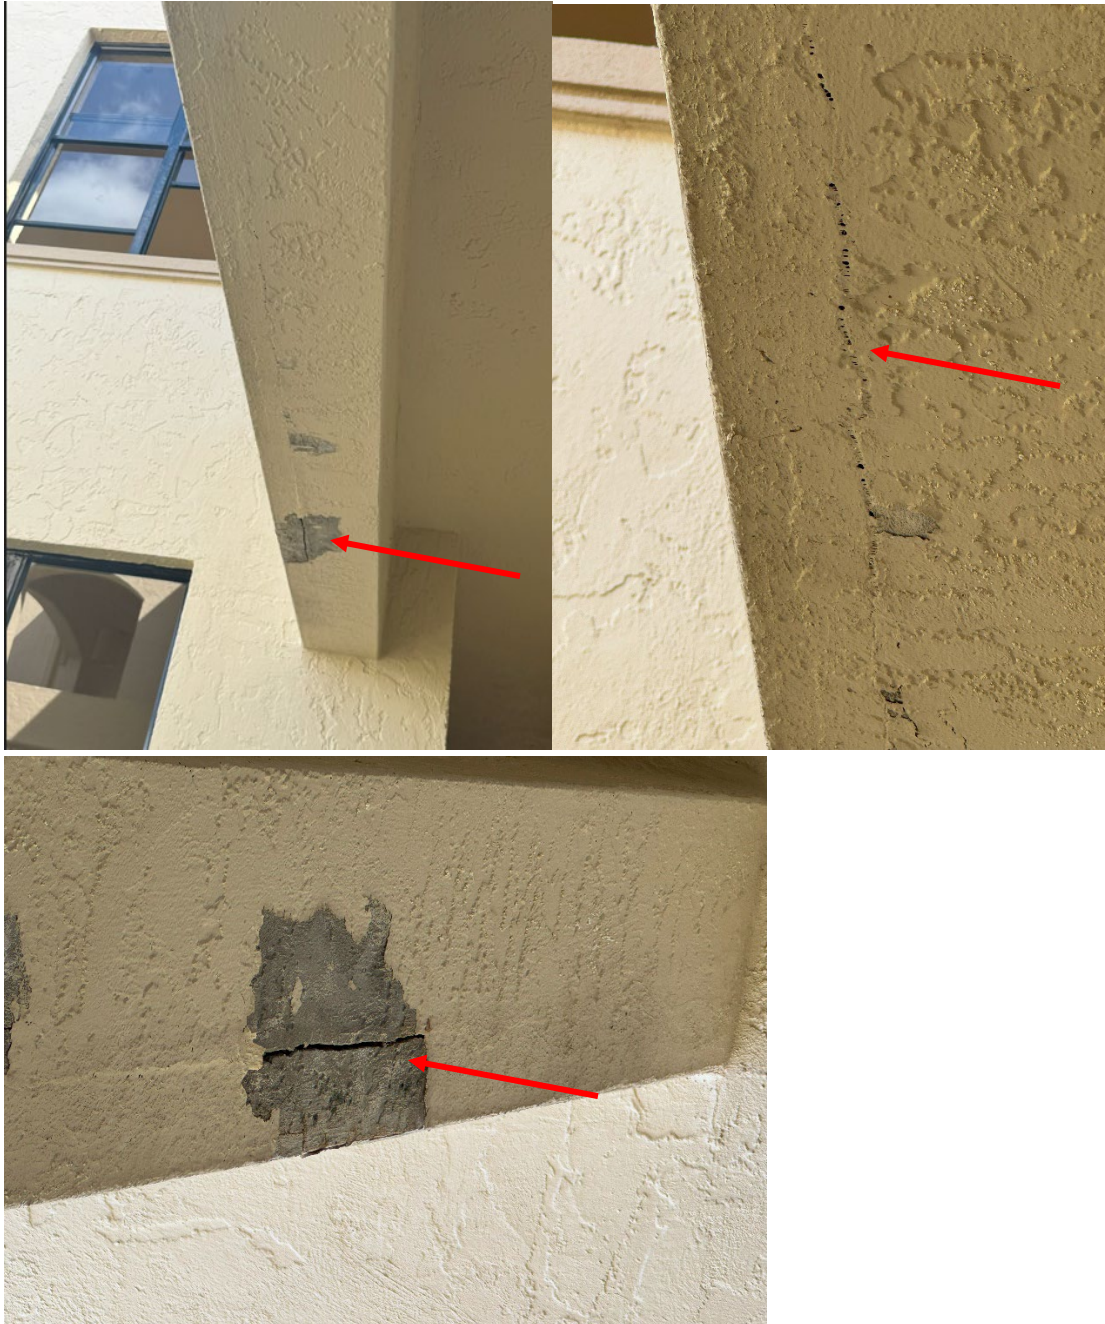
We observed delamination in this area as well. The linear fractures in the concrete surface can be superficial or extend through the concrete. To properly assess the area, we recommend sounding the area and proceeding with the removal of damaged/hollow sections to examine the extent of delamination to determine the depth of deterioration.

Fourth Floor Walkway: Observed delamination and linear crack along header.
