## Calais at Pelican Bay

### Project Management Report – Building D

#### 1. Unit 203 Headers:

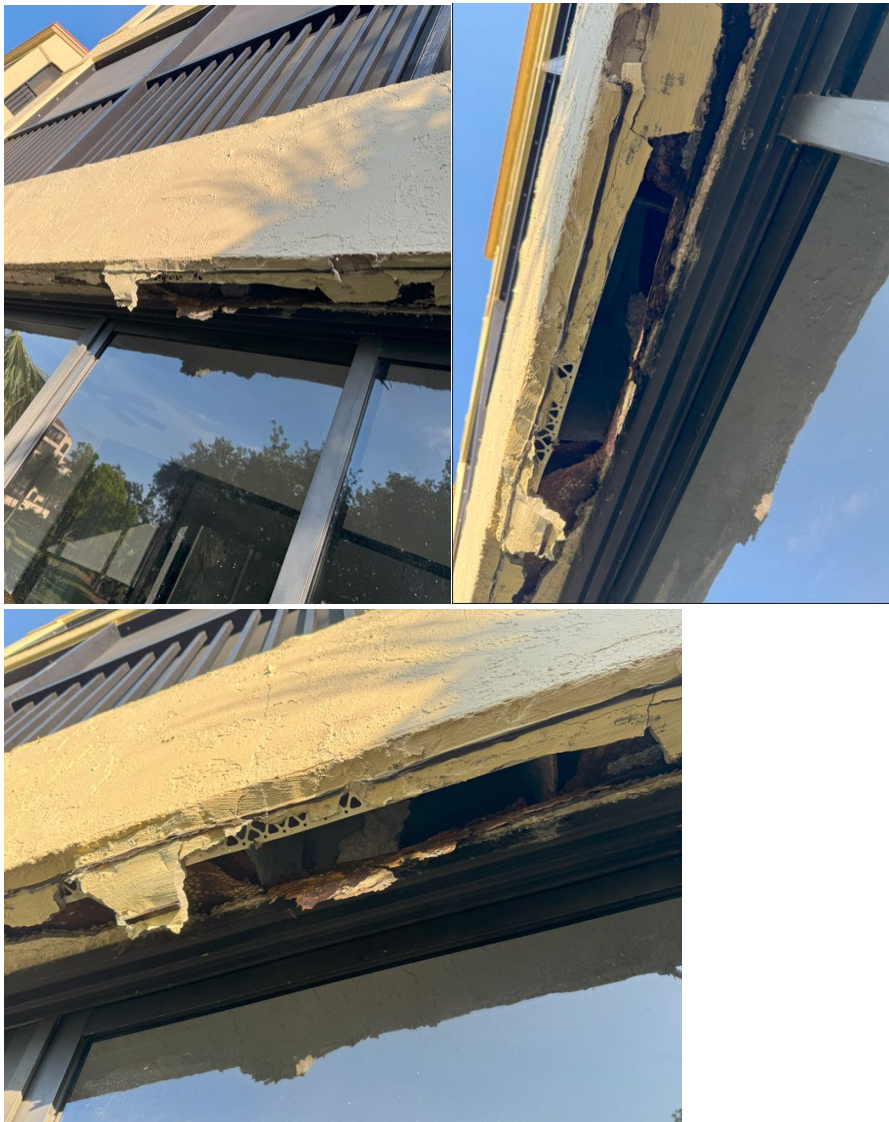
Larger Header – Signs of severe corrosion and deterioration of metal framing.

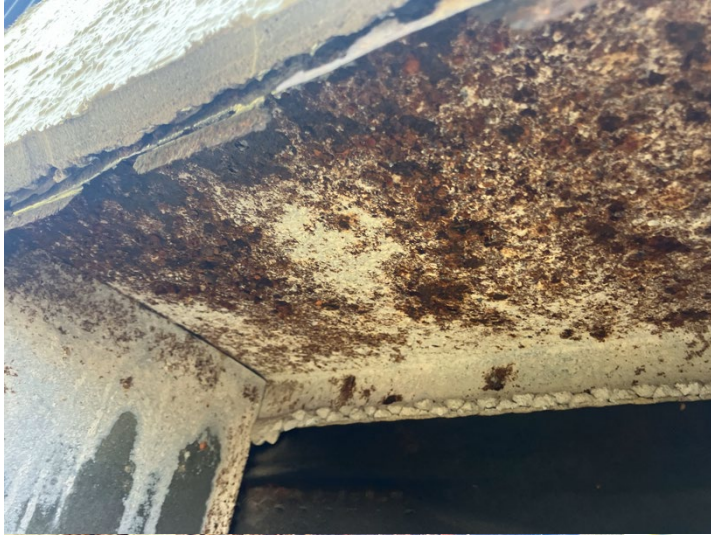
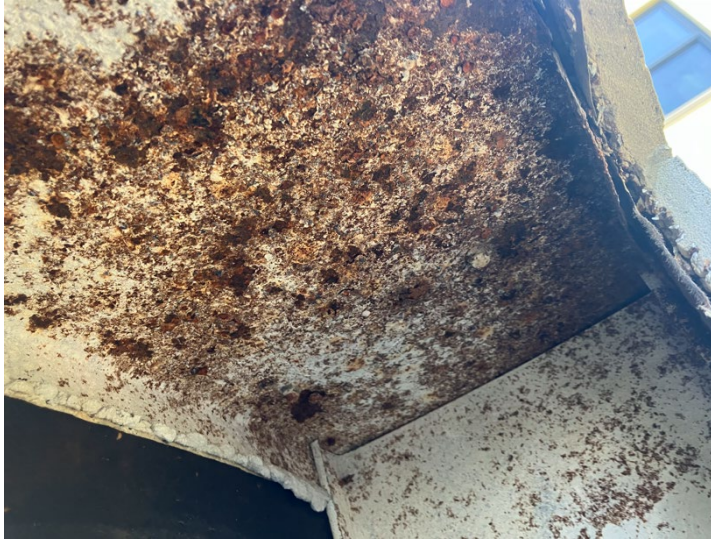
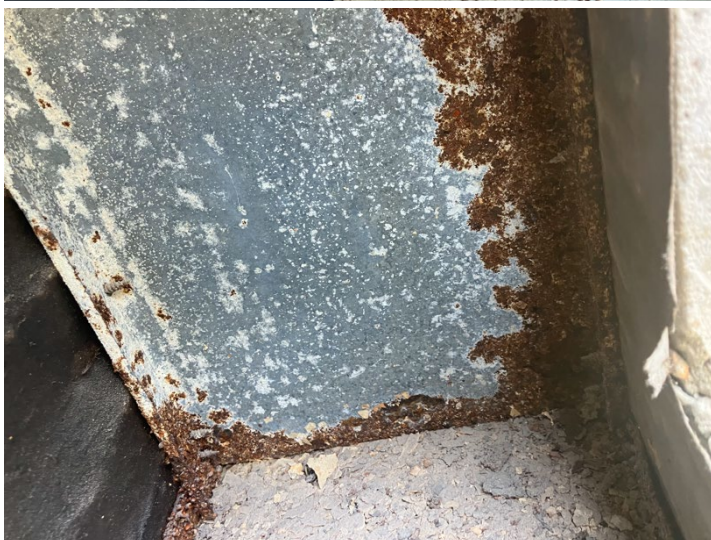
Right Header – Signs of severe corrosion of the metal framing.

After further investigation of the headers at unit 203 we found the right header light gauge metal framing is badly corroded and the large center header is also severely corroded and deteriorated. The left header appears to be in good condition and does not require replacement at this time. Please see the photos attached. It is in Socotec's opinion that both severely corroded headers will need to be removed and replaced in accordance with the details provided and the exploratory hole in the right header shall be patched as soon as possible.

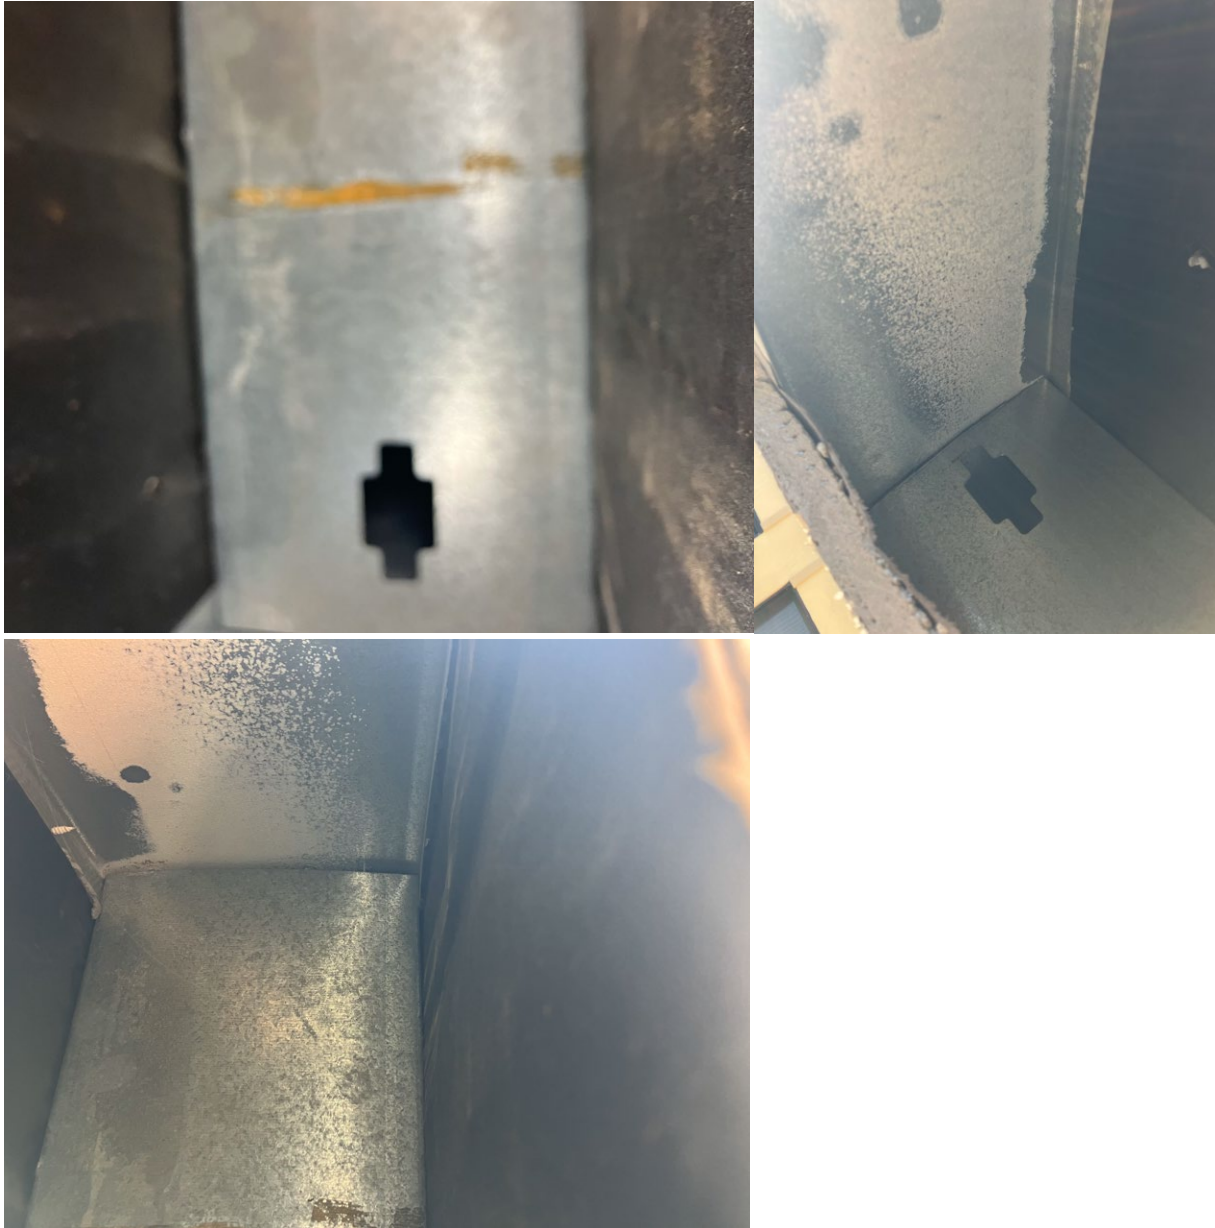
Left Header – No signs of corrosion and deemed in good condition.
