## **Calais at Pelican Bay**

### **Project Management Report – Building F**

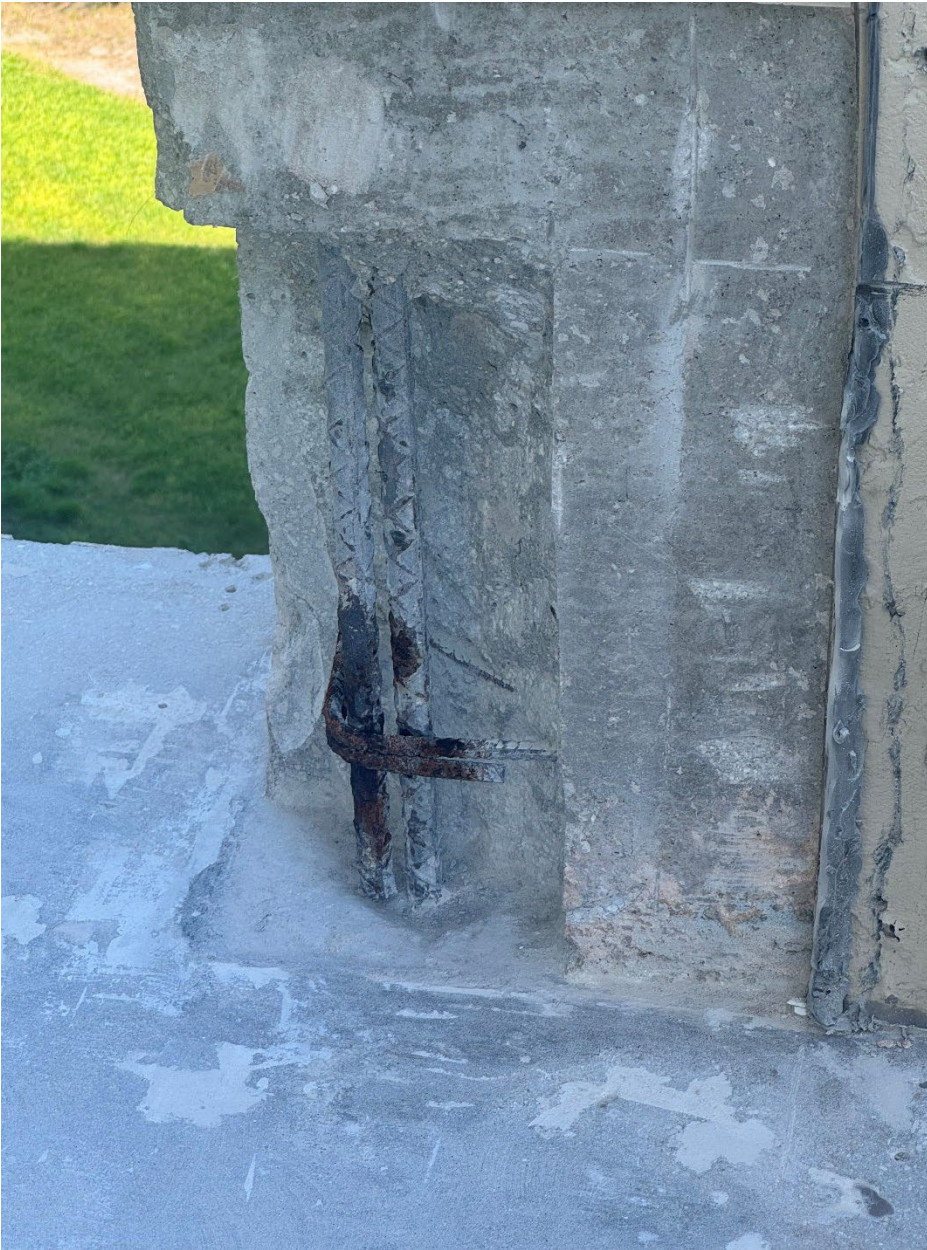
#### **1. Unit F303 Concrete Restoration:**

Structural distress (cracking) at a column was inspected by Socotec and instructions for repair were given onsite to the field supervisor. A standard concrete restoration procedure in accordance with the permitting plans provided is in progress.

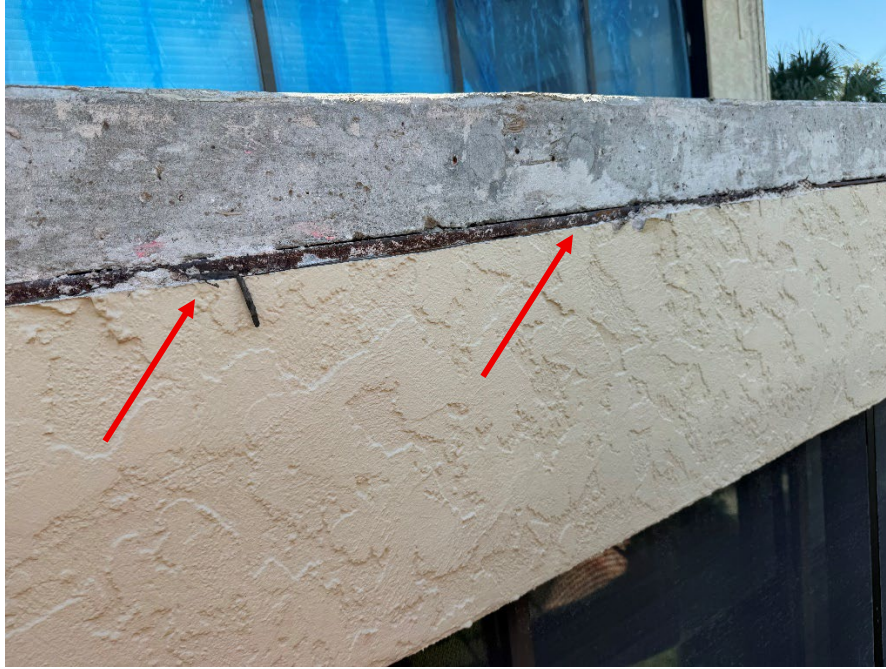
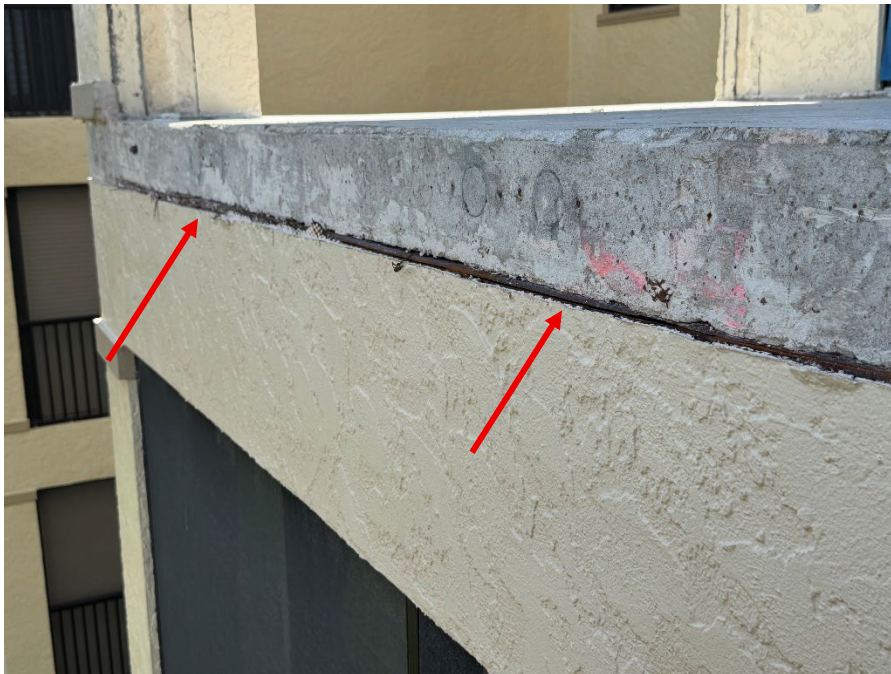
2. Unit F203 Header:

Severe corrosion of the edge of the light gauge metal framing was observed at the large header of the lanai. We recommend an exploratory hole be made in the header to further investigate the condition of the header.

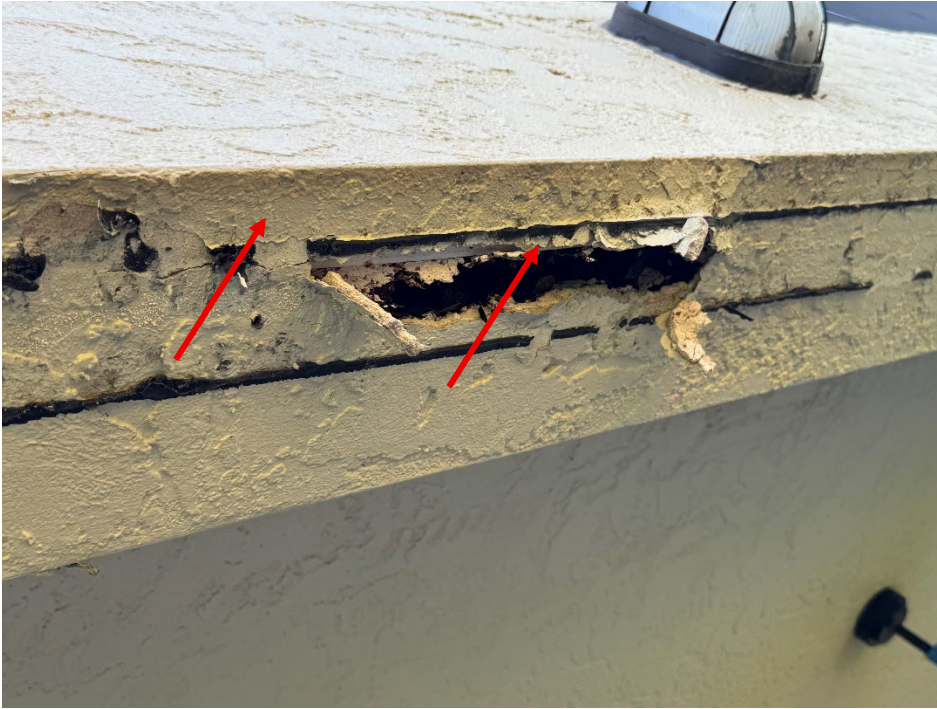
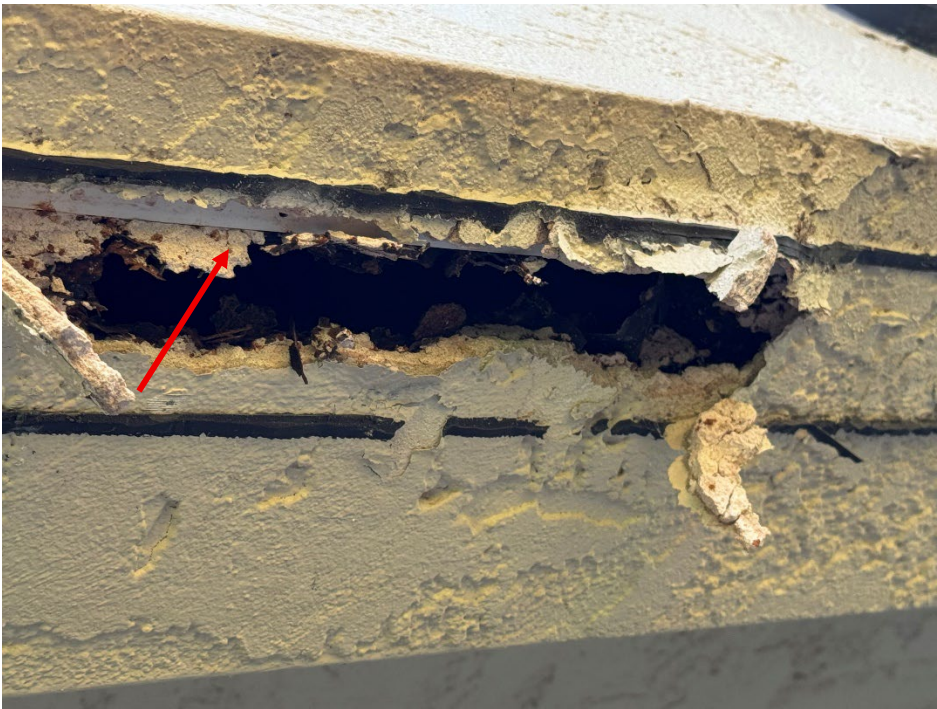
3. Unit F103 Header:

Structural distress (cracking) and severe corrosion of the light gauge metal framing was observed at the large header of the lanai. It is in Socotec's opinion that a standard header restoration procedure must be performed in accordance with the permitting plans provided.
