## **Calais at Pelican Bay**

### **Project Management Report – Building F**

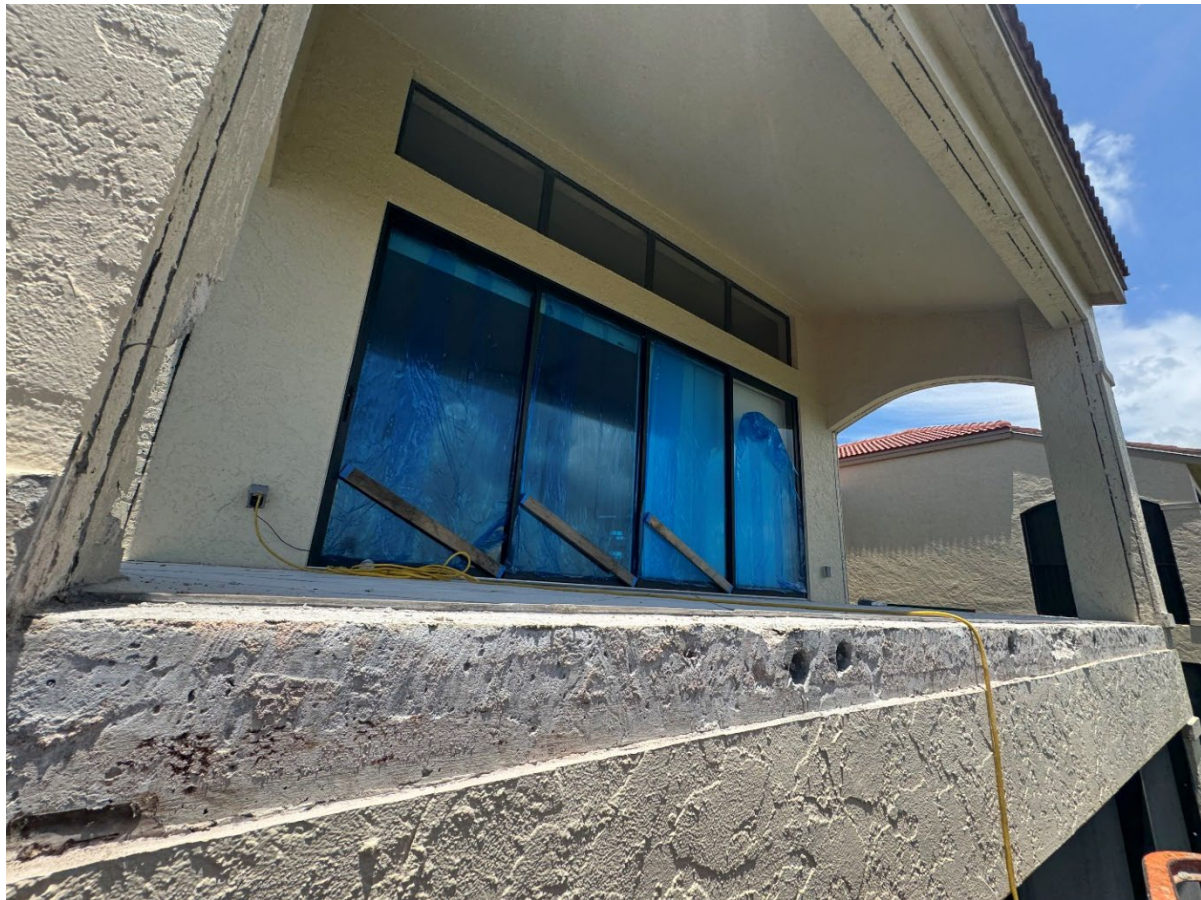
#### **1. Unit F502 Concrete Restoration:**

Structural distress (corroded and exposed rebar, and concrete delamination) at the left balcony column and along the entire deck edge of the lanai was observed by Socotec. The tiles along the entire balcony will need to be removed to inspect the deck for any issues (cracks, spalls, etc.), perform any necessary concrete restoration work, and waterproof the entire balcony deck. A standard concrete restoration procedure in accordance with the permitting plans provided must be followed. We also noted the deterioration of eleven (11) post-tension cables requiring repair. A specialist will be assisting with the cable tensioning and sequencing work related to the post tension cable repairs. Installation of shoring and reshoring posts in accordance with the provided plans will be necessary to perform the repairs since most likely the concrete demolition will be done around the post tension cables. Locations of the shoring posts shall be as indicated by the Engineer of Record (EOR) on site on 8/5.

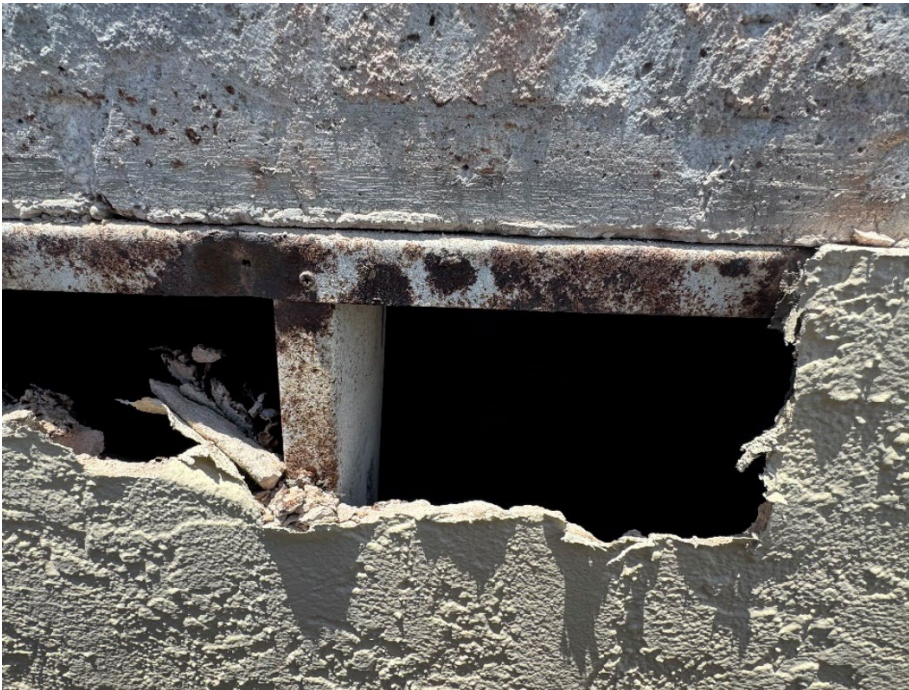
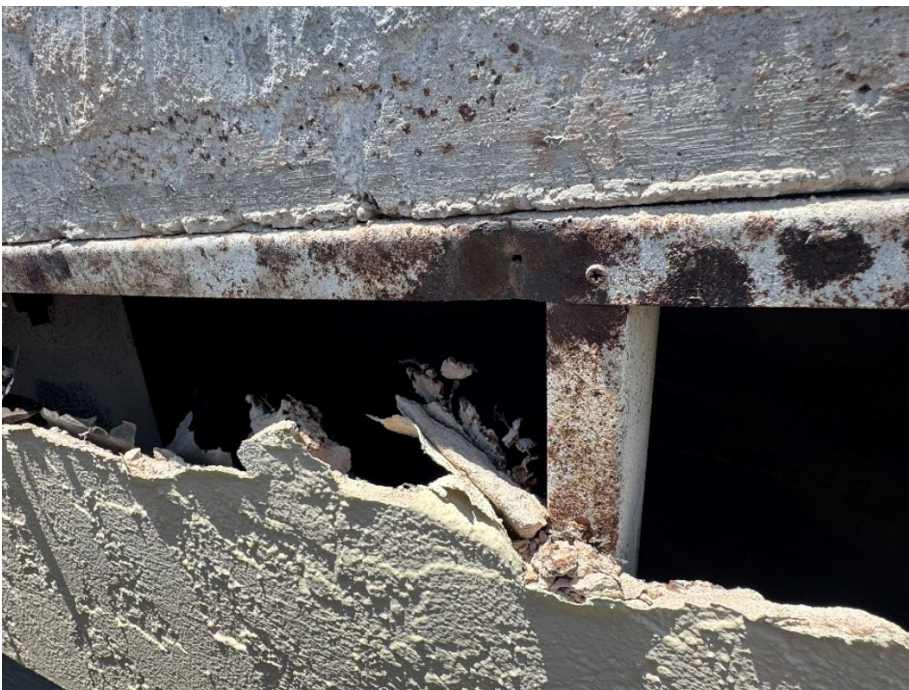
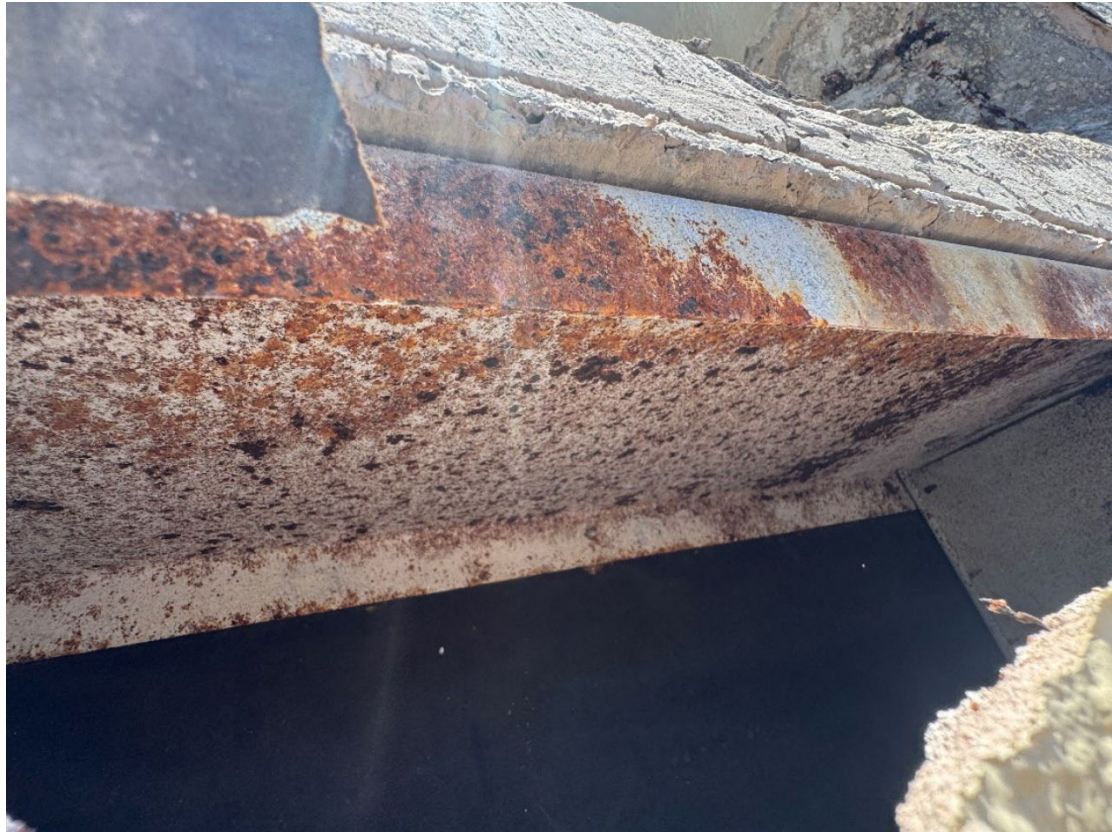
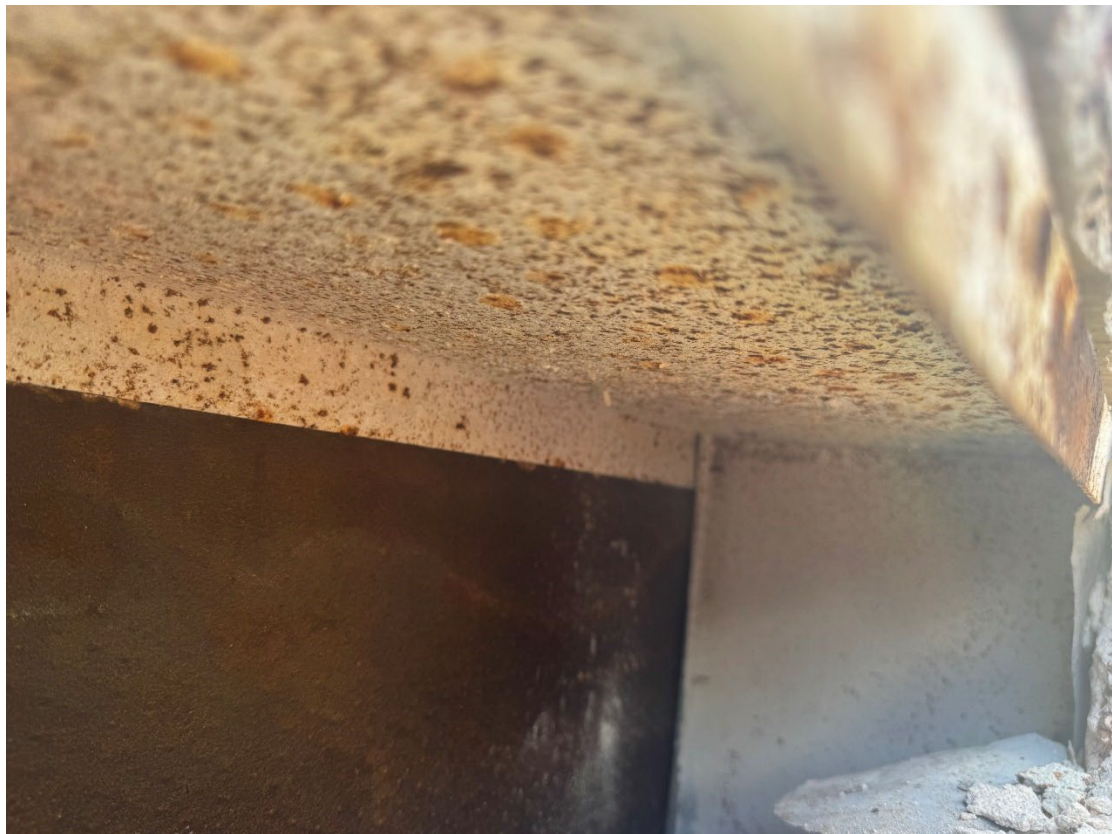
2. Unit F402 Headers:

Exploratory holes were opened in all 3 headers to assess the condition of the header framing. Severe corrosion of the light gauge metal framing was observed at all headers of the lanai. A standard header restoration procedure in accordance with the permitting plans provided must be followed.

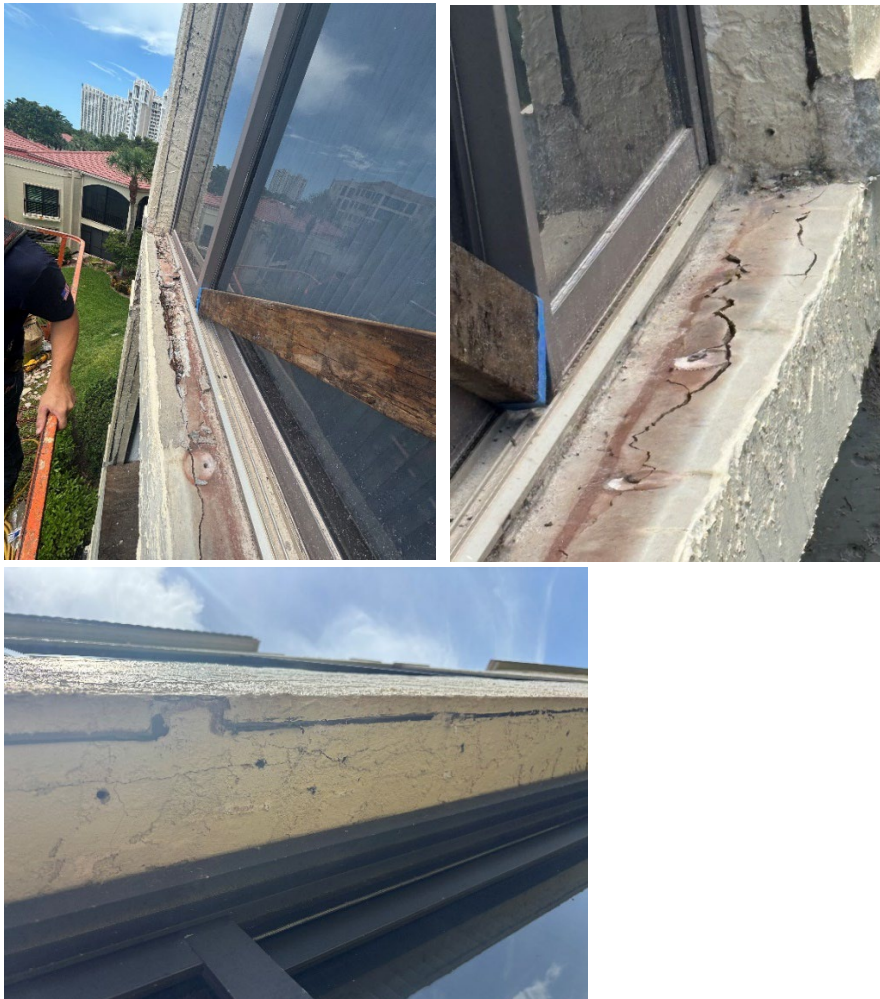
### 3. Unit F302 Concrete Restoration and Headers:

Structural distress (corroded and exposed rebar, and concrete delamination) along the deck edge of the lanai was observed by Socotec. The sliding glass door must be removed to properly perform any necessary concrete restoration work. A standard concrete restoration procedure in accordance with the permitting plans provided must be followed. In addition, we also noted signs of potential deterioration of several post tension cables requiring repair. While the full extent of affected post-tension cables is unknown, based on our observations of the existing conditions, we anticipate that the pattern and extent of deterioration will likely be similar to what was previously documented in the 04 stack. Installation of shoring and reshoring posts in accordance with the provided plans will be necessary to perform the repairs since most likely the concrete demolition will be done around the post tension cables. Locations of the shoring posts shall be as indicated by the Engineer of Record (EOR) on site on 8/5. Structural distress (cracking) was also observed at the large header of the lanai. It is in Socotec's opinion that a standard header restoration procedure must be performed in accordance with the permitting plans provided.
