## Calais at Pelican Bay

### Project Management Report – Building D and F

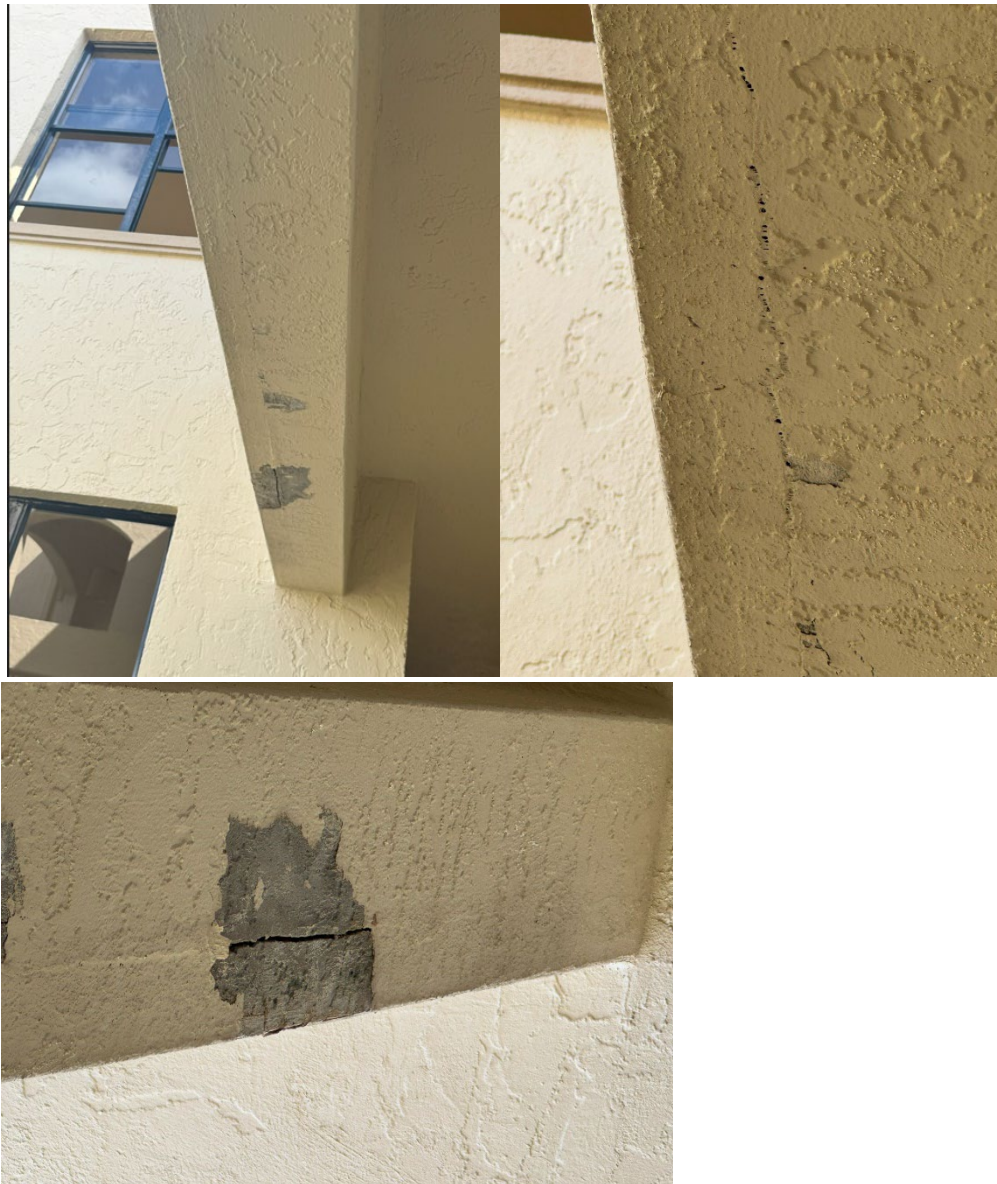
Structural distress (concrete delamination) along the header was previously observed and directions to remove all distressed/hollow sections of the concrete/stucco were given. Upon removal of the header, we noted the deterioration of one post tension cable requiring repair. A specialist will be assisting with the cable tensioning and sequencing work related to the post-tensioned cable repairs.

Fourth Floor Walkway: Previously observed delamination and linear crack along header.

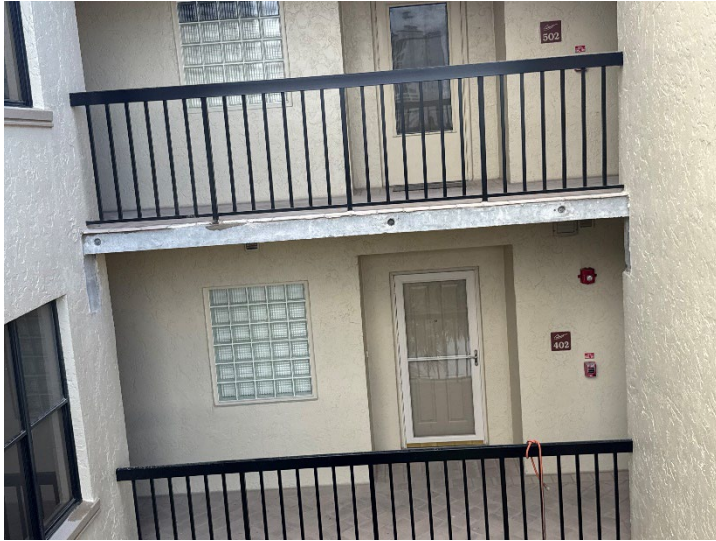
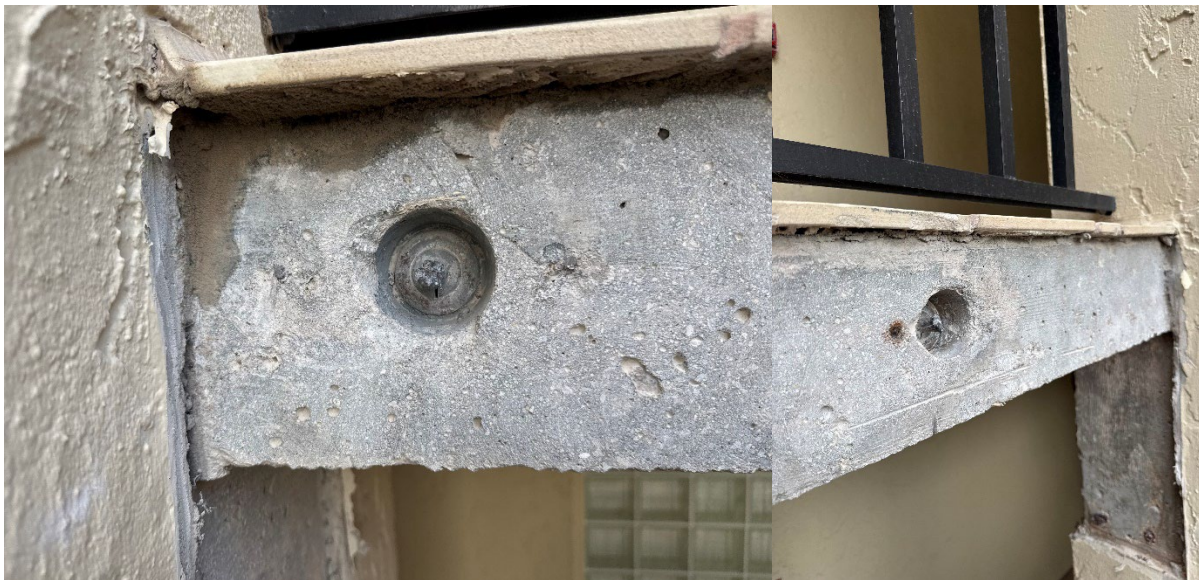
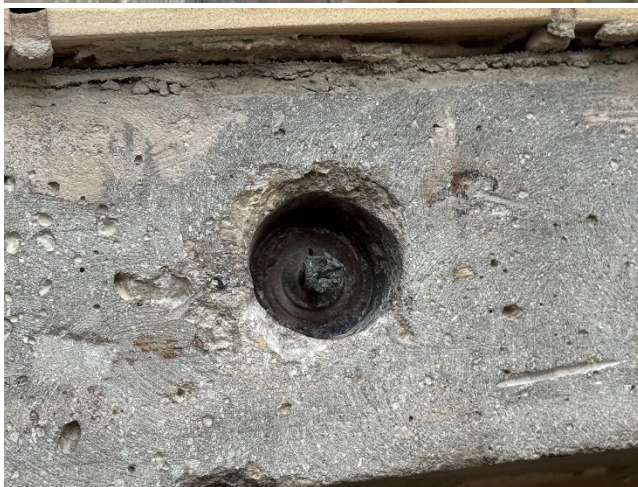
Fourth Floor Walkway: Observed deterioration/corrosion of the post tension cable anchor pocket.

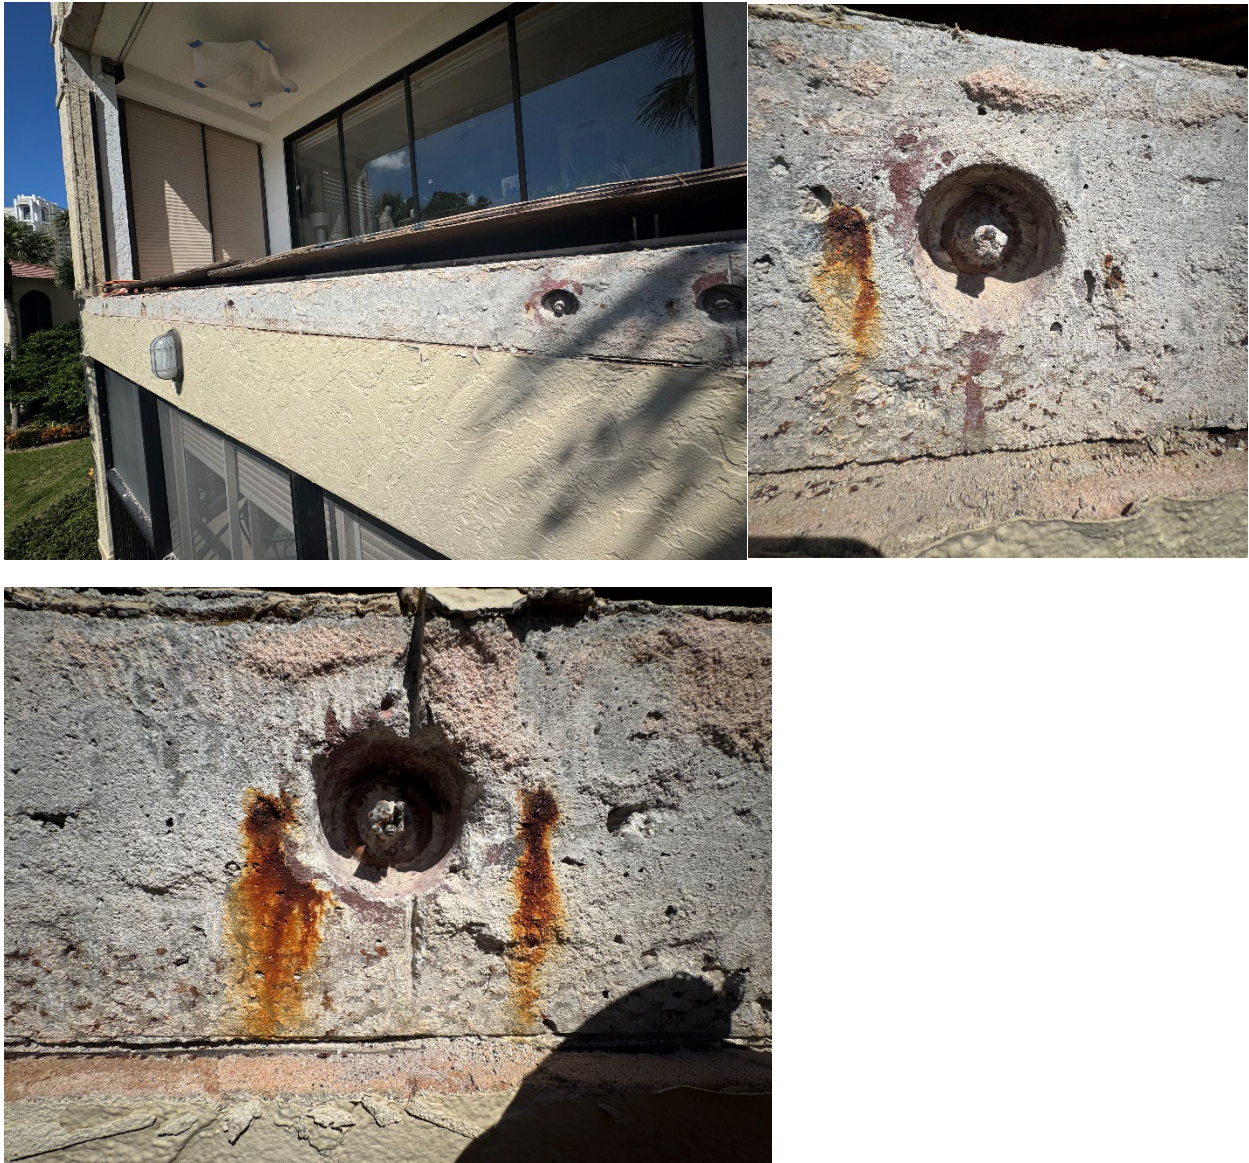
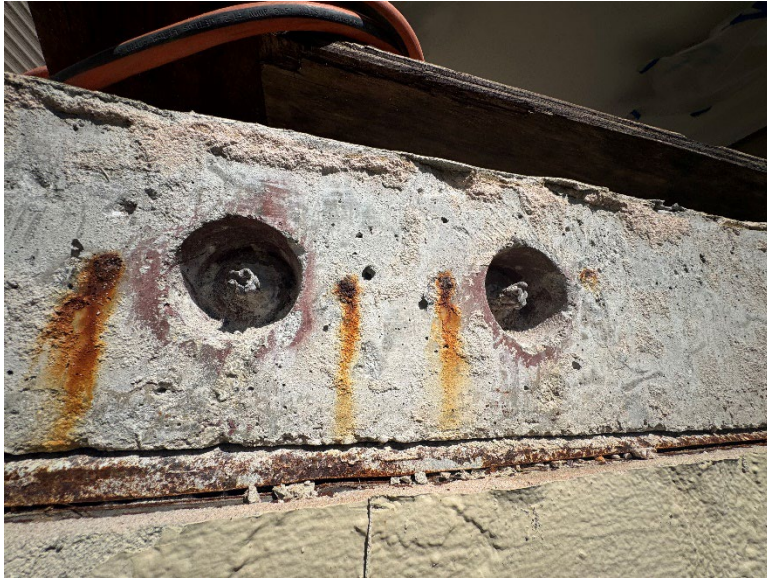
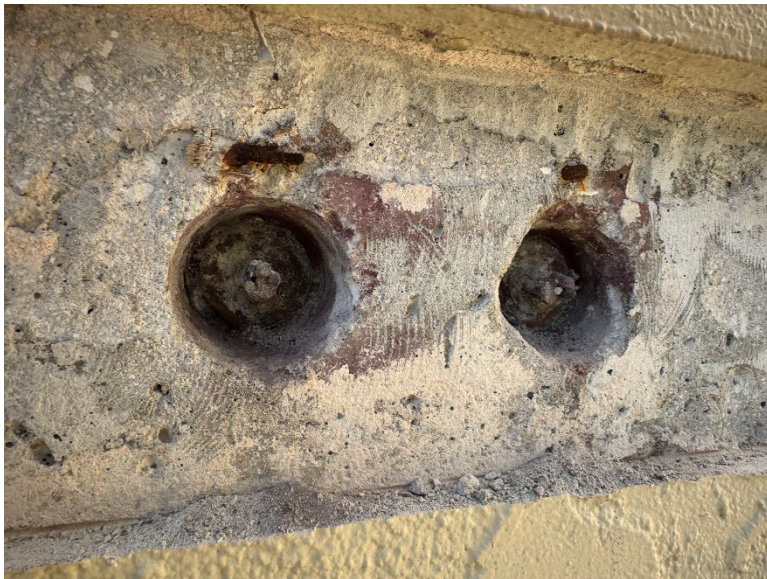
Structural distress along the deck edge of the lanai was observed by Socotec and instructions for repair were given onsite to the field supervisor. A standard concrete restoration procedure in accordance with the permitting plans provided must be followed. In addition, we also noted the deterioration of twelve (12) post tension cables requiring repair. A specialist will be assisting with the cable tensioning and sequencing work related to the post-tensioned cable repairs. Installation of shoring and reshoring posts in accordance with the provided plans will be necessary to perform the repairs since most likely the concrete demolition will be done around the post tension cables.

Unit F202: Observed deterioration/corrosion of the post tension cable anchor pockets.

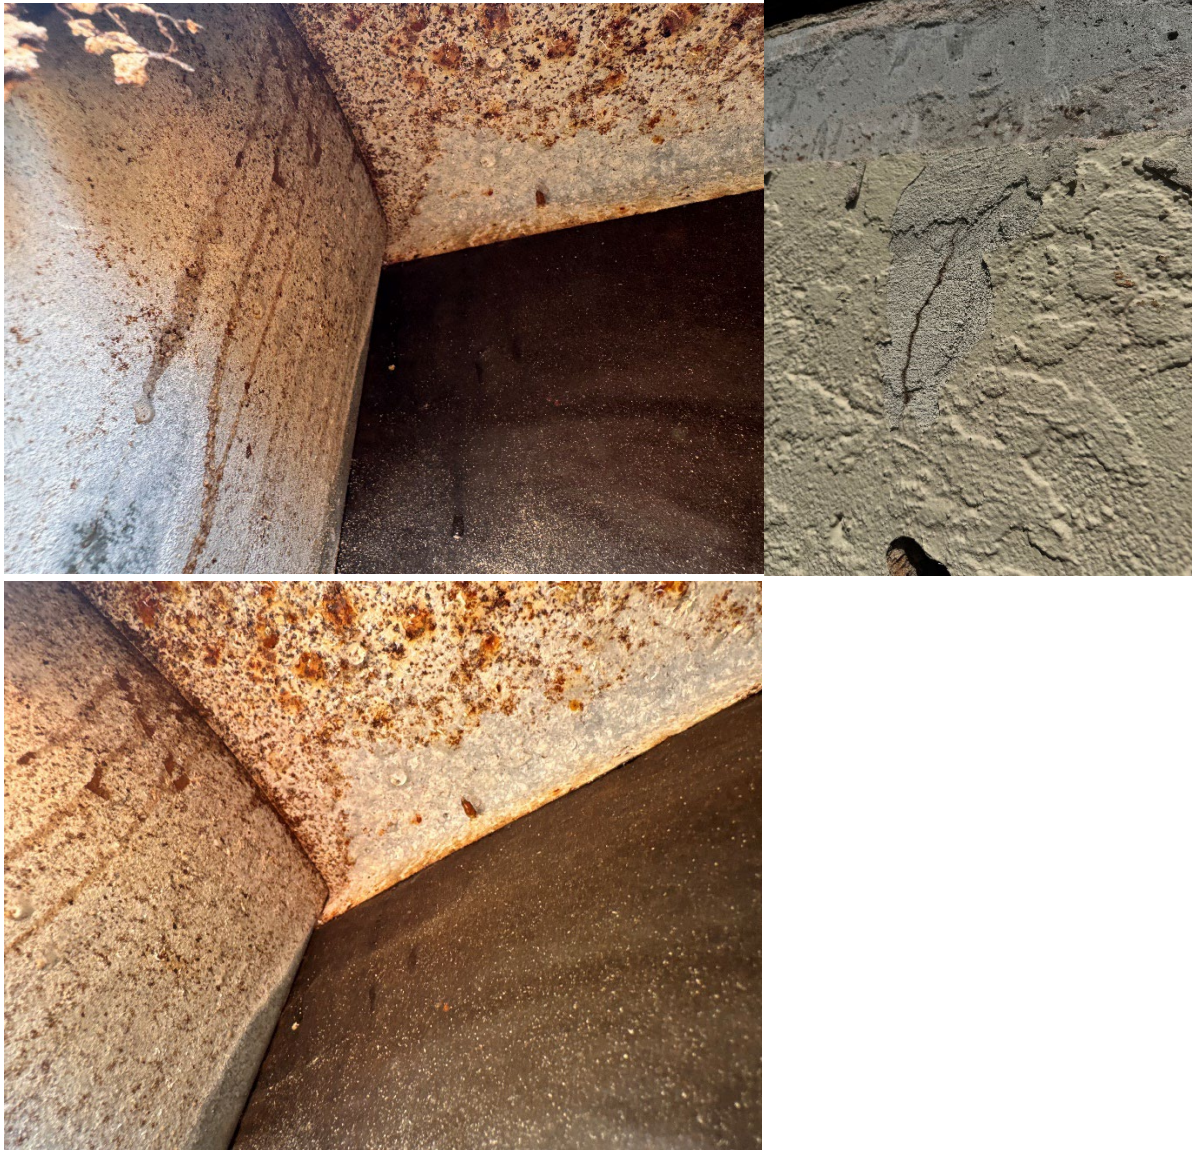
Structural distress (cracking) and corrosion of the light gauge metal framing was observed at the headers of the lanai. A standard header restoration procedure in accordance with the permitting plans provided must be followed.

Unit F102: Observed corrosion of the metal framing and structural distress.
