## Calais at Pelican Bay

### Project Management Report 19 – Building F

**RE:** Scope of Work Updates and Revisions – Unit F-301, Building F Post-Tension Cable Repairs

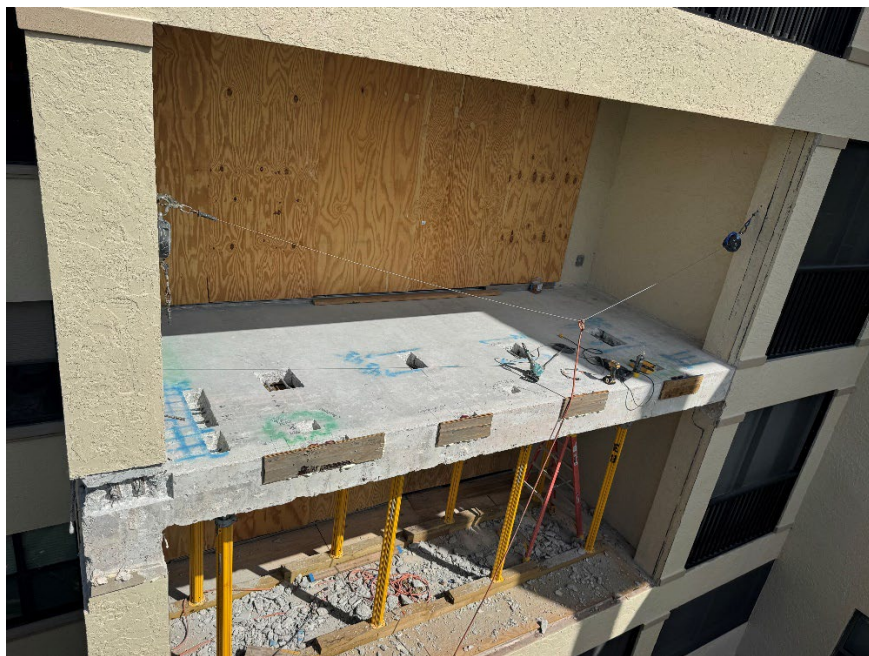
Full view of Unit F-301 balcony deck, showing completed uniform cable repairs.

- **7 out of 9 uniform cables** have been repaired in accordance with the typical repair instruction (locking off, splicing, and re-stressing).

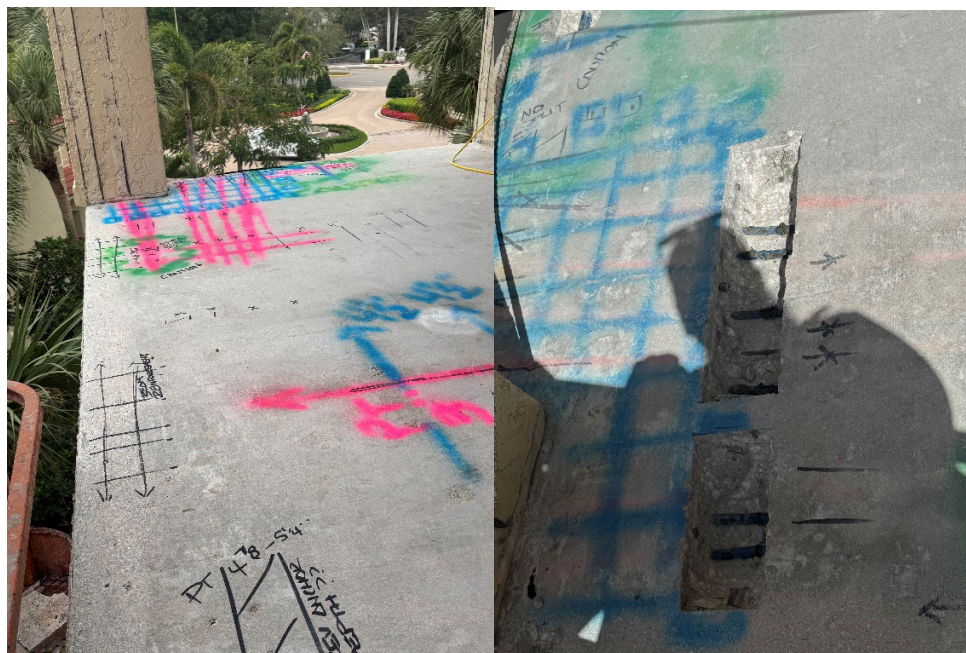
- Post-tension cable positioning and reinforcement bar clustering in the south corner of the balcony prevented the typical repair approach (locking off, splicing, and re-stressing) due to the required clearance needed between the cables for splicing.
- Standard repair procedures would necessitate extensive shoring throughout multiple unit stacks from the ground floor to the affected balcony, adding costs and impractical complexity.

Concentration and clustering of reinforcement bars and PT cables identified through GPR scanning in the south corner of balcony, Unit F-301.

All parties agreed to **full replacement of the six (6) band line cables** (from Unit F-301 to Unit F-303) rather than attempting standard repairs. Each cable would be replaced from one end to the other (01 stack to 03 stack) 2 cables at a time.

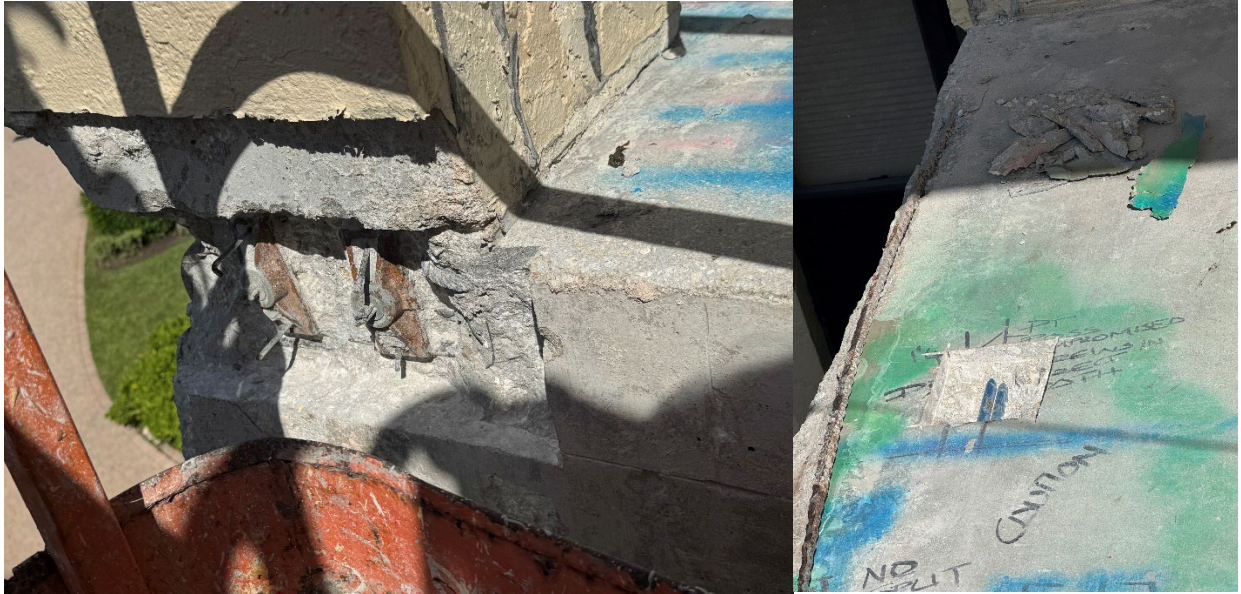
Following exploration of the **remaining 2 uniform cables**, field investigation has revealed the same complexities encountered with the band line cables:

- Insufficient clearance for locking off with a chuck splice to perform partial repairs.
- High concentration of reinforcement bars in the affected area, adding structural complexity.
- Standard repair procedures would require extensive shoring through the units.

Remaining uniform cables requiring full cable replacement, showing clearance between the cables and proximity to band line cables, Unit F-301.

In consultation with the PT Specialist during today's on-site meeting, **full cable replacement for the remaining 2 uniform cables** has been determined as the best course of action.

**Timeline:** Upon approval, these 2 uniform cables are scheduled for replacement **mid next week**.

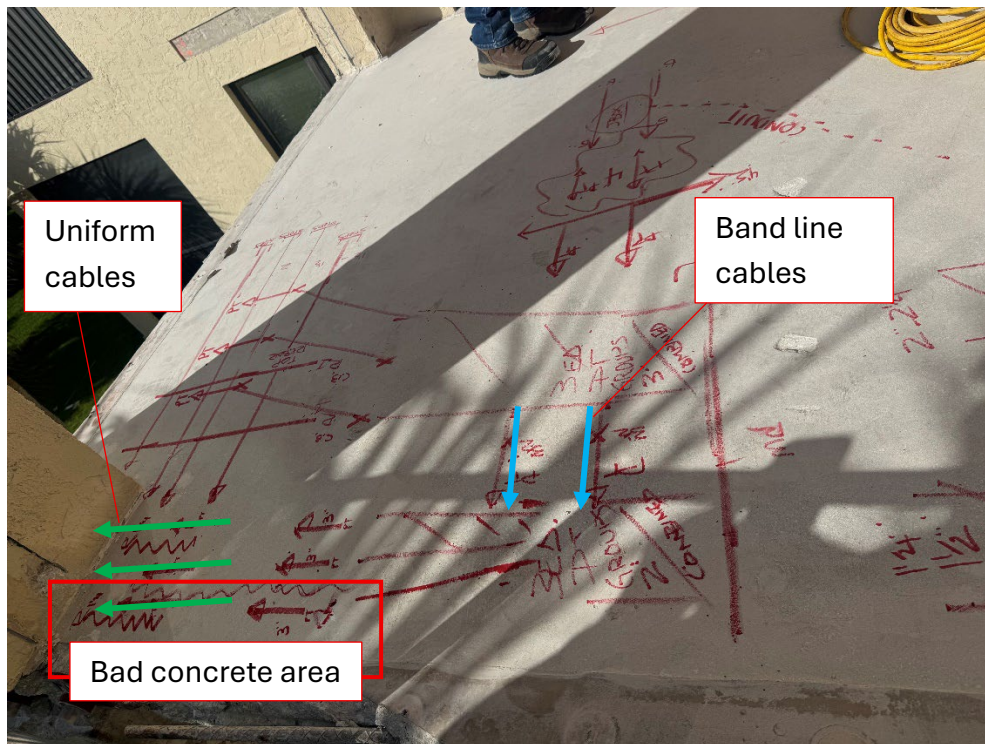
- Strong reflections often signifying **delamination within the concrete**.
- The affected area appears to extend beyond the first identified uniform PT cable.
- Similar complexities to those found in Unit F-301 are present.

Based on current observations and GPR findings, **up to 5 cables may be affected or compromised:**

- **3 uniform cables** emanating from the column.
- **2 band line cables**.

GPR scan results indicating clustering of reinforcement bars and PT cables and location of 5 cables that may be affected, Unit F-303.

Further investigation and exploratory work are required to confirm the extent of damage and determine the appropriate repair or replacement strategy for Unit F-303. A detailed assessment will be provided following additional exploration and consultation with the PT Specialist.

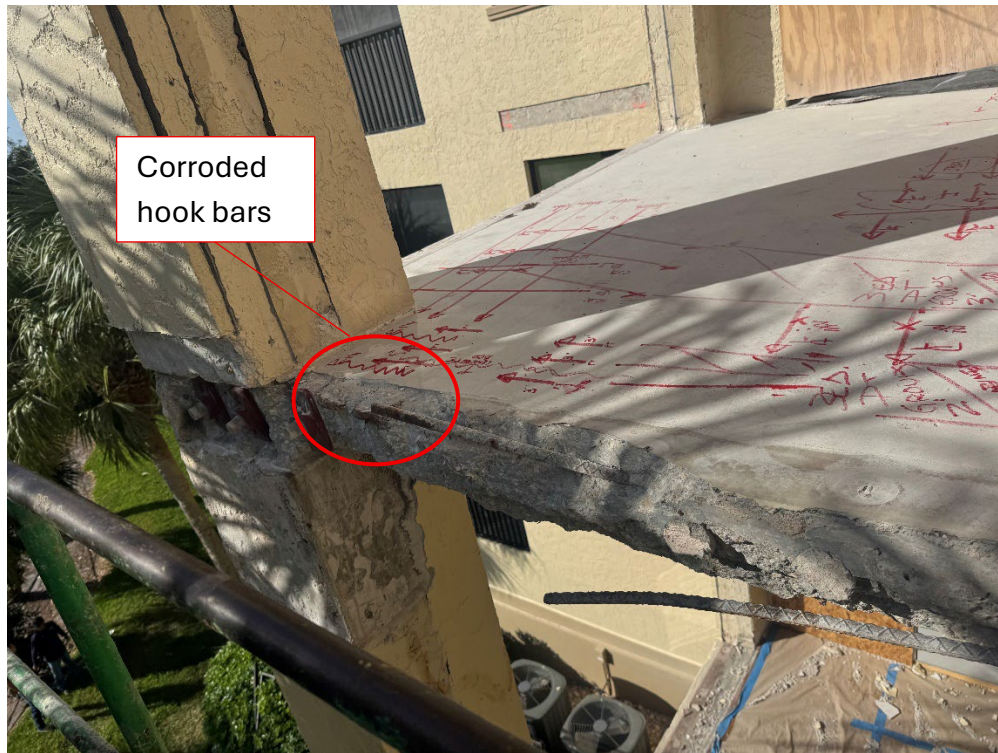
- Corroded hook reinforcement bars at the slab edge.
- Slight corrosion on the uniform PT anchors.

Slab edge conditions at Unit F-303 balcony showing corroded hook reinforcement bars and area of potential delaminated concrete.
