# Calais at Pelican Bay

## Project Management Report 20 – Building F

**RE:** Scope of Work Updates and Revisions – Unit F-303, Building F Post-Tension Cable Repairs/Replacement

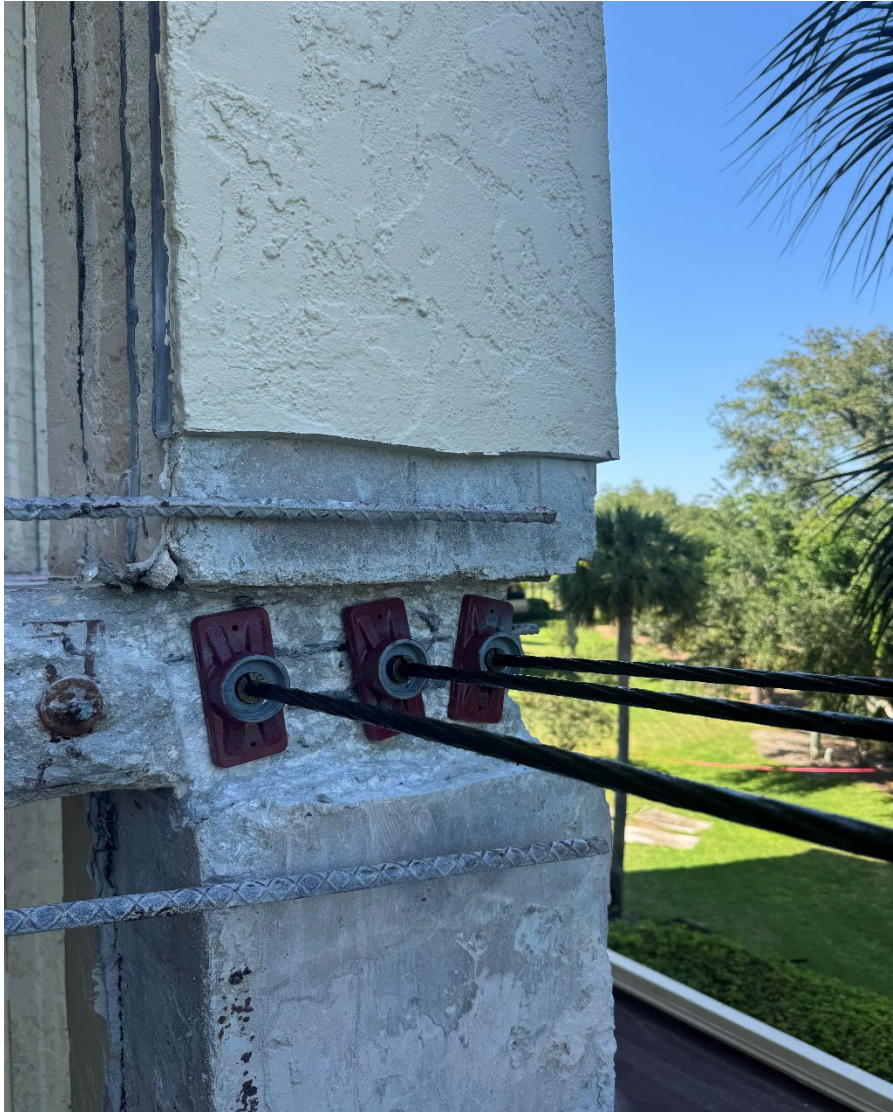
- **3 uniform cables** emanating from the column.
- **2 band line cables.**

- Corroded hook reinforcement bars at the slab edge.
- Slight corrosion on the uniform PT anchors.

*Unit F-303 balcony slab edge: 3 original uniform cables emanating from the column.*

- According to the PT Specialist, while performing the typical repair procedure (locking off, splicing, and re-stressing) on these 3 uniform cables at Unit F-303, during the stressing operation, at least one cable failed and released at its wedge anchor located at the balcony slab edge of Unit F-305.
- Initial investigation and observation suggest that these 3 uniform cables do not terminate between Units F-303 and F-304 as indicated in the structural plans. Instead, these cables run across the full length of the building from Unit F-303 to Unit F-305 and are configured as double live end cables (cables with stressing capability at both ends, rather than one live end and one dead end).

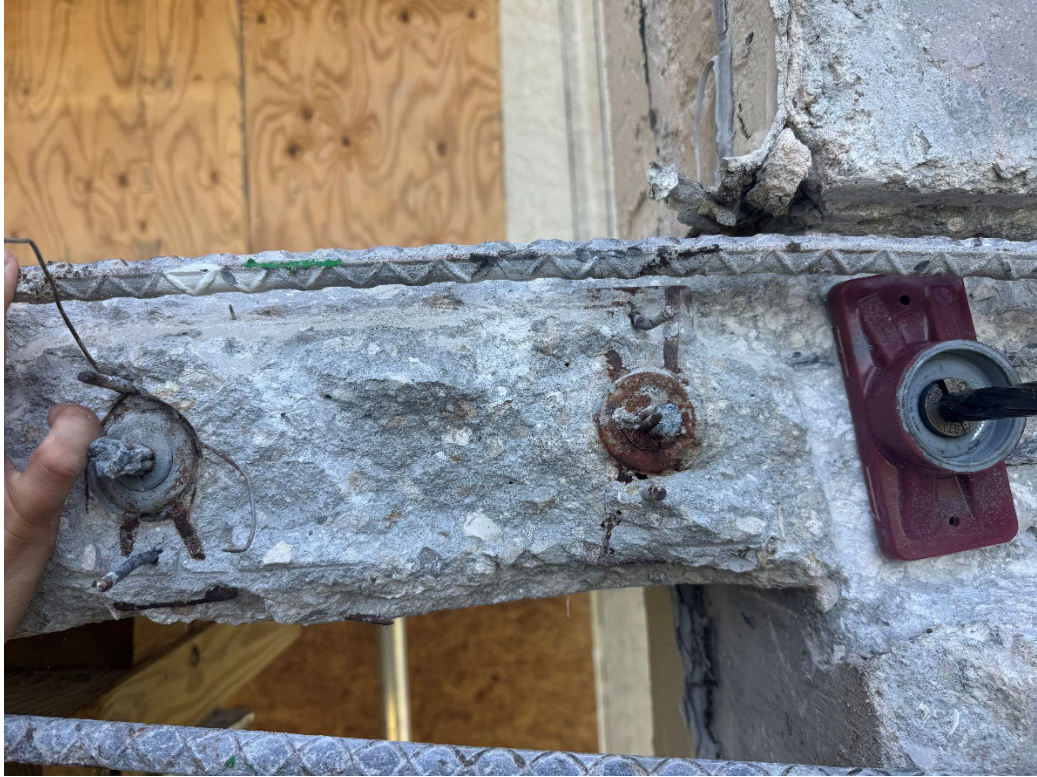
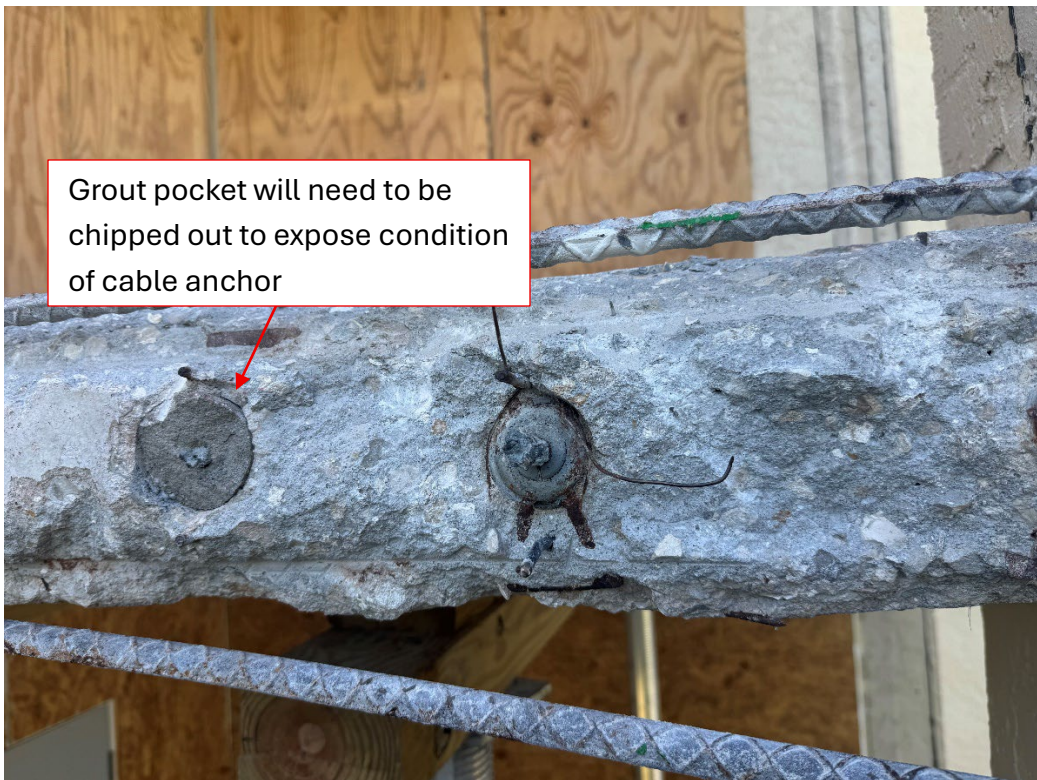
During the repair work on the three uniform cables emanating from the column in Unit F-303, additional exposure and chipping of the slab edge revealed three additional uniform cables located to the left of the originally identified cables. These newly exposed cables exhibit similar signs of distress:

- Slight corrosion on the edge reinforcement steel with insufficient concrete coverage
- Corrosion on the cable anchors
- Evidence of water intrusion, likely originating from fastener holes at the top of the slab edge where the screen enclosure was attached

*Unit F-303 balcony slab edge: 3 additional uniform cables adjacent to the 3 originally exposed cables.*

To develop a comprehensive and accurate repair scope for these compromised cables, Elias Brothers will expose the slab edge of Unit F-305 at the location where damage was observed. This exposure will allow us to confirm the prediction that all of these additional cables extend the full length of the building to this edge, rather than terminating at interior locations as indicated on the original structural plans and verify whether these cables are configured as

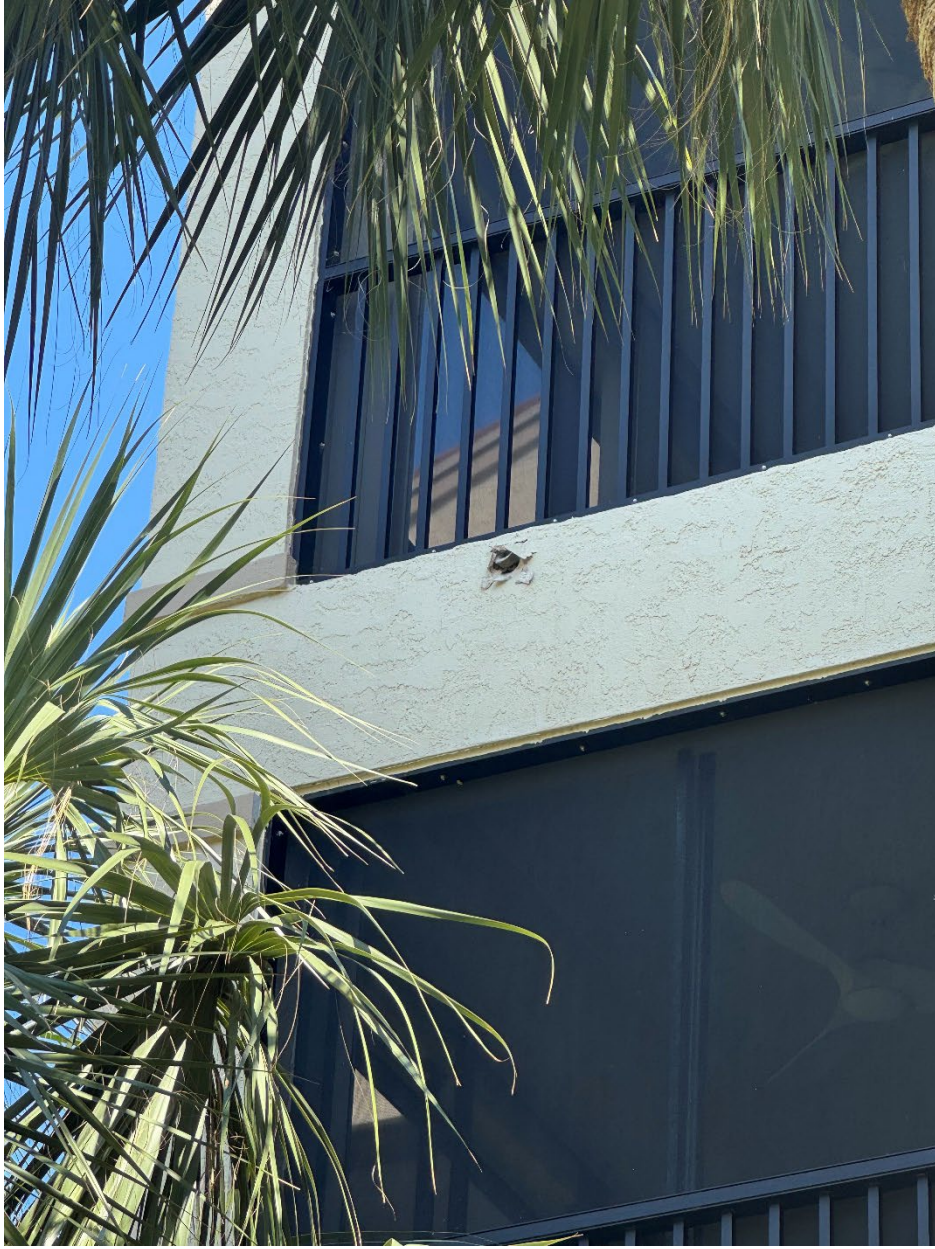
and re-stressing), at least one cable is confirmed to have failed and released, with the resulting damage observed at the balcony slab edge of Unit F-305.

*Unit F-305 condition: damage observed at balcony slab edge. Full exposure will be necessary for proper assessment.*

double live end cables. Once the slab edge of Unit F-503 is exposed, we will assess the condition of the cables and provide a revised repair scope.

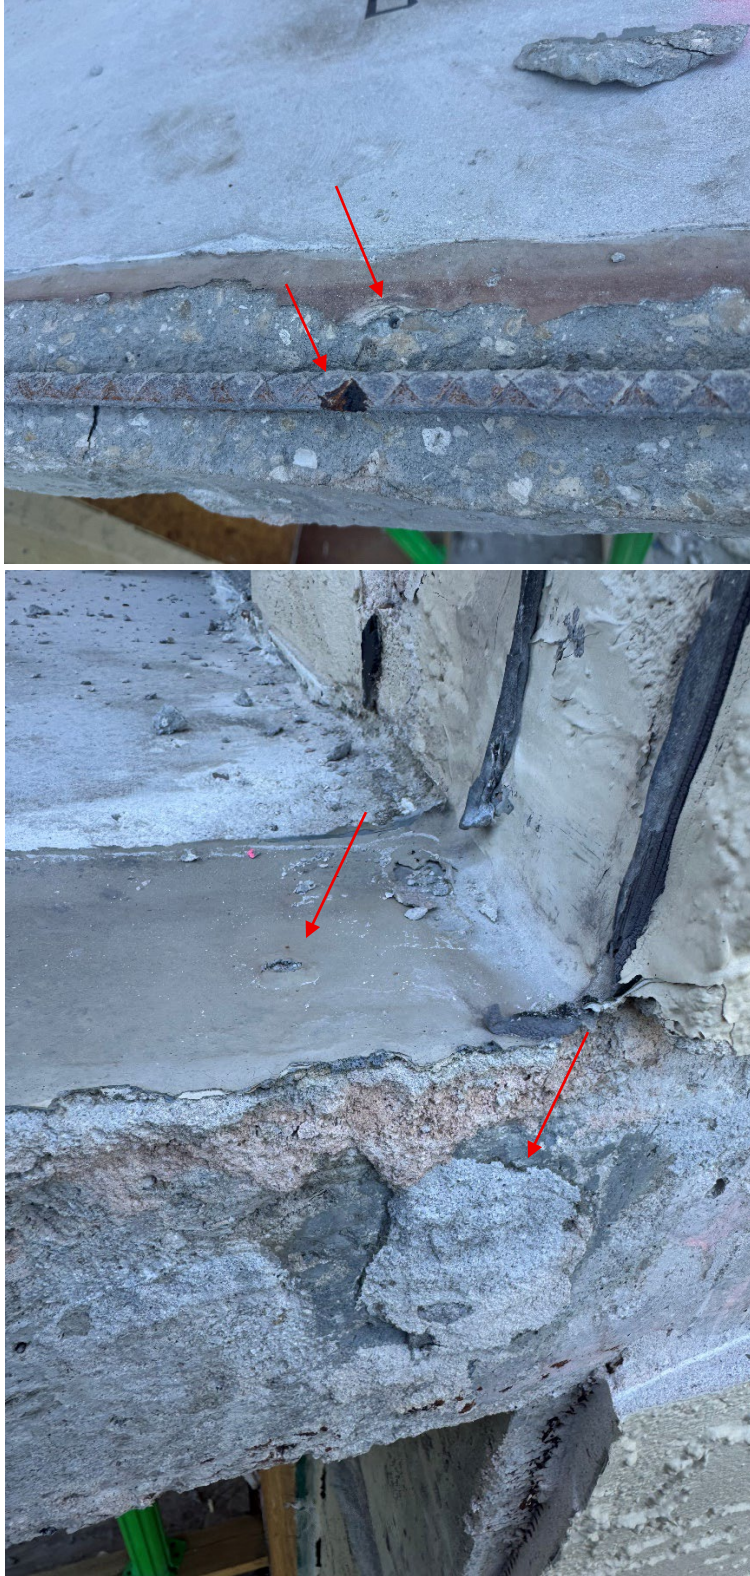
The corrosion patterns observed align with the locations of these fastener holes, suggesting they are a primary source of water intrusion contributing to the deterioration of both the reinforcement steel and the post-tension cable anchors.

*Unit F-303 balcony slab edge: corrosion patterns and PT pockets aligned with the locations of fastener holes.*

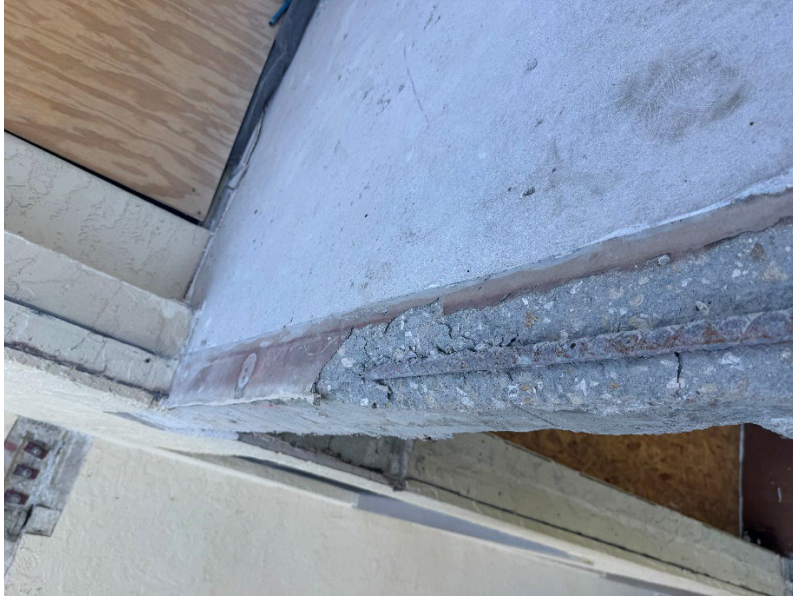
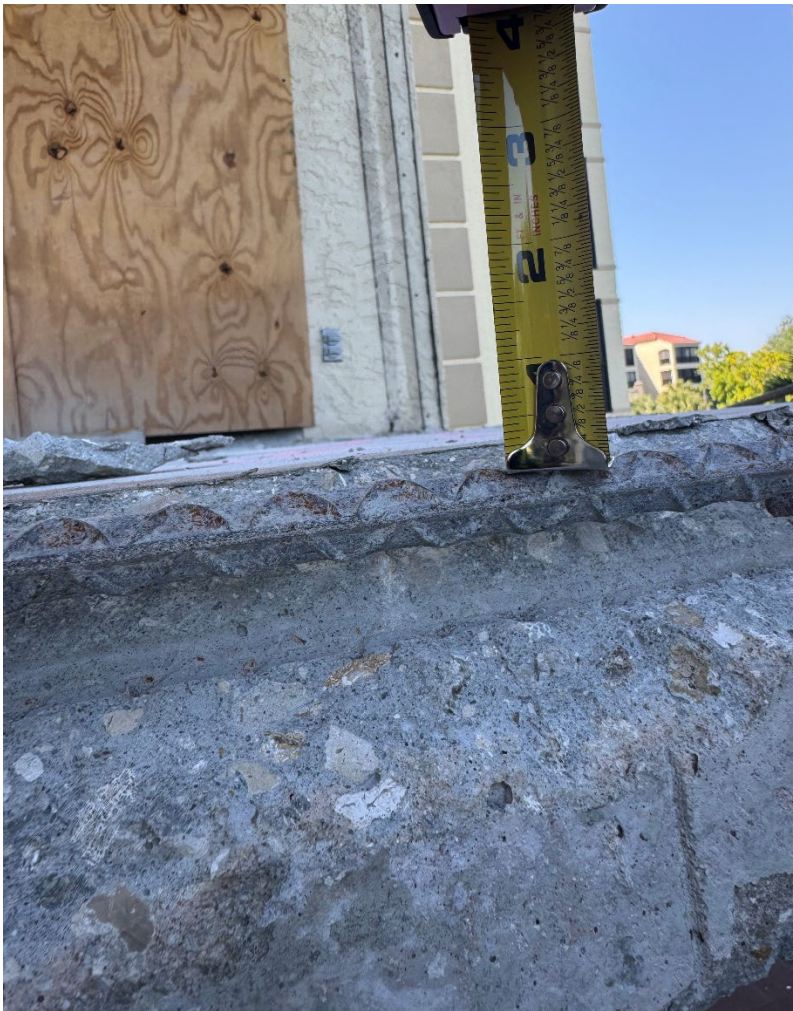
*Unit F-303 balcony slab edge: Insufficient coverage on slab edge reinforcement not achieving the required 2 inches.*

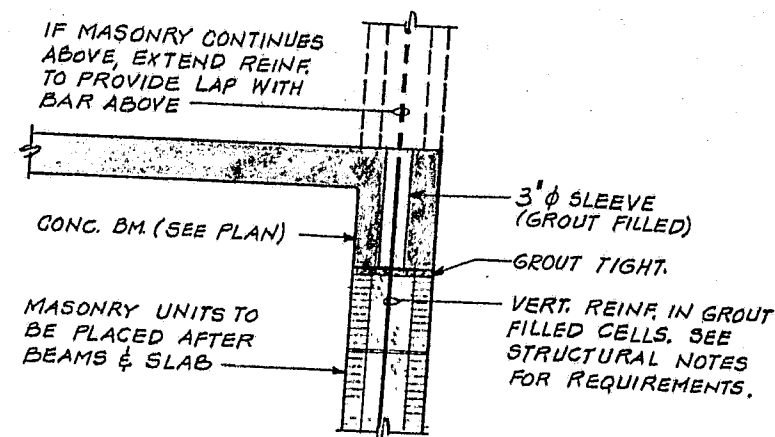
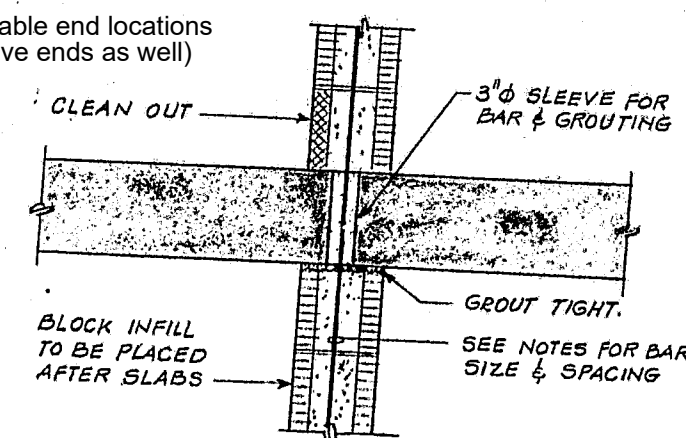
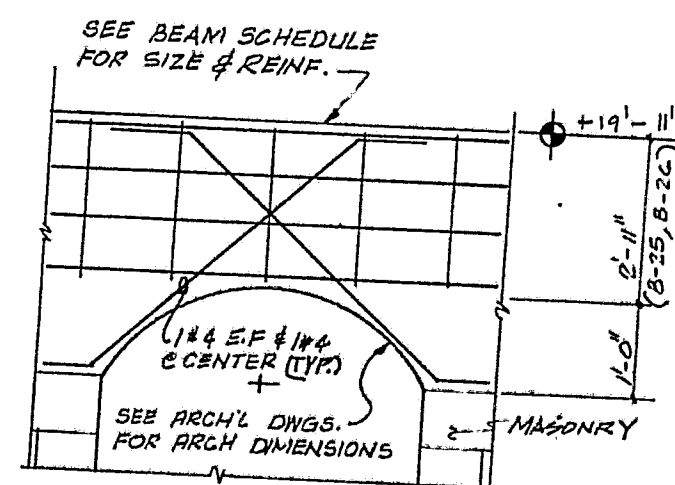
Based on the structural plans originally provided, the three uniform cables emanating from the column in Unit F-303 were assumed to have their live end (where stressing occurs) at the balcony slab edge of Unit F-303 and their dead end (anchored end) between the interior of Units F-303 and F-304.

However, during the repair process and subsequent investigation by the PT Specialist, it was discovered that these cables may run across the full length of the building from Unit F-303 to Unit F-305 rather than terminating between F-303 and F-304 as shown on the plans. When stressing was attempted during the typical repair procedure (locking off, splicing,

Predicted Cable end locations (assuming live ends as well)

Structural plans reflect dead end of cable between Unit F-303 and Unit F-304

Due to the cable failures and the unknown location of the break point, full cable replacement has been recommended by the PT Specialist as the only viable course of action for the affected cables.
