# Calais at Pelican Bay

## Project Management Report 21 – Building F

**RE:** Post-June 2nd Meeting Update – Unit F-303, F-304, F-305 Post-Tension Cable Investigation and Repair Strategy

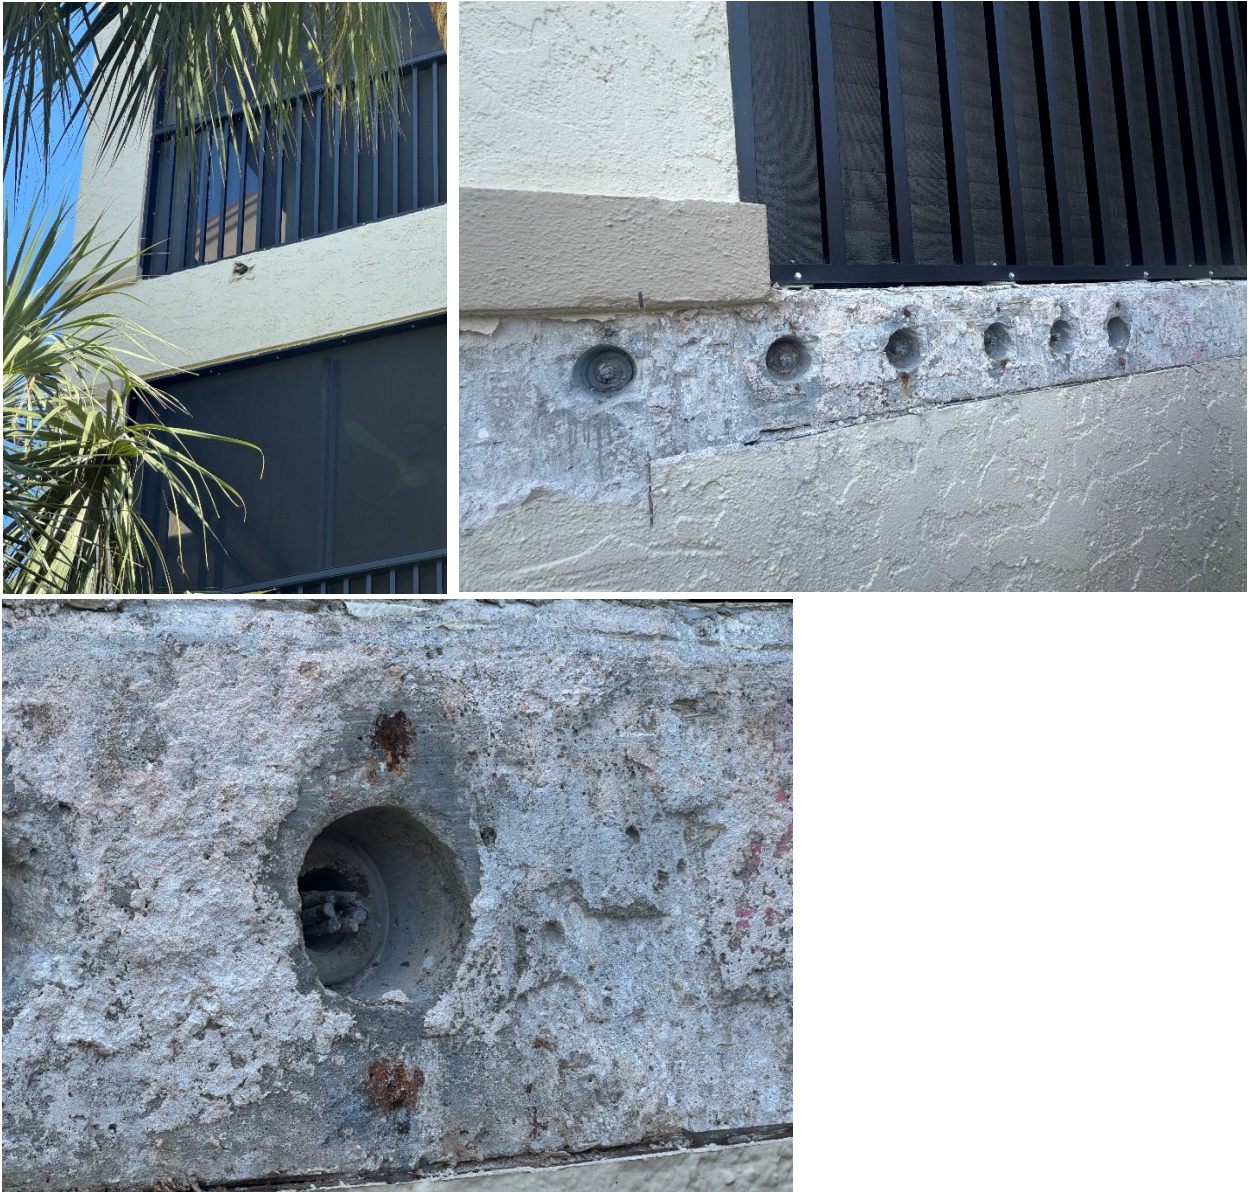
- GPR confirmed cable paths leading to the balcony slab edge where damage was previously observed.

*Unit F-305 condition: damage observed at balcony slab edge. Cable observed with wedges released.*

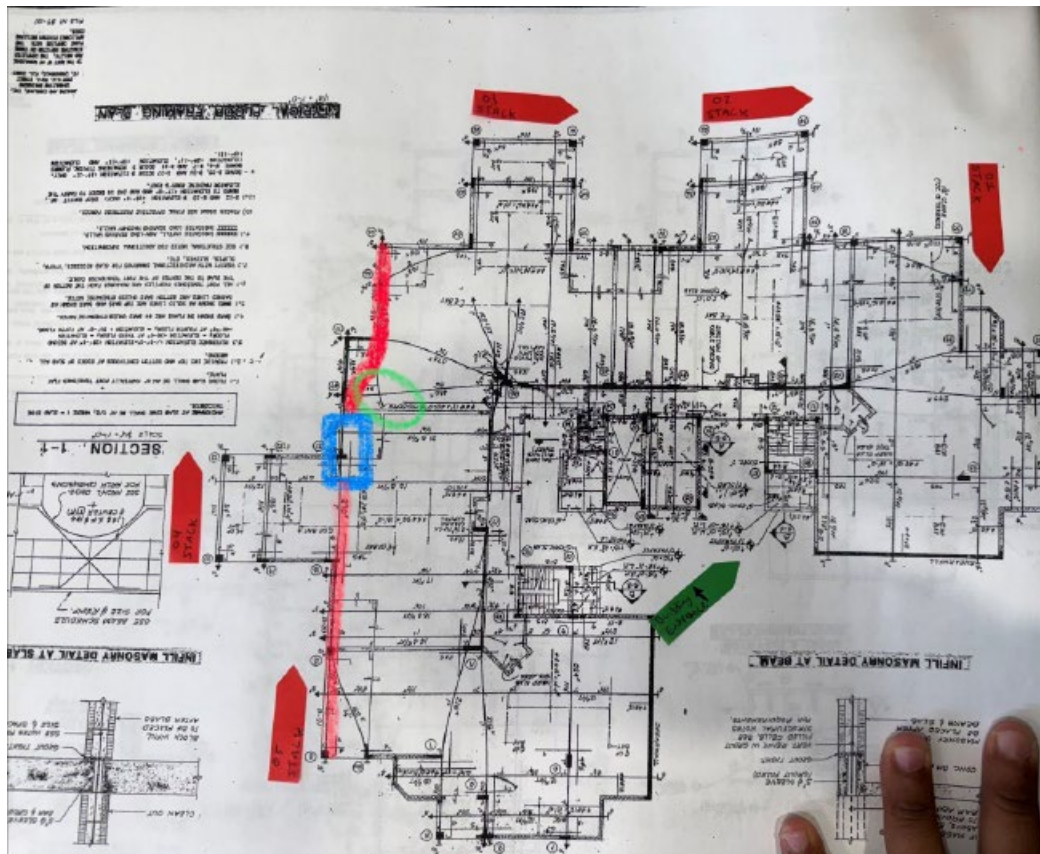
- The tendon group leading from Unit F-303 does not follow the path indicated on the original structural plans.
- The band line group joins with an additional band line cable group that starts at the exterior wall of the guest bedroom of Unit F-303, proceeds toward the column on the northeast wall, and transitions into Unit F-304.

- Critical Discovery: An area highlighted in blue on the GPR scan within Unit F-304 reflects heavy concrete saturation and is located in the direct path of both uniform and band line tendons at the enclosed lanai of Unit F-304.

Building Plans discrepancy: GPR scan confirmed path of the tendon groups emanating from Unit F-303 balcony slab edge to Unit F-305 balcony slab edge. Blue highlighted area indicated heavy concrete saturation in GPR scan in direct path of band line and uniform cable tendons.

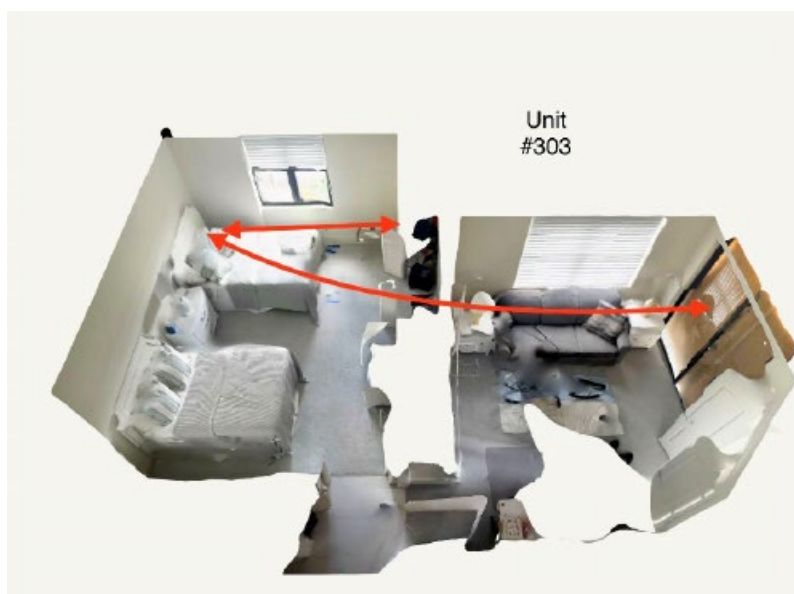
- GPR confirmed the path of the tendon groups emanating from the balcony slab edge.

*Unit F-303: confirmed path of tendons and new group of band line cables confirmed starting at the exterior wall of the guest bedroom.*

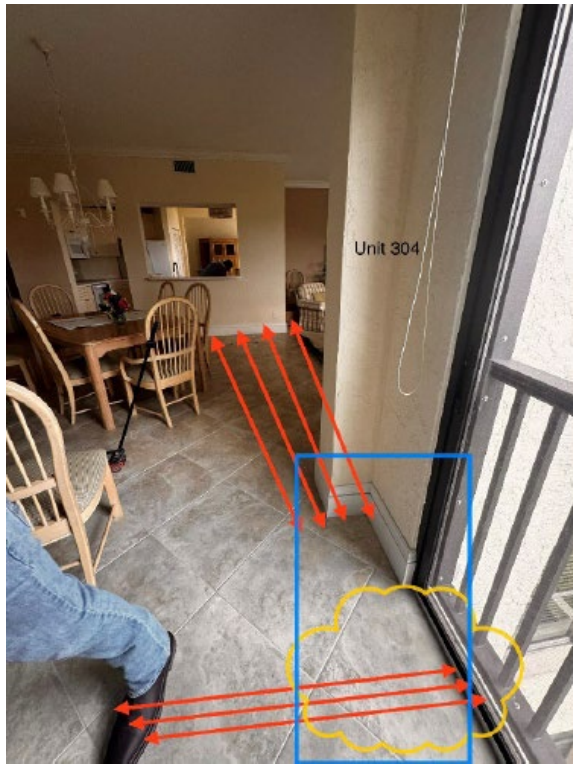
- This saturated area is directly beneath the location where screen frame fasteners were observed to be installed at an angle, tiles along this area sound hollow, suggesting delamination and potentially suggesting a correlation between these observations and possible cable distress or suspected transitions.

- Approximately 3-4 uniform tendons terminate on the enclosed lanai of Unit F-304, in the area backing up to the bedroom of Unit F-303.

*Unit F-304: confirmed path of tendons, yellow highlighted area reflected heavy saturation, blue highlighted area is the suspected area of consideration for possible tendon transition or break point.*

- Based on the GPR scan, investigation in the area for consideration of tendon transitions at the enclosed lanai of Unit-304 is recommended. HCT recommends considering other means to confirm findings before interior demo is necessary.
-

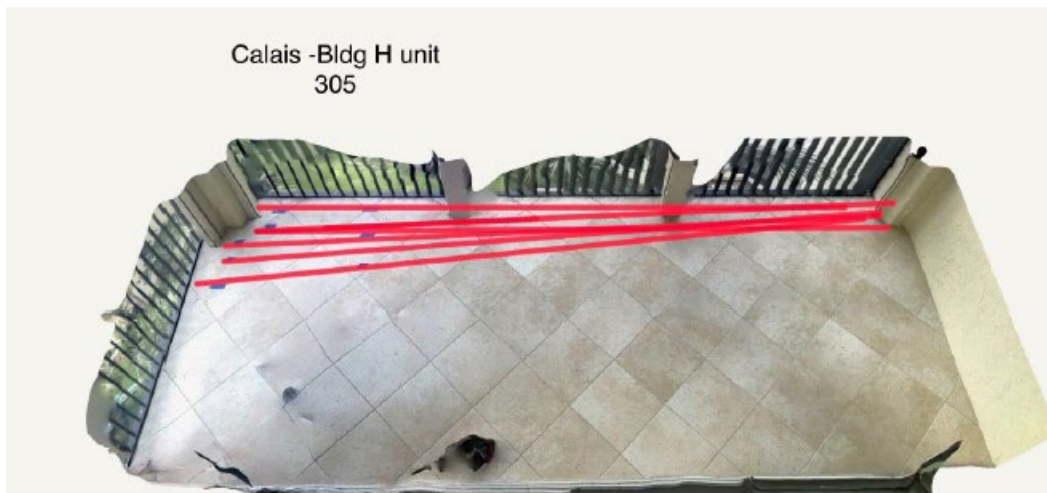
*Unit F-305: confirmed path of tendons through to the balcony slab edge.*
