# Calais at Pelican Bay

## Project Management Report 22 – Building F

**RE:** Structural Distress in the Ground Level Garages of Building D, F, and H

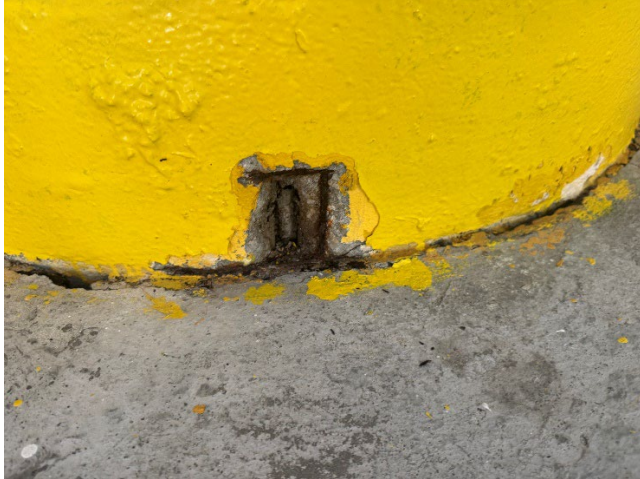
*Building H – Ground Level Garage: Structural distress observed*

While the current structural distress observed in the ground level garages of Buildings D, E, and F does not pose an immediate threat to structural integrity, timely remedial action is

essential to prevent potential deterioration of the surrounding structural elements and avoid escalation of repair costs associated with delayed intervention. The recommended restoration work should be planned and executed within a 1-2 year timeframe.

Until restoration works are completed, we recommend periodic monitoring of the affected areas to ensure no progression of the distress occurs that could impact structural performance.

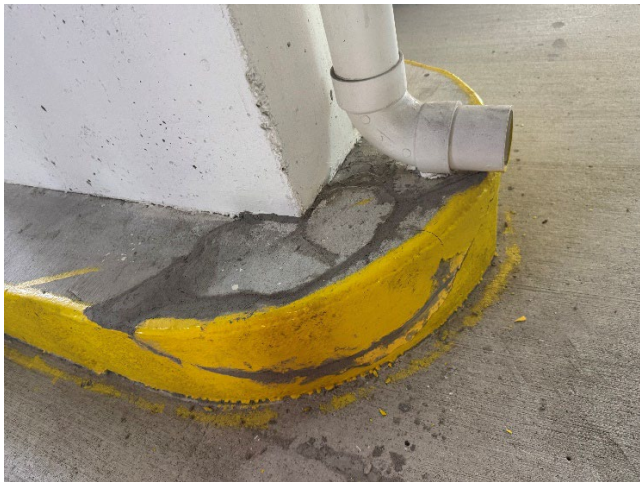
*Building F – Ground Level Garage: Structural distress observed*

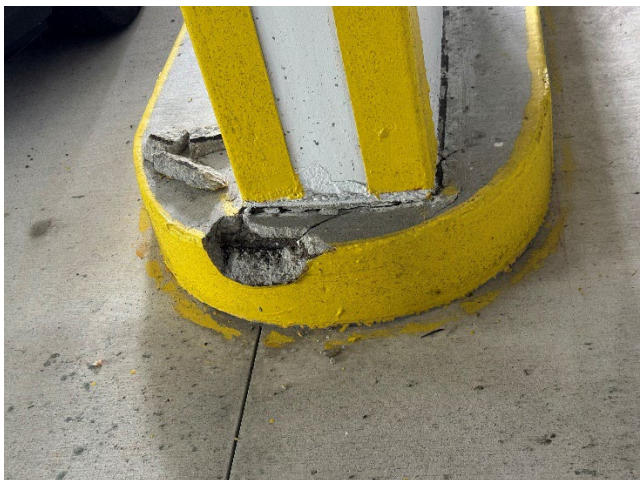
*Building D – Ground Level Garage: Structural distress observed*
