## **Calais at Pelican Bay**

### **Project Management Report 23 – Building H**

**RE:** Newly Discovered Post-Tension Cable Issues – Unit H-501, Building H

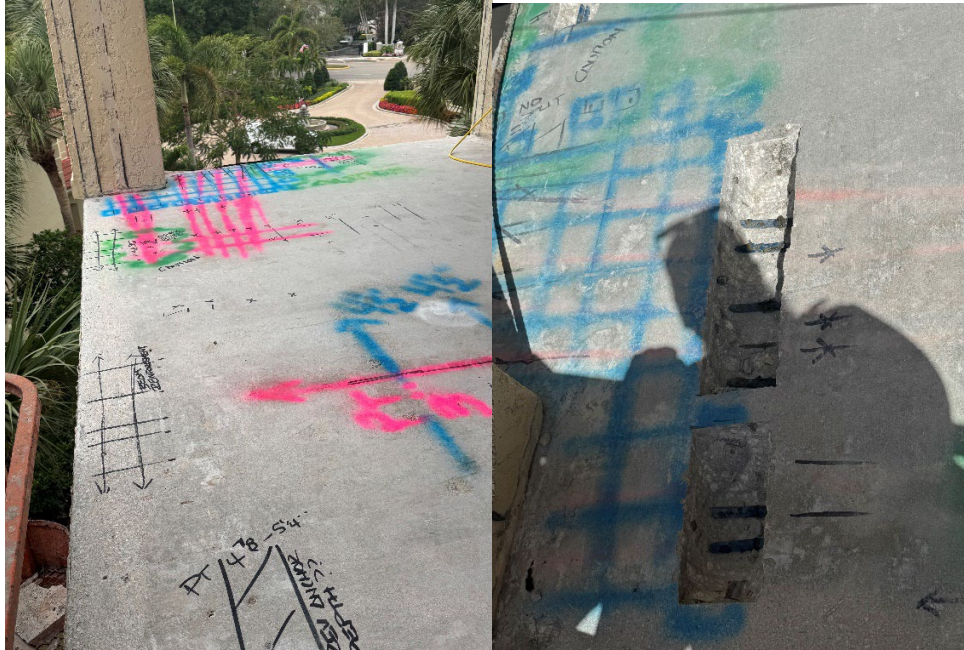
- **Post-tension cable positioning and reinforcement bar clustering** in the south corner of the balcony prevented the typical repair approach (locking off, splicing, and re-stressing) due to insufficient clearance needed between cables for splicing operations.

**Unit F-301** – Concentration and clustering of reinforcement bars and PT cables identified through GPR scanning in the south corner of balcony

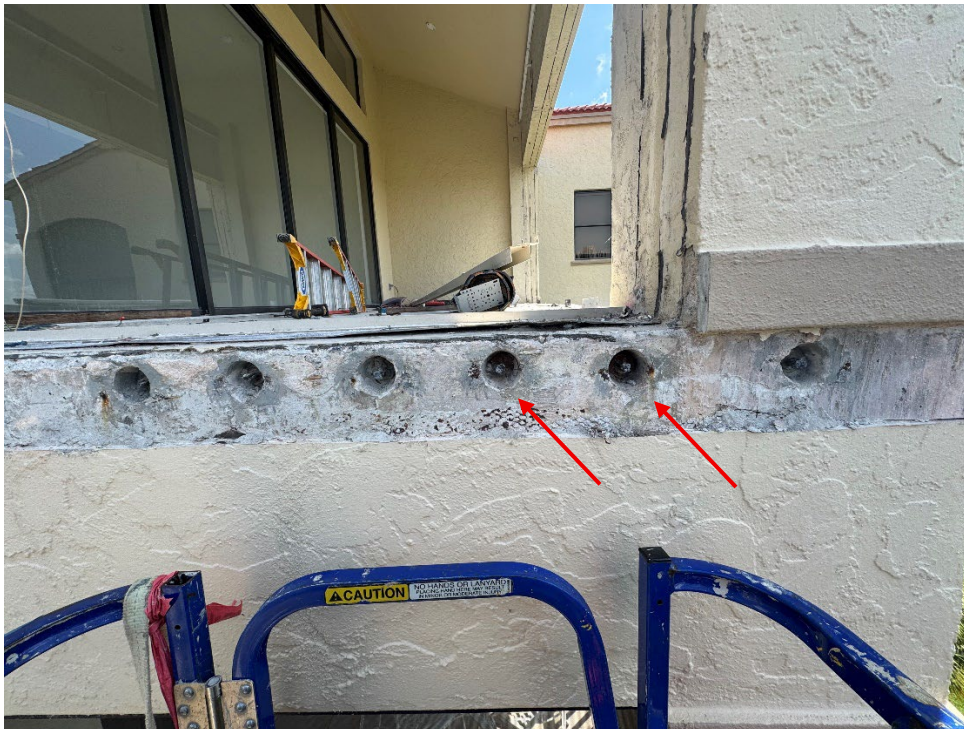
During the inspection of Unit H-501's balcony, **2 band line cables** at the southwest slab edge were observed with severe deterioration/corrosion of the post tension cable anchors and have been identified as compromised.

**Unit H-501** – Southwest slab edge, exposed cable anchor pockets

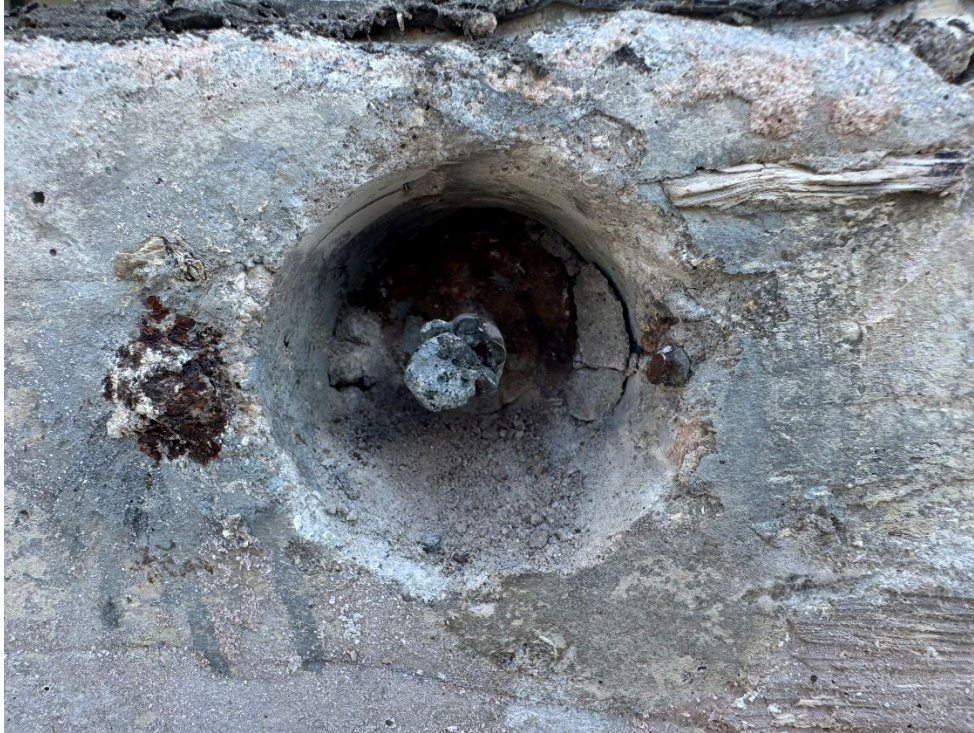
***Unit H-501 – Observed severely corroded cable anchor***

Given these anticipated constraints, **full cable replacement from Unit H-501 through to Unit H-503** may be required for the 2 compromised band line cables, following the same approach implemented at Building F.

The balcony deck at Unit H-501 must be scanned using GPR to:

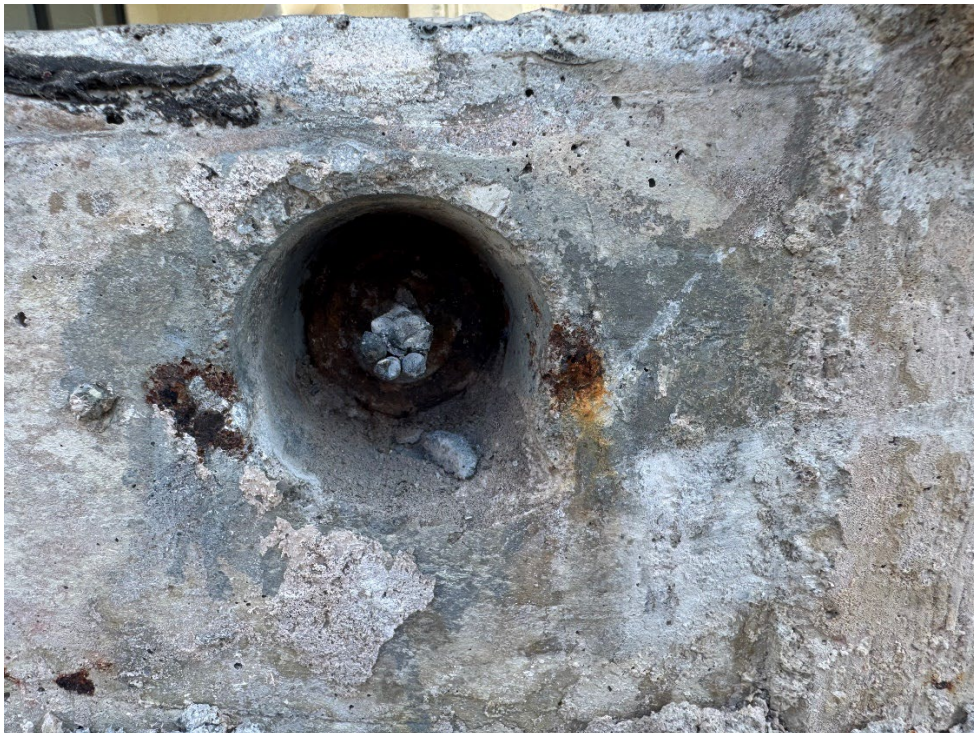
***Unit H-501 – Observed severely corroded cable anchor***
