## **Calais at Pelican Bay**

### **Project Management Report 25 – Building F**

**RE: Updated Investigation Findings – Unit F-303, F-304, F-305 Post-Tension Cable Investigation and Revised Repair Strategy**

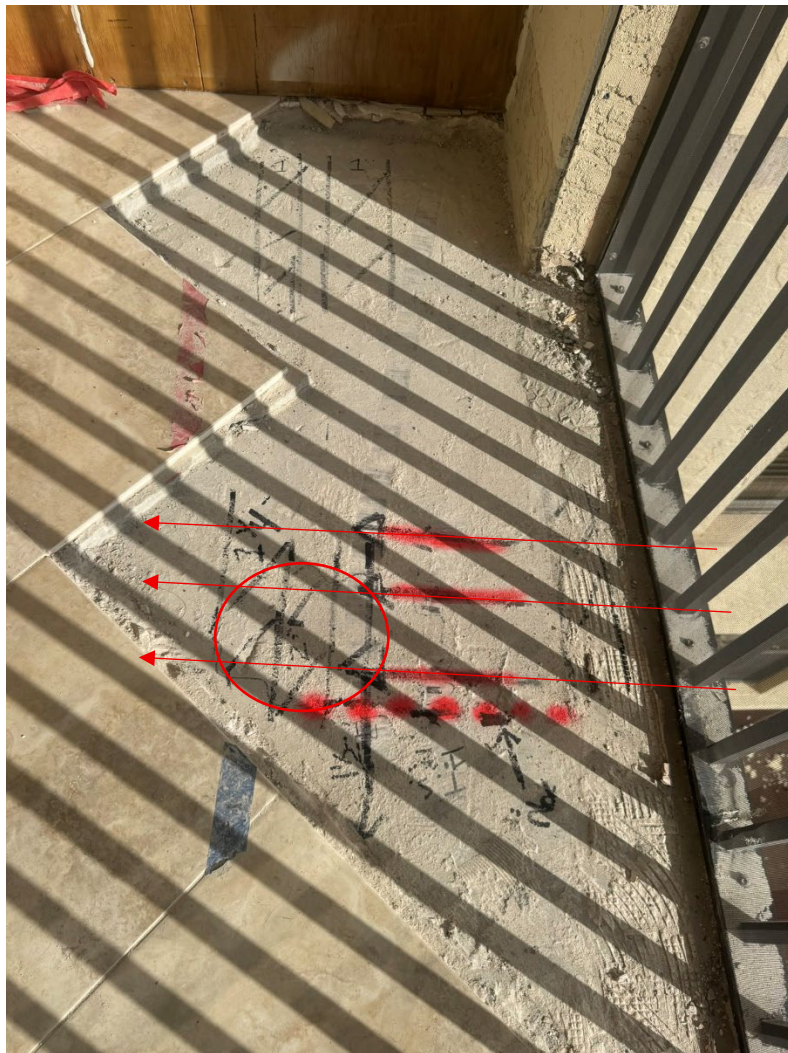
- **Scanning Following Tile Removal:** To obtain clearer GPR data, tiles in Unit F-304's enclosed balcony were removed to eliminate interference. The second scan continues to identify this area as the suspected end location.

- **Dead-End Reflection Identified:** HCT has identified GPR reflections similar to those characteristic of cable dead-ends in this location.
- **Probable Plan Deviation:** These findings suggest a deviation from the original structural plans, which indicated the dead-end location should be in Unit F-303 just before the wall of F-304. The actual termination location appears to be within Unit F-304's enclosed balcony area.

**Unit F-304 – Suspected dead-end location for the 3 uniform cables extending through to Unit F-303.**

1. Concrete Chipping Required: The suspected area within Unit F-304's enclosed balcony must be chipped to expose and verify cable terminations.
2. Band Line Cable Destressing: Two of the three band line cables running through this area will need to be locked off/destressed prior to chipping operations to ensure safe working conditions and prevent unintended loading changes.
3. Potential Band Line Replacements: Depending on the condition observed upon exposure and the extent of required access, these two band line cables may require replacement.

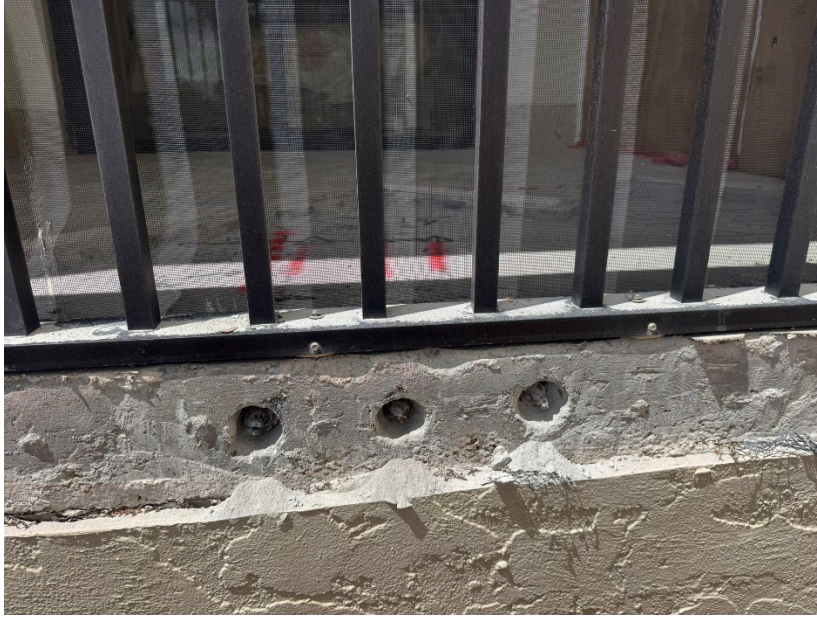
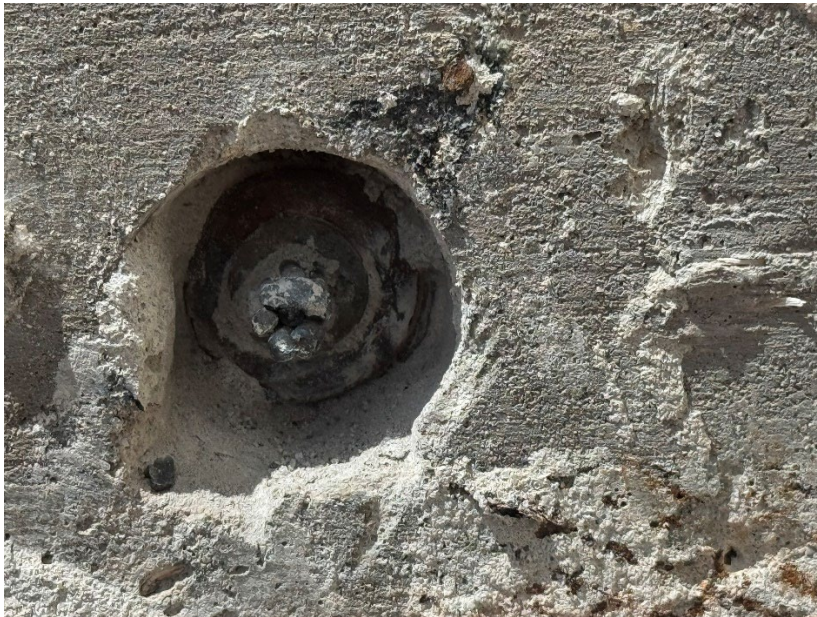
- **Band Line Cable Complication:** Three band line cables are also located in this suspected termination area, adding complexity to the required repair work. (Green cables on updated plan)

**Unit F-304 – 3 band line cables identified in the suspected dead-end location.**

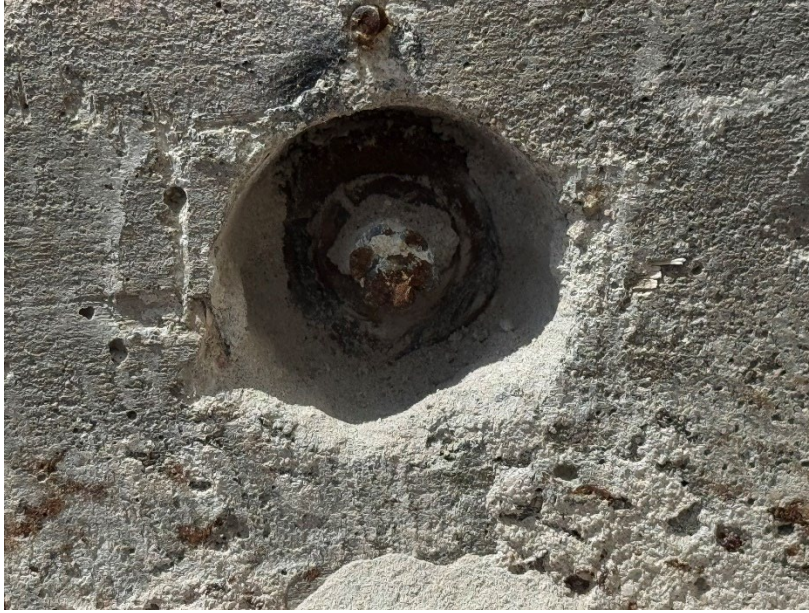
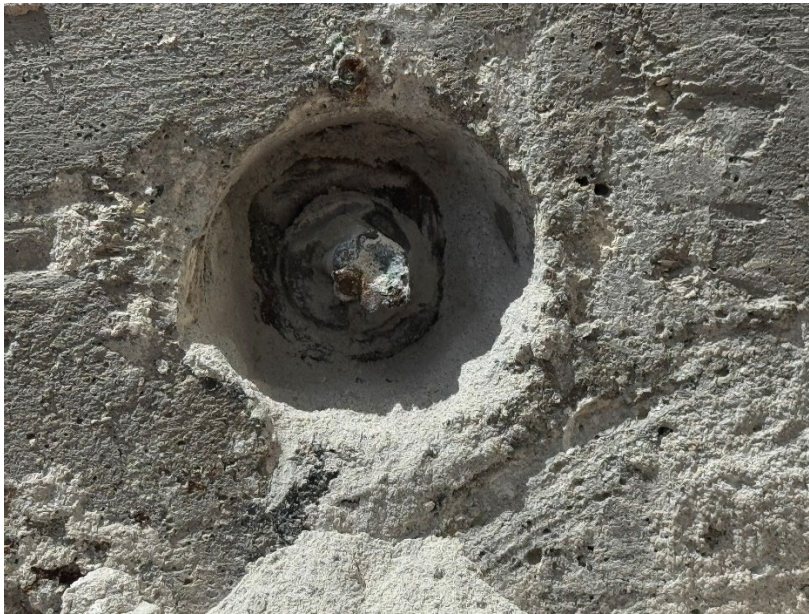
- **Corrosion Observed:** Initial observations of the band-line cable pockets show signs of corrosion on the anchors, consistent with the distress indicators observed at other affected locations.

**Unit F-304 – Initial observations of the band-line cable pockets show signs of corrosion on the anchors at the cable pockets.**

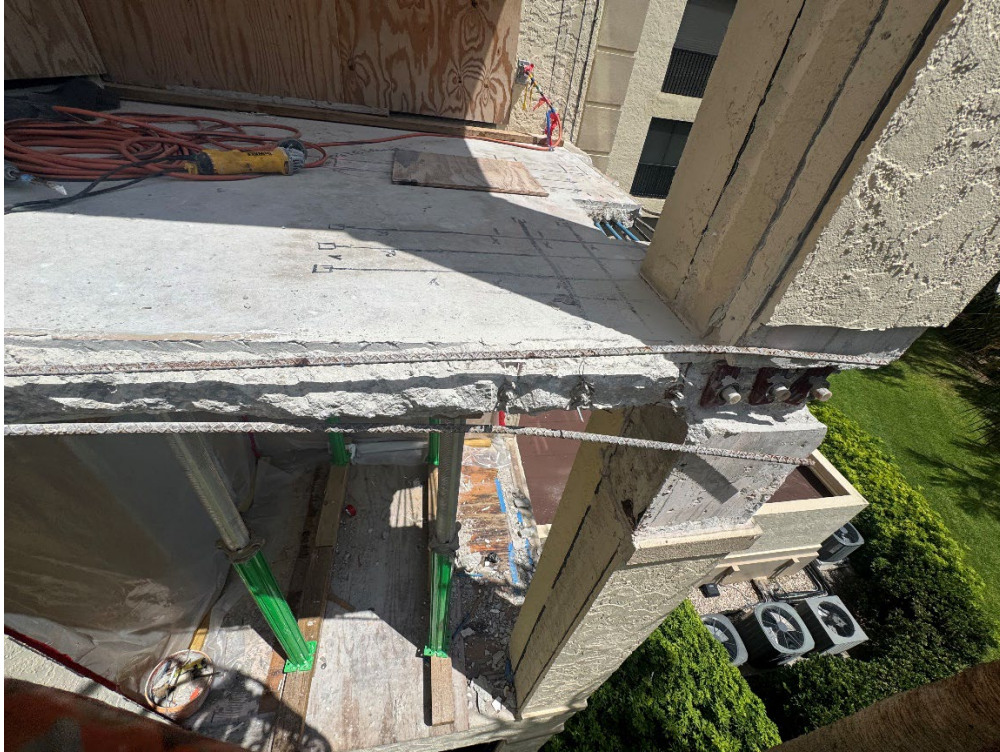
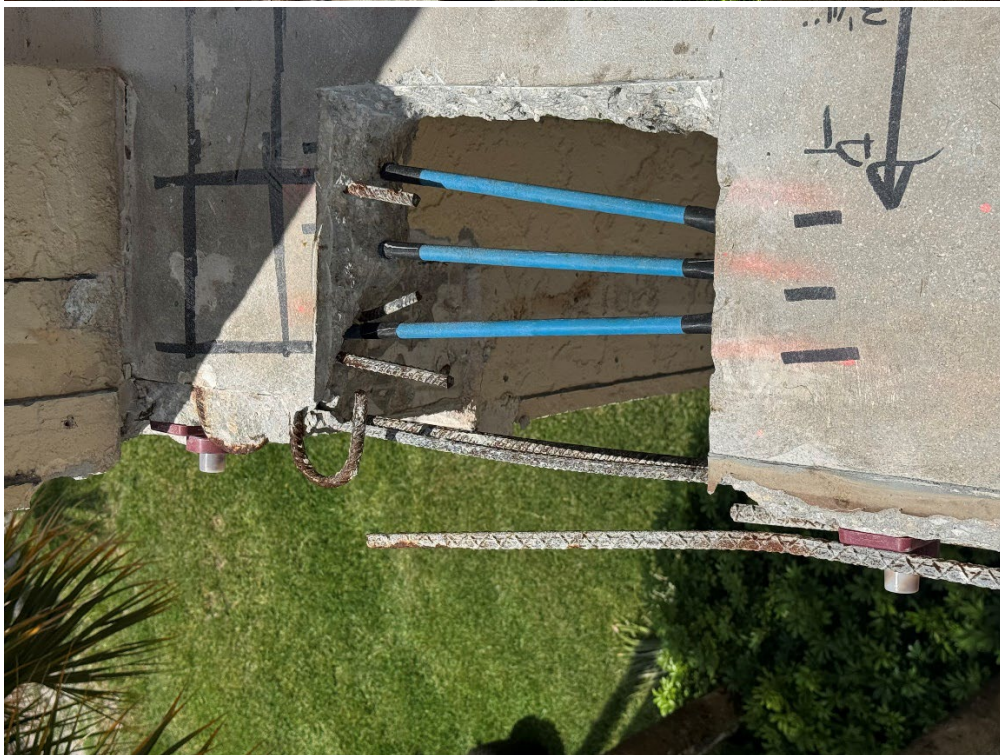
Full cable replacements of the first three uniform cables emanating from the column at Unit F-303's southeast balcony corner have been successfully completed. These cables were confirmed to extend from F-303 to F-305. (Yellow cables on updated plan)

**Unit F-303 – Full cable replacements completed for the 3 uniform cables emanating from the column.**

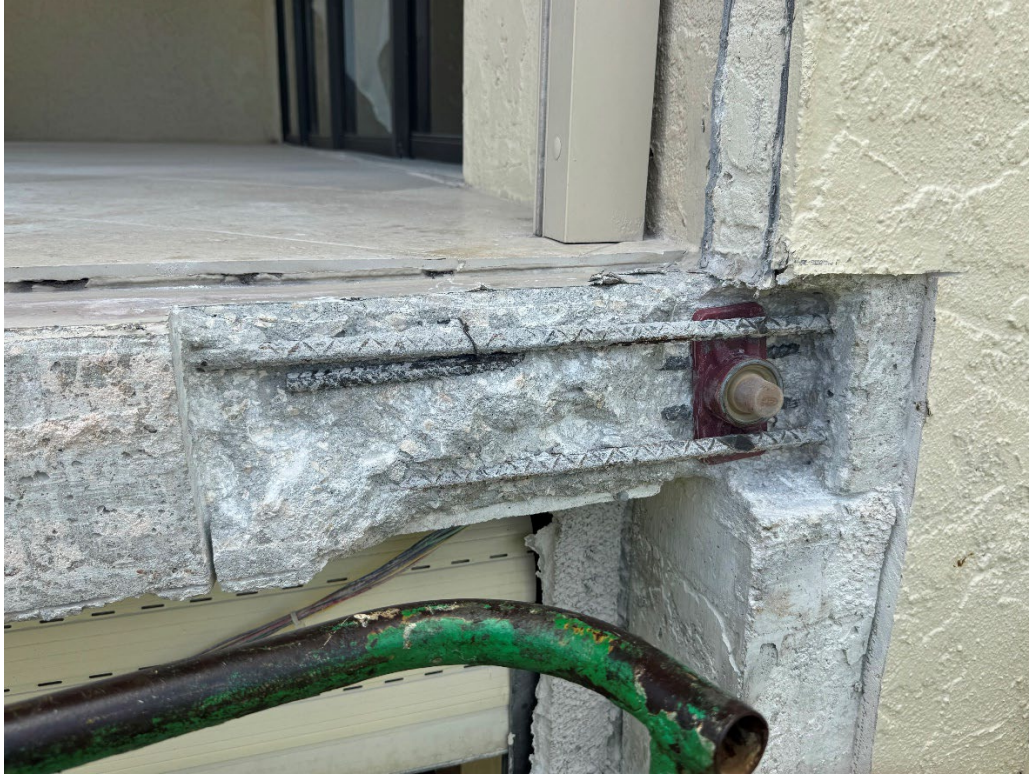
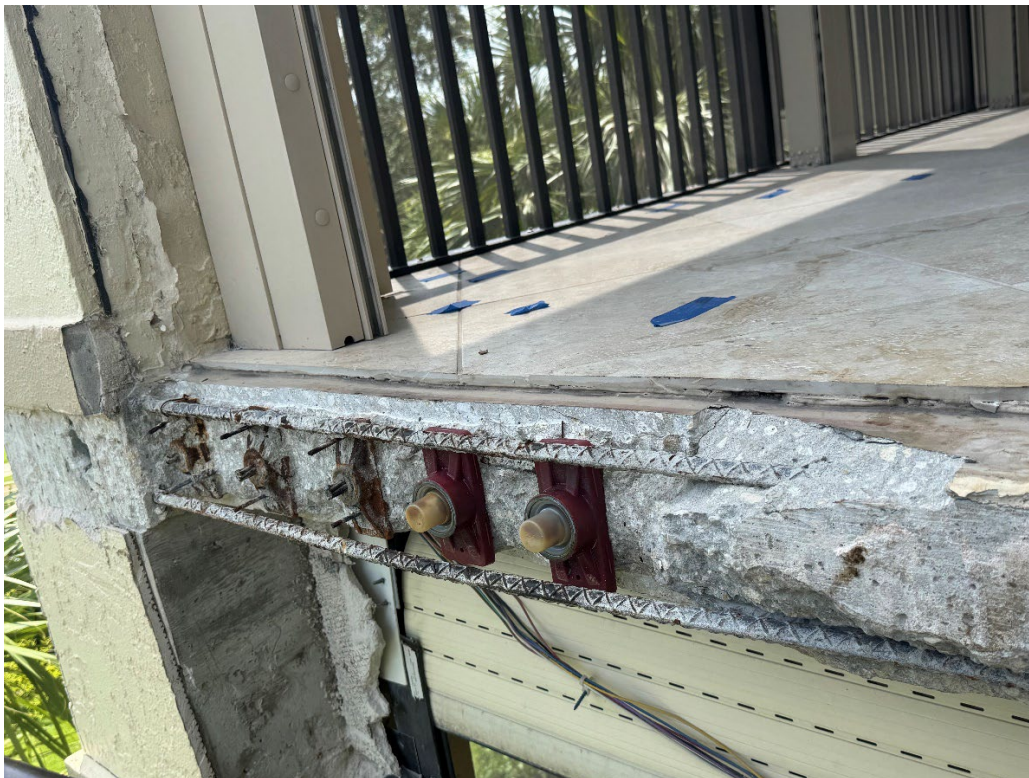
- These cables remain suspected to terminate at the shear wall of F-303 exact end locations and quantity of cables still unconfirmed.

**Unit F-305 – 7 identified PT cable anchors, 3 of which are cables extending through to Unit F-303. Remaining 3 severely corroded anchors observed to be replaced, suspected to end at wall of Unit F-303.**

- Investigative work continues to confirm end locations for the three cables at Unit F-305's balcony edge.

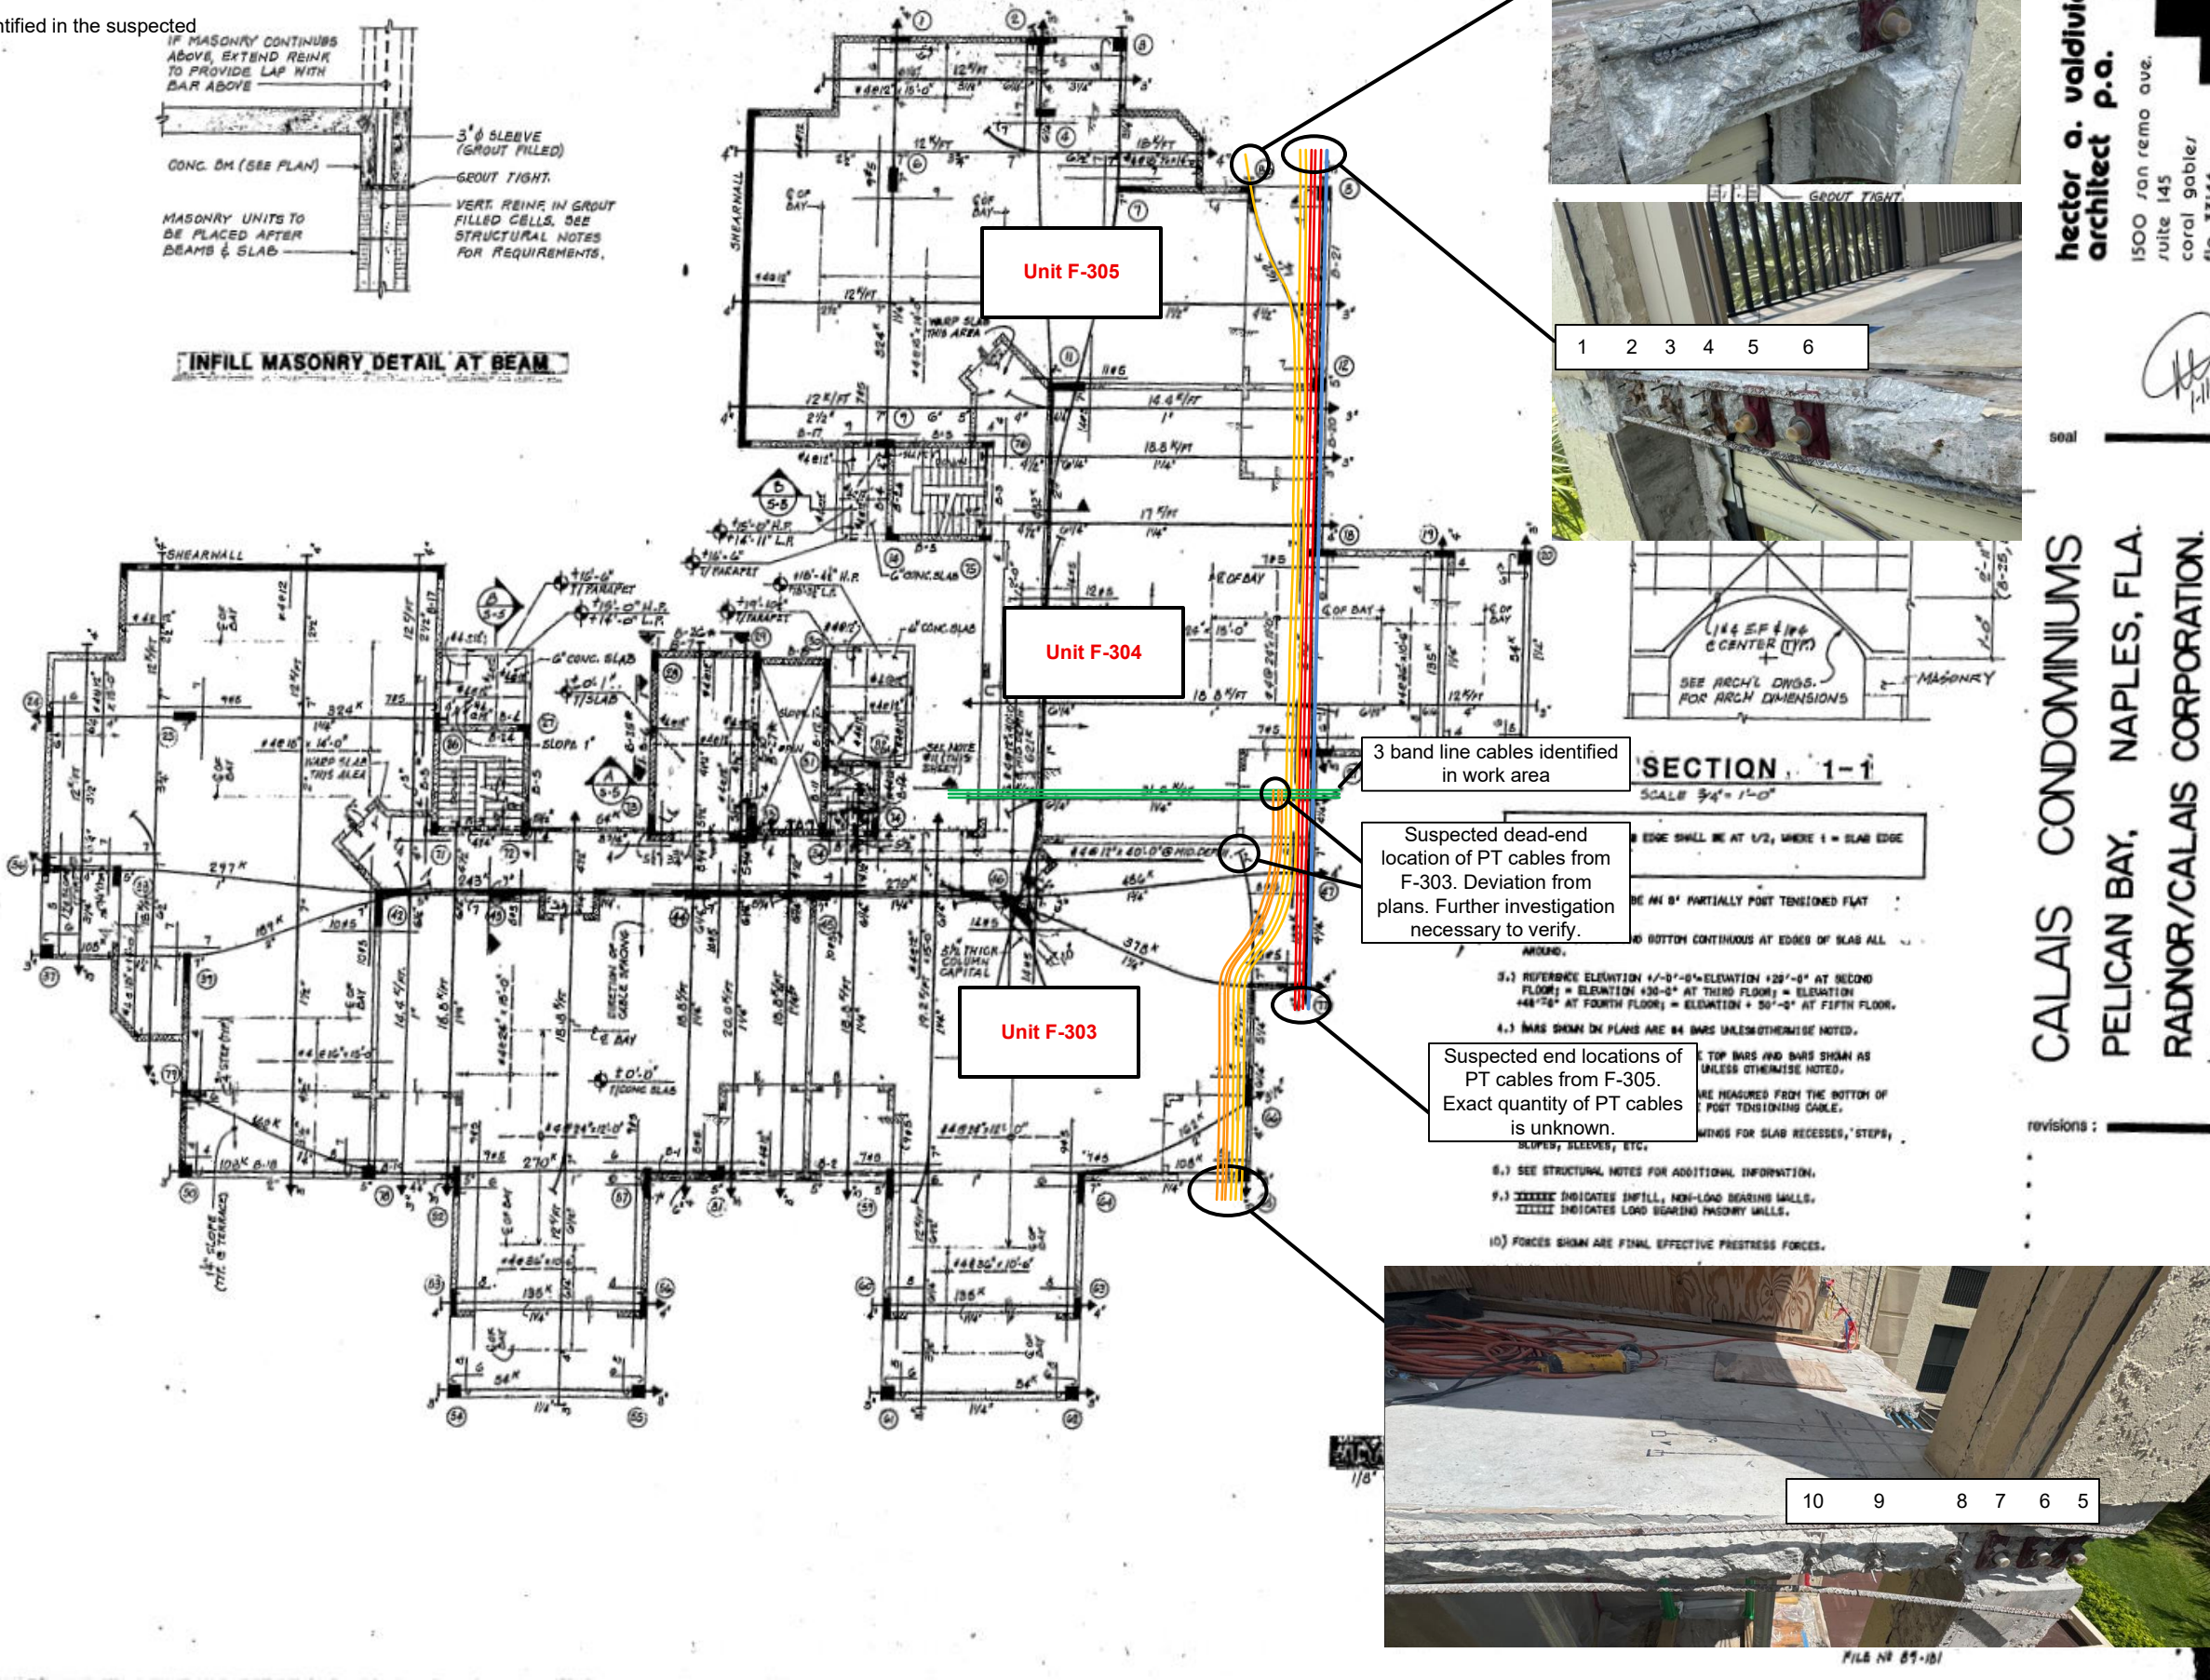
| Sheet 1 of 1 | PT Cable Replacement |

Blue 1 PT Cable not compromised at F-305 Column  
Red 3 Full cable replacements left at F-305 end of cables unknown  
Yellow 3 Full cable replacements completed F-303 to F-305  
Orange 3 Full cable replacements left at F-303 end of cables unknown  
Green 3 band line cables identified in the suspected dead end location
