# Calais at Pelican Bay

## Phase II Work Scope

### Project Management Report – Week 3

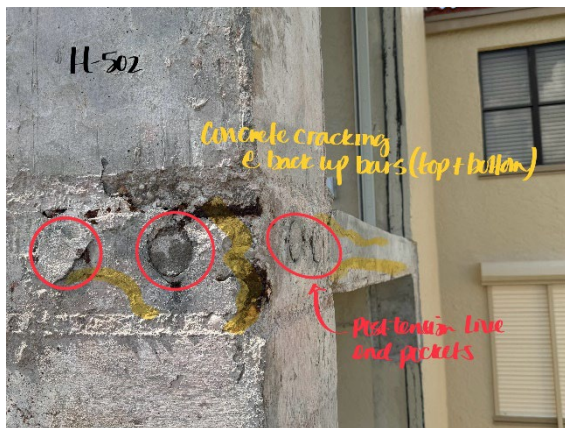
PT cables at column

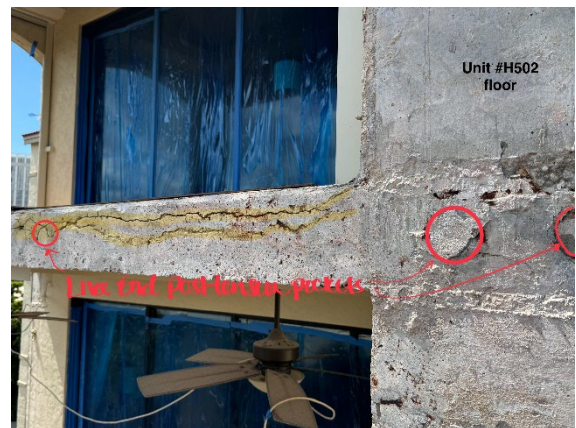
1. Elias Brothers continues to make good progress this week on the 02 and 04 stacks of building H. This work included column repairs, stucco repairs and deck edge work. Decks were X-rayed to identify post tension cable locations and reinforcing steel. The extent of needed repairs in the 402 and 502 units will require shoring of the decks from the ground up.

Extent of 502 deck damage

2. In addition, a specialty contractor will be needed on the 502 deck for the post tensioning cables while concrete repairs are completed. The post tensioning and shoring will add costs to the project and Elias Brothers is developing those costs currently and will present them when completed. Some additional time will be added as well but these are critical repairs that cannot be ignored.

6. The engineer provided direction regarding shoring requirements and the order of the repair work to be completed on the 02 stack. All other work at this point is in order to be continued as planned and scheduled.
7. The Manager and the Board vice president have been included in these discussions.

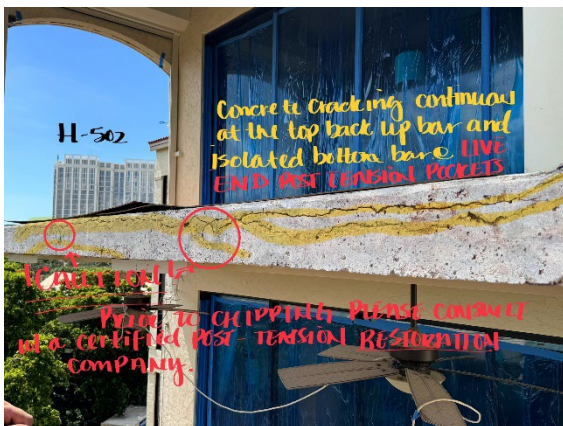
Extent of 502 damage

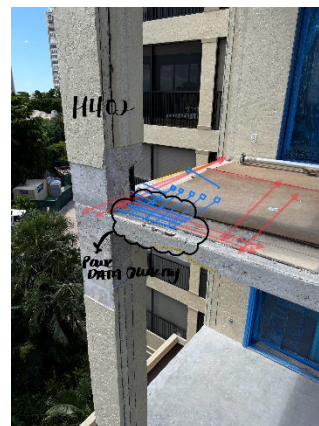
402 X-ray result w needed repairs
