## Calais at Pelican Bay

### Phase II Work Scope

#### Project Management Report No 8

Site visit, Date 2.17.2025 Building D

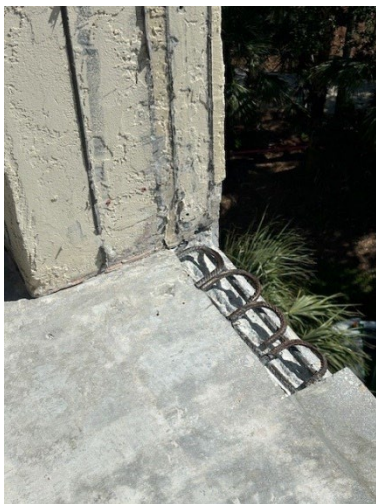
Picture 1

1. Permitting for building D continues with the County.
2. Permitting for building F has been secured with the County.
3. Concrete restoration work is in progress in building D, a balcony deck edge location at unit 502 (please see picture 1) was inspected by Socotec and instructions for repair were given onsite to the field supervisor.

I would like to add that at the time of my last inspection, the structural damage discovered in building D is minor, only related to the balconies deck edge, the subject damage is typically caused by poor concrete cover (construction defect) and water intrusion through the fastening system attaching the railing/shutter/and/or openings installed along the deck edge. Fortunately, no damage to the post-tension tendons has been yet observed.

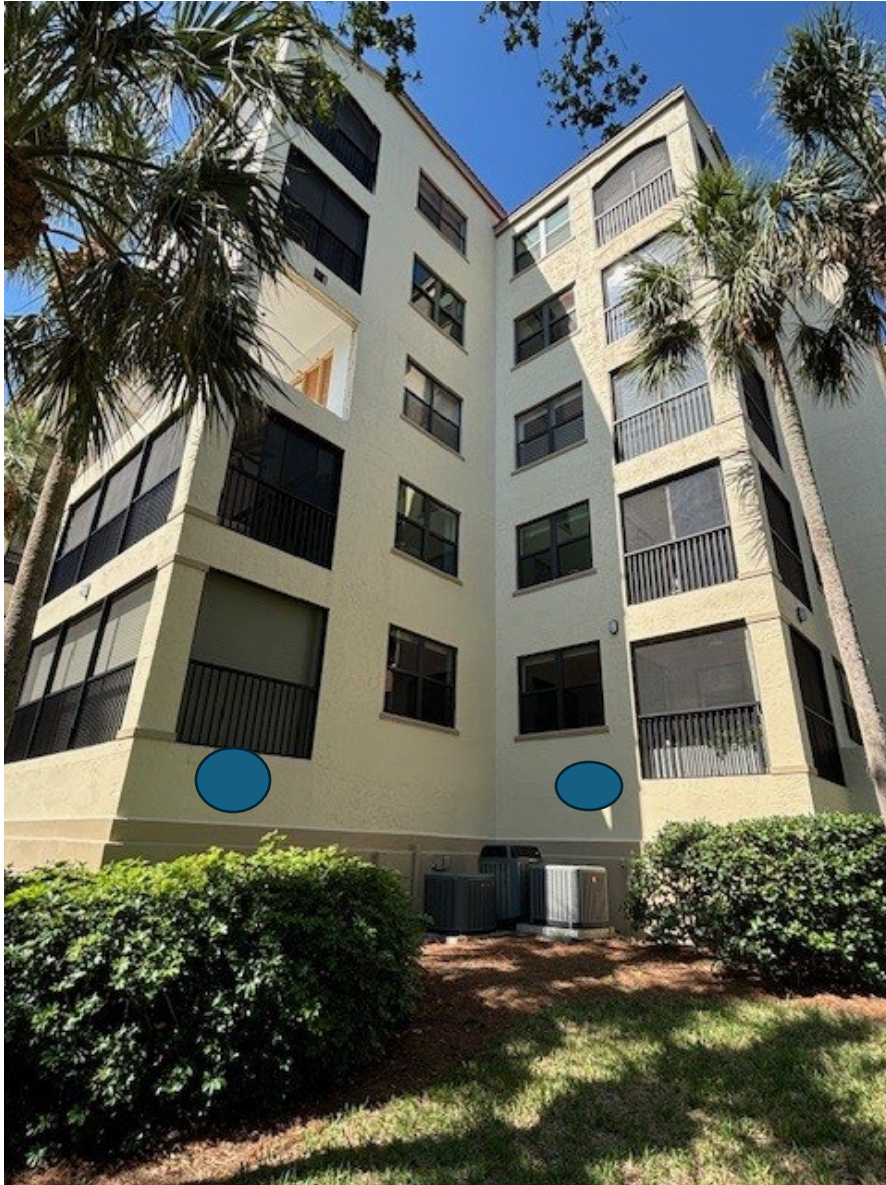
4. As requested by the board, an inspection was completed on the exteriors of unit 103, specifically along both balconies deck edges and exterior walls associated with them. During my inspection I found signs of delaminated stucco. However, no signs of stucco cracking and/or spalling were observed. The delaminated stucco is most likely associated with the gap between the CMU wall (exterior garage wall) and the balconies deck edge (Please see picture 2 for reference). Instructions were given on site to the field supervisor to remove the stucco at two different locations for further investigation (Please see picture 4).

Picture 4, Locations where the stucco must be removed for further investigation.
