## Calais at Pelican Bay

### Project Management Report – Building F

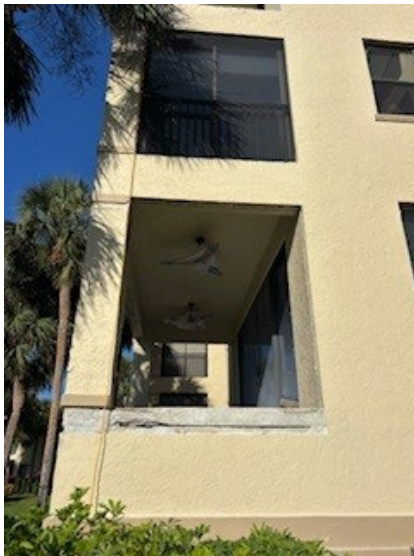
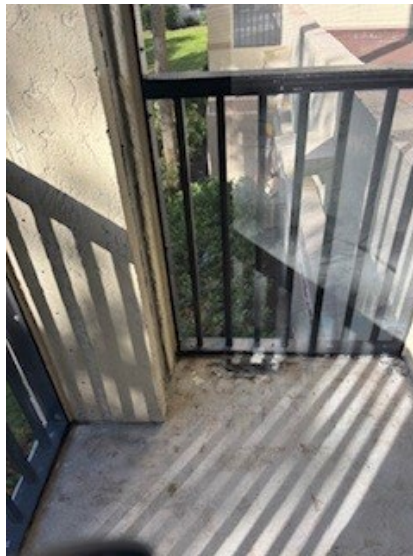
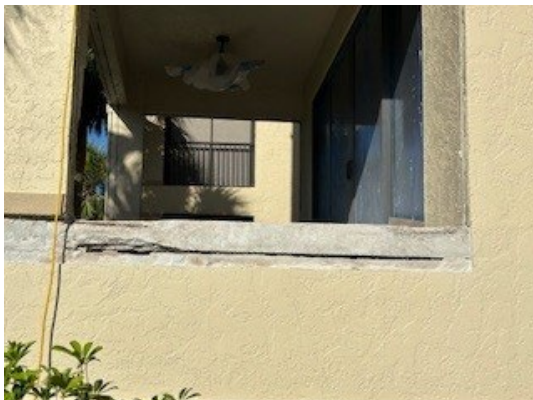
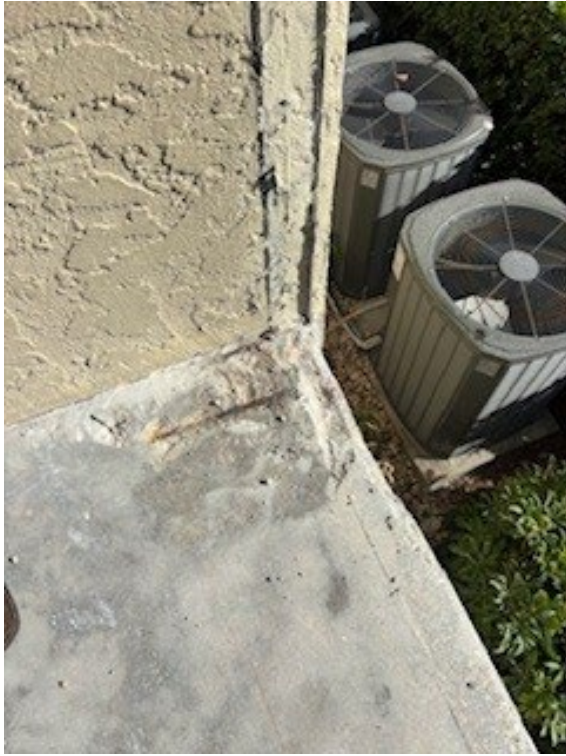
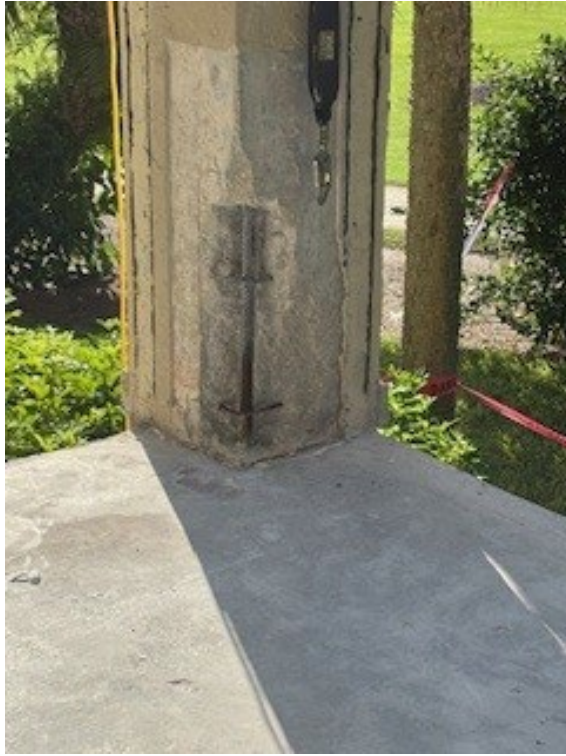
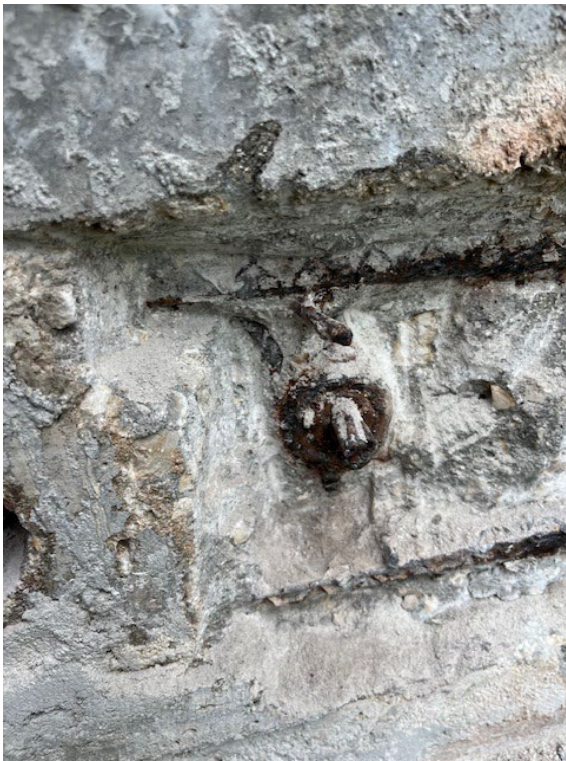
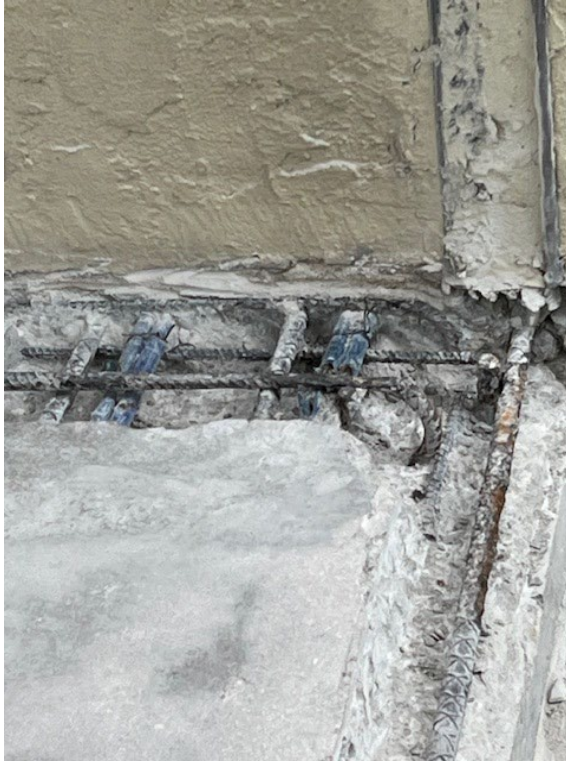
#### 1. Unit F103 Concrete Restoration:

Structural distress (cracking) at a column and deck edge was inspected by Socotec and instructions for repair were given onsite to the field supervisor. A standard concrete restoration procedure in accordance with the permitting plans provided is in progress. We also noted the deterioration of two (2) post-tensioned cables requiring repair. A specialist will be assisting with the cable tensioning and sequencing work related to the post tension cable repairs. In addition, signs of delaminated stucco were also observed. The delaminated stucco is most likely associated with the gap between the CMU wall (exterior garage wall) and the balconies deck edge. Instructions for repair were given on site to the field supervisor. Installation of shoring and reshoring posts in accordance with the provided plans will be necessary to perform the repairs since most likely the concrete demolition will be done around the post tension cables. Locations of the shoring posts shall be as indicated by the Engineer of Record (EOR) on site on 7/18.

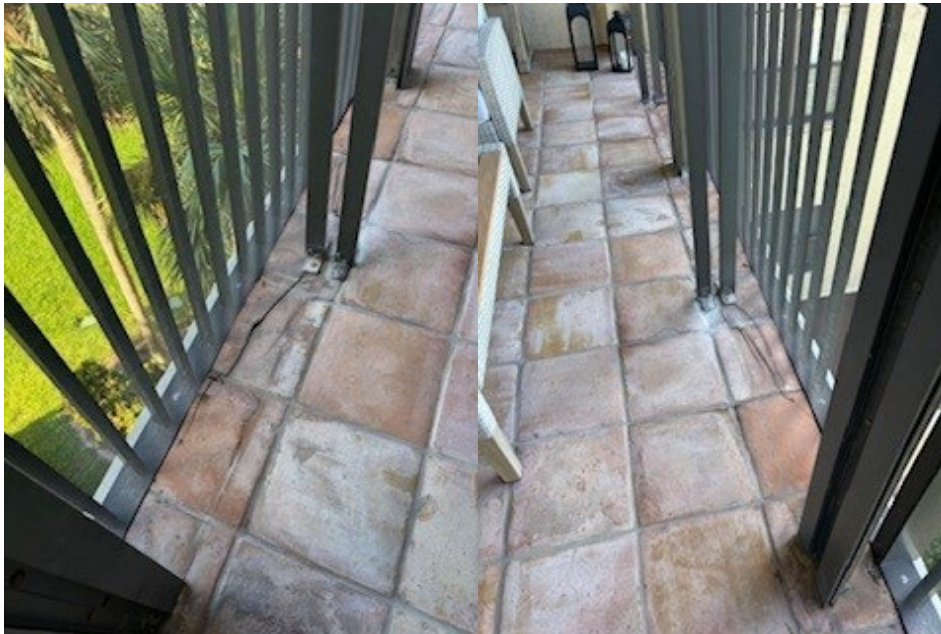
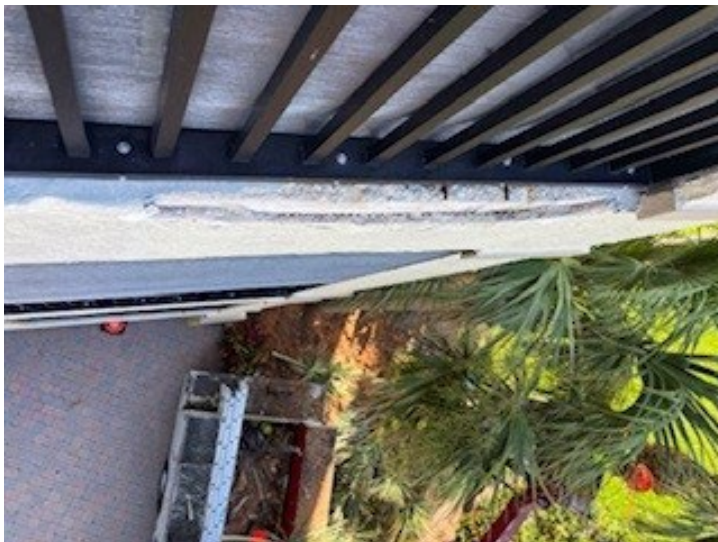
## 2. Unit F301 Deck Concrete Restoration:

Structural distress (corroded and exposed rebar, concrete delamination) along the entire lanai's deck edge was observed by Socotec and instructions for repair were given onsite to the field supervisor. The tiles along the entire balcony will need to be removed to inspect the deck for any issues (cracks, spalls, etc.), perform any necessary concrete restoration work, and waterproof the entire balcony deck. Temporary removal of the shutter system and screen enclosure will also be necessary to properly access the area of concrete restoration and install the waterproofing system. A standard concrete restoration procedure in accordance with the permitting plans provided must be followed.

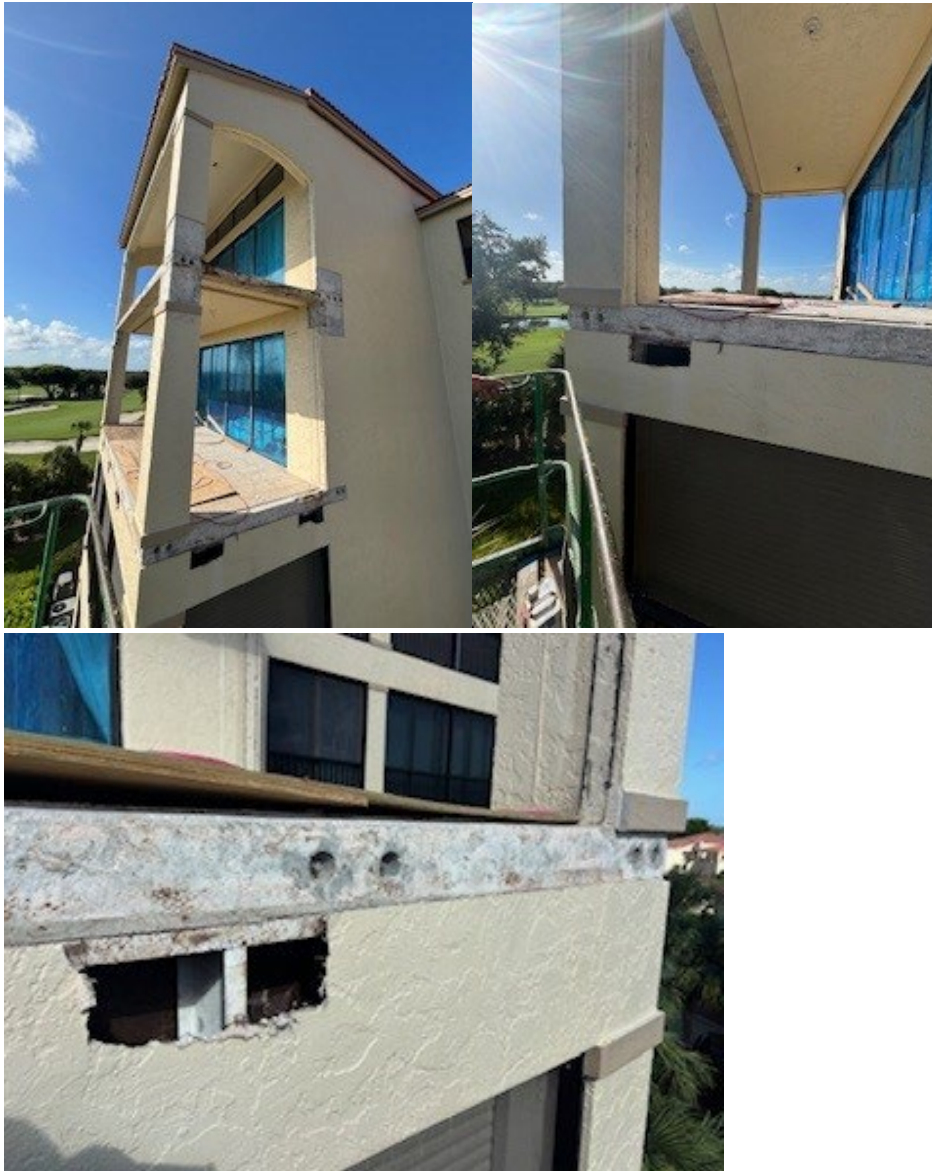
### 3. Unit F404 Deck Concrete Restoration:

Structural distress (corroded and exposed rebar, and concrete delamination) along the entire deck edge of the lanai was observed by Socotec and instructions for repair were given onsite to the field supervisor. A standard concrete restoration procedure in accordance with the permitting plans provided must be followed. In addition, we also noted the deterioration of sixteen (16) post tension cables requiring repair. The project team met to finalize the post-tensioned cables repair scope of work. A specialist will be assisting with the cable tensioning and sequencing work related to the post-tensioned cable repairs. Installation of shoring and reshoring posts in accordance with the provided plans will be necessary to perform the repairs since most likely the concrete demolition will be done around the post tension cables.

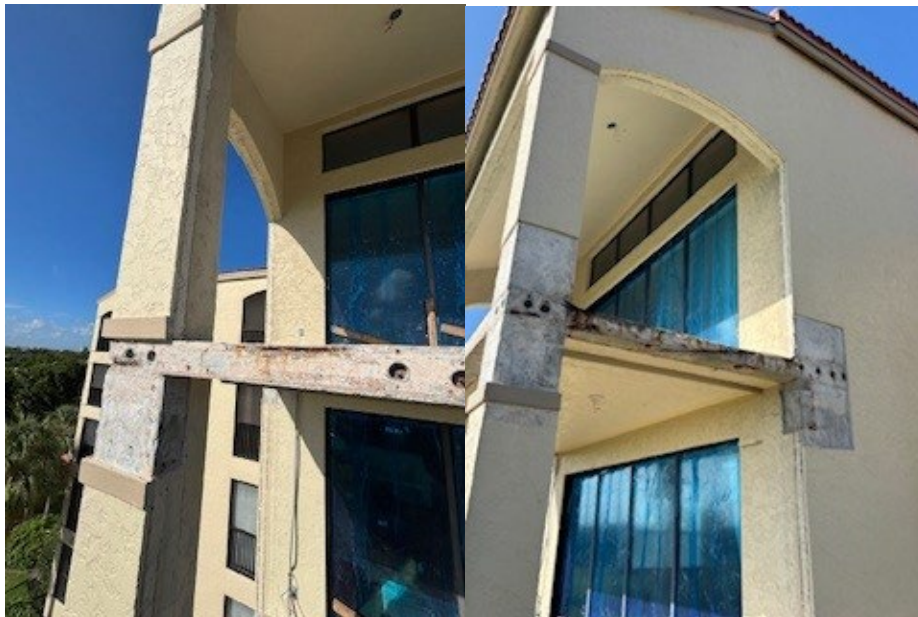
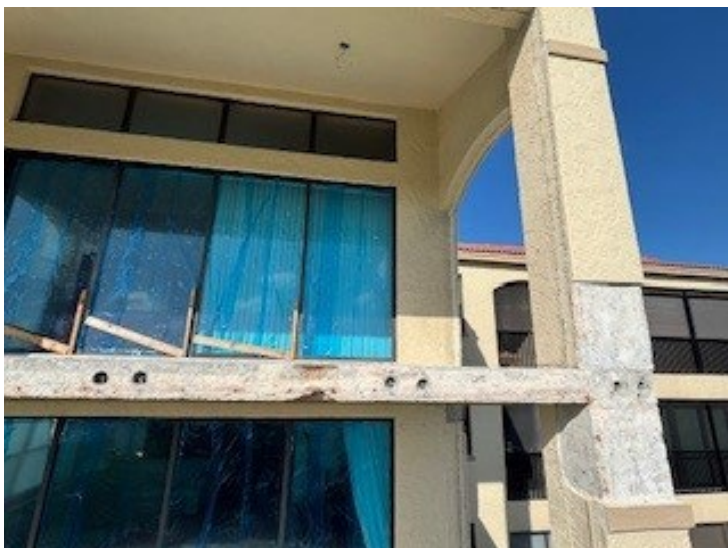
#### 4. Unit F504 Deck Concrete Restoration:

Structural distress (corroded and exposed rebar, and concrete delamination) along the entire deck edge of the lanai was observed by Socotec and instructions for repair were given onsite to the field supervisor. A standard concrete restoration procedure in accordance with the permitting plans provided must be followed. In addition, we also noted the deterioration of eighteen (18) post tension cables requiring repair. The project team met to finalize the post-tensioned cables repair scope of work. A specialist will be assisting with the cable tensioning and sequencing work related to the post-tensioned cable repairs. Installation of shoring and reshoring posts in accordance with the provided plans will be necessary to perform the repairs since most likely the concrete demolition will be done around the post tension cables.

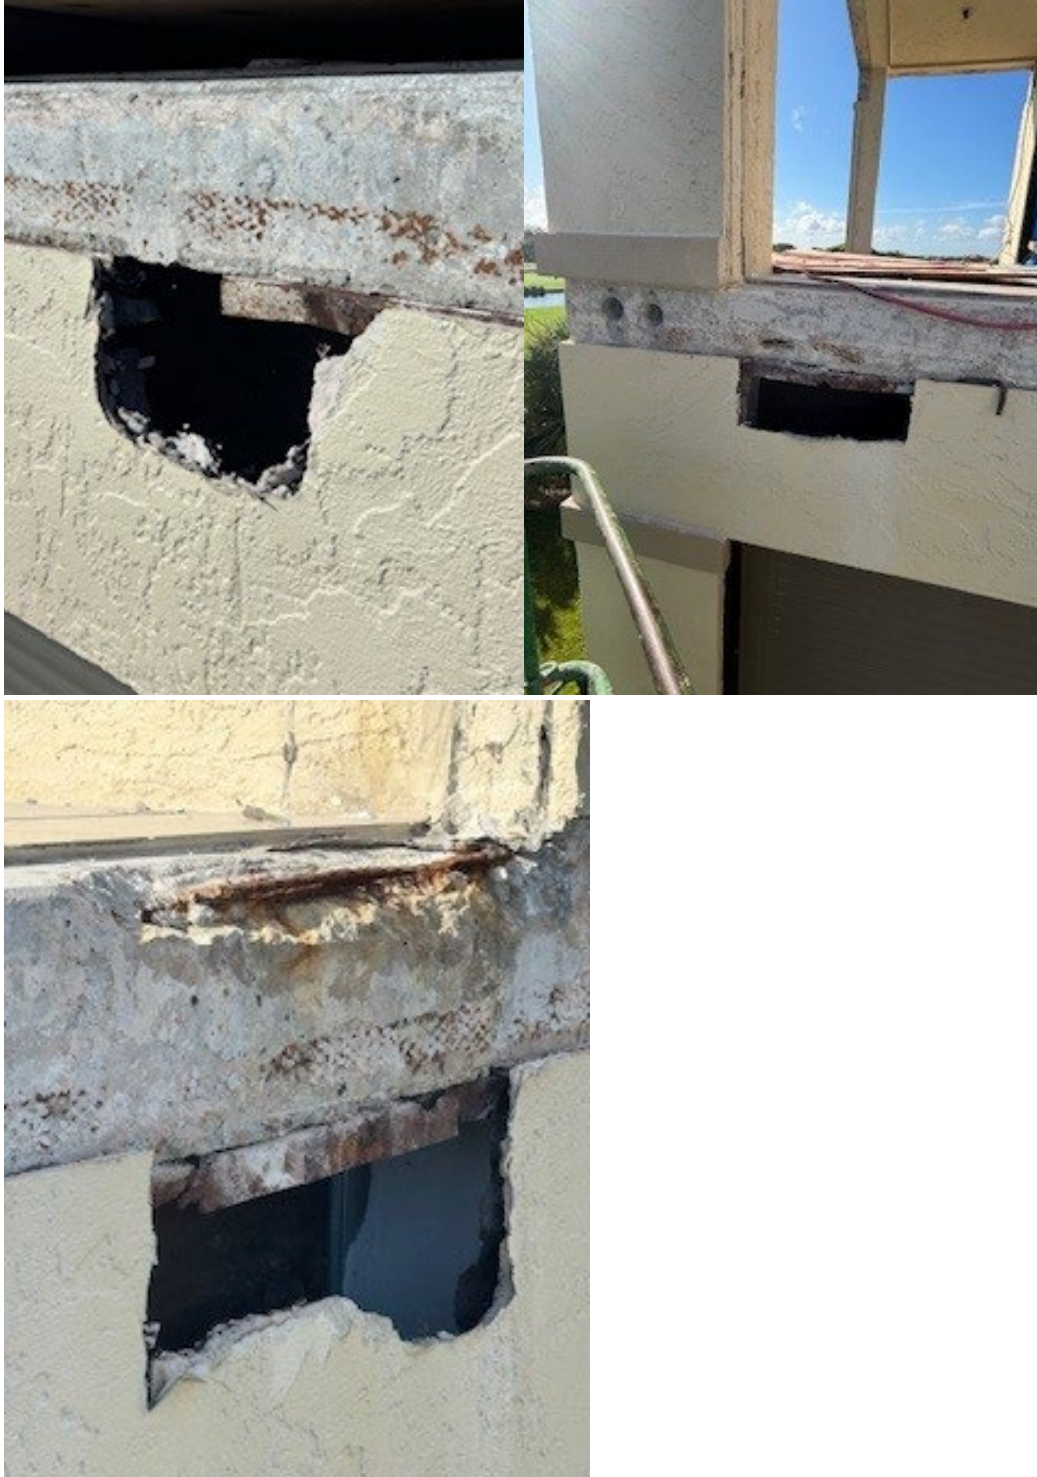
5. Unit F304 Header:

Structural distress (cracking) and severe corrosion of the light gauge metal framing was observed at the headers of the lanai. A standard header restoration procedure in accordance with the permitting plans provided must be followed.
