July 11, 2025

**CALAIS AT PELICAN BAY CONDOMINIUM ASSOCIATION, INC.**

**Subject:** Report of Engineering Consulting Services  
**UNIT F103 – BALCONY TILE DELAMINATION EVALUATION**  
Calais at Pelican Bay  
Naples, Collier County, Florida 34108  
SOCOTEC Project Number VS232306

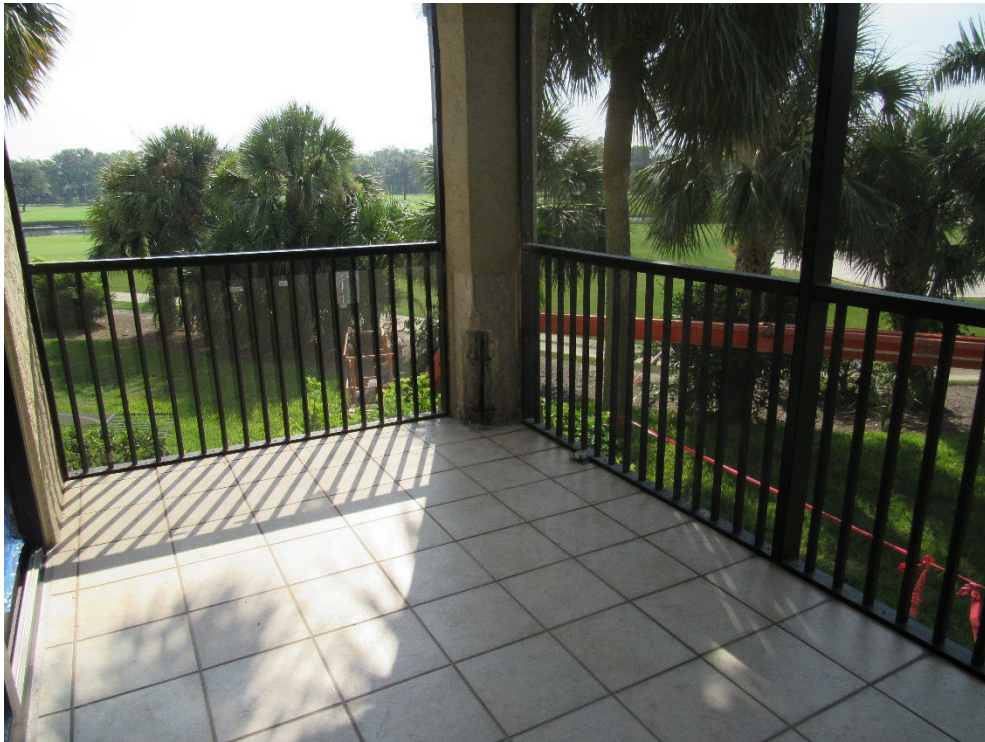
Overview of unit F103 balcony.

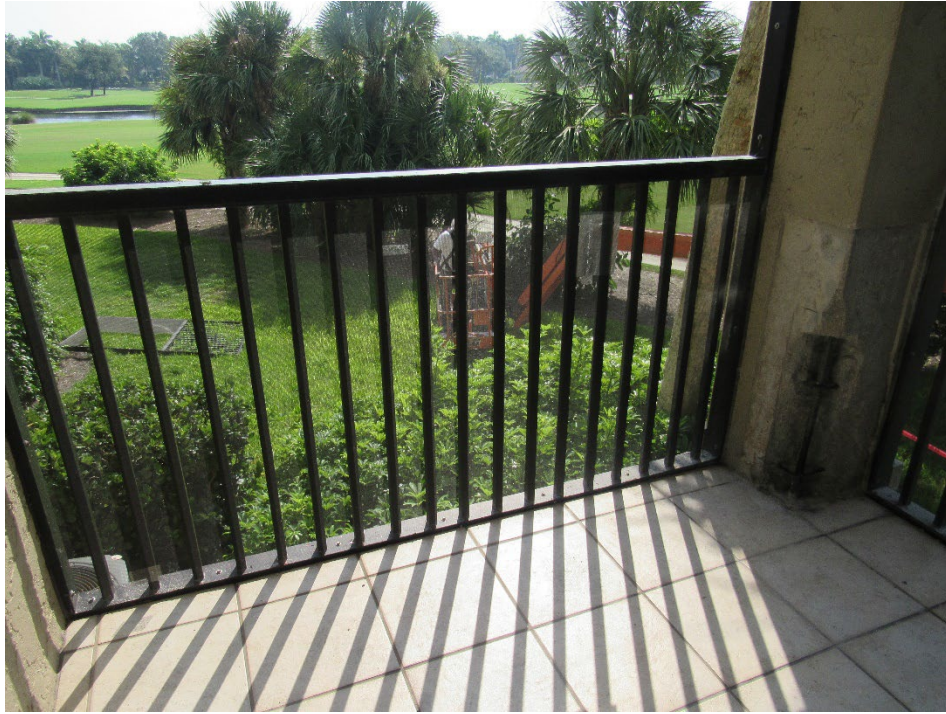
View of area of delaminated tiles.

Based on our observations and evaluation, it is our professional engineering opinion that the unit balcony exhibits significant deterioration of the tiling system and/or loss of the waterproofing system integrity. The subject deterioration is revealed through several debonded and/or cracked tiles observed. This type of tile distress is typically caused by the combination of different factors. Factors causing the tile distress are most likely the age of the thin set and/or the failure or lack of the waterproofing system under the tiling system. When the thin set loses its elasticity and bonding capacity, it may cause the tiles to become delaminated as is occurring on several tiles throughout the balcony deck. The typical useful life for waterproofing systems ranges from 5 years to 20 years depending on the system installed. Based on our observations, we recommend the tiling system be removed and the waterproofing system on the balcony deck be replaced. If no remediation action is taken, the waterproofing system will continue to deteriorate exponentially, which may lead to potential water intrusion compromising the structural integrity of the balcony deck.

- a) Removing the screen enclosure of unit F103 to properly mitigate any concrete issue (spalling, cracking, etc.) along the deck edge.
- b) Remove the existing tile system and any membrane installed over the balcony's concrete deck.
- c) Inspecting the concrete deck for issues (cracks, spalls, etc.) and all issues should be repaired.
- d) All concrete deck surfaces shall be clean, dry and properly sealed before the waterproofing membrane application work begins.
- e) Install a suitable waterproof sealing material (silicone or elastomeric, exterior grade application is recommendable) along each exterior wall/deck junction and sliding glass door/deck junction.
- f) Applying a new waterproofing membrane along the balcony's concrete deck and 4-inches up the walls, the new waterproofing membrane should

be installed from the sliding glass doors bottom track to the outer face of the structural deck.

- g) Re-install the screen enclosure. Each fastener penetration shall be properly sealed with an exterior grade sealant such as silicone or elastomeric and new stainless-steel fasteners shall be used to re-attach the screen enclosure.
- h) If floor tiling is installed on top of the waterproofing system, the thin-set tile shall be compatible with the selected waterproofing system and include a bonding agent mixed in the mortar.

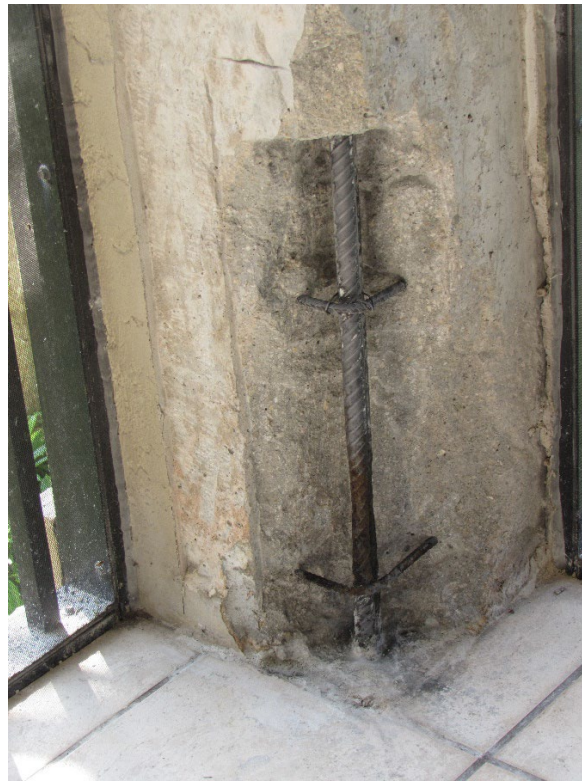
View of ongoing concrete restoration procedure at balcony column.

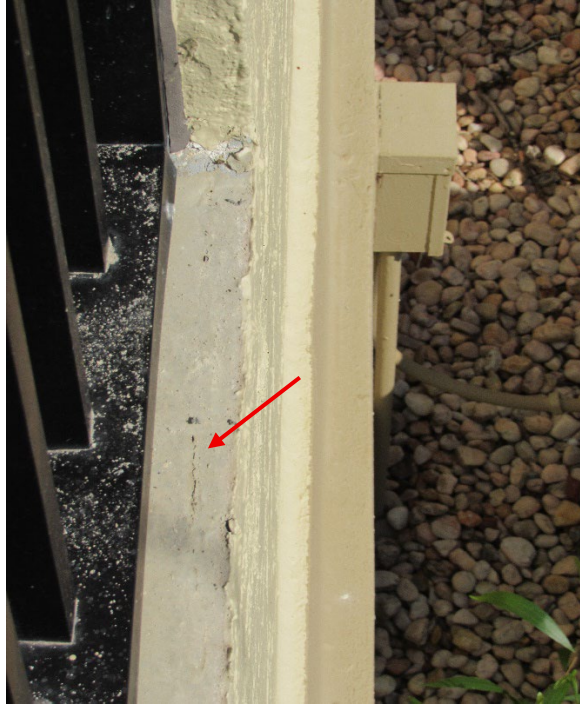
View of crack observed at the balcony slab edge.

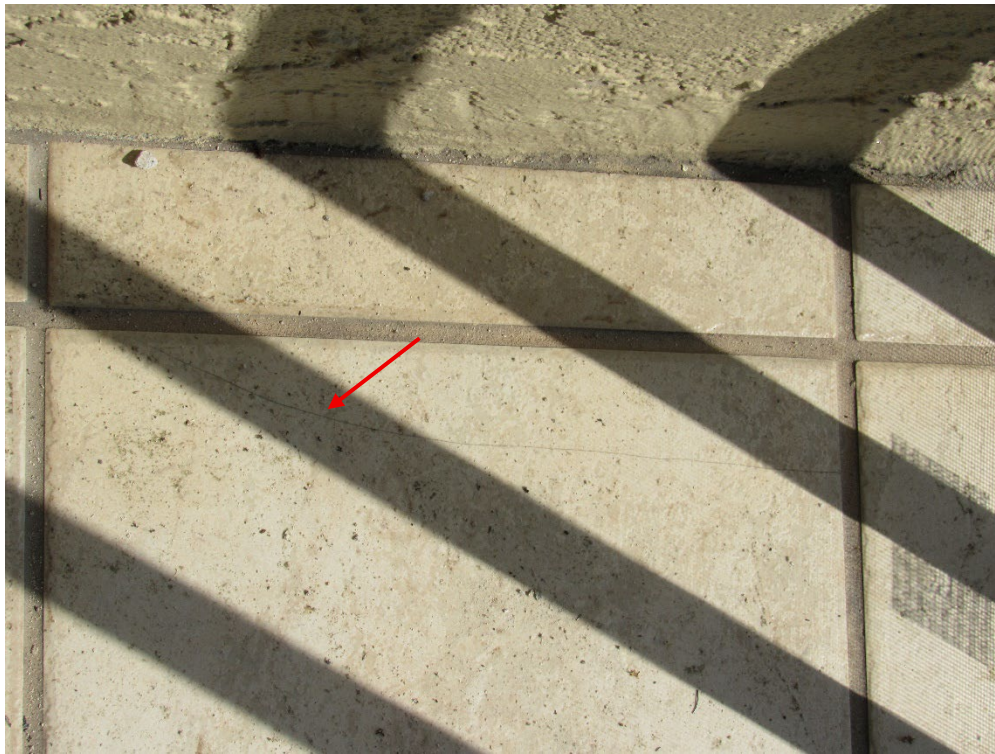
View of cracked tile observed.
