## **Calais at Pelican Bay**

### **Project Management Report – Building E**

#### **1. Unit E301 Interior Structural Slab Crack Repair**

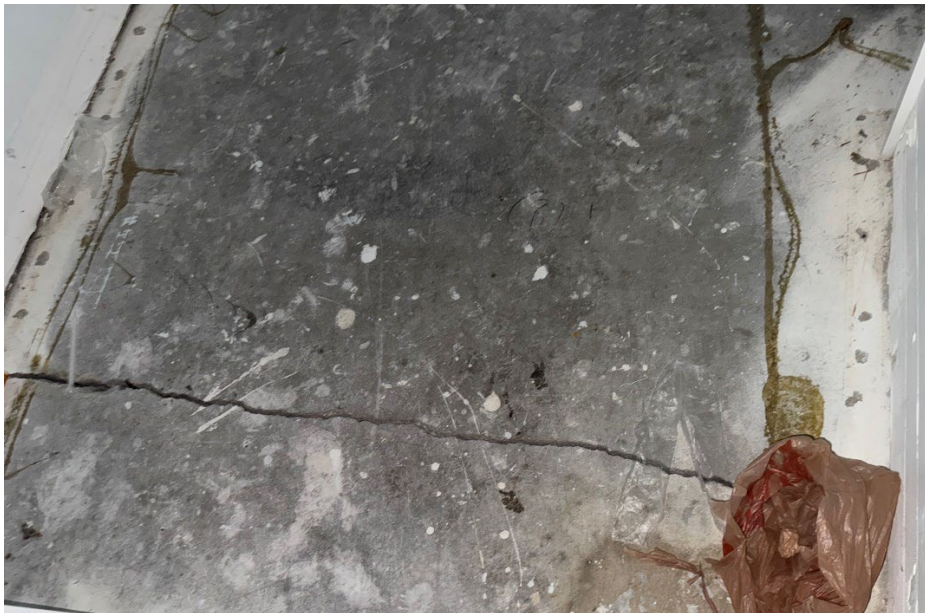
Observed interior structural slab crack.

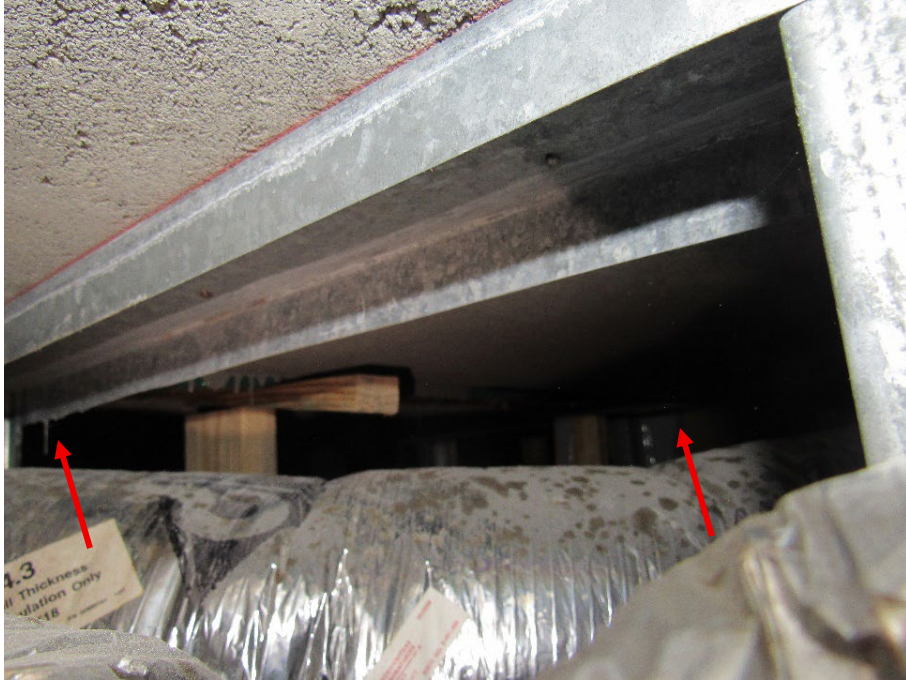
Observed formwork starting and end points.

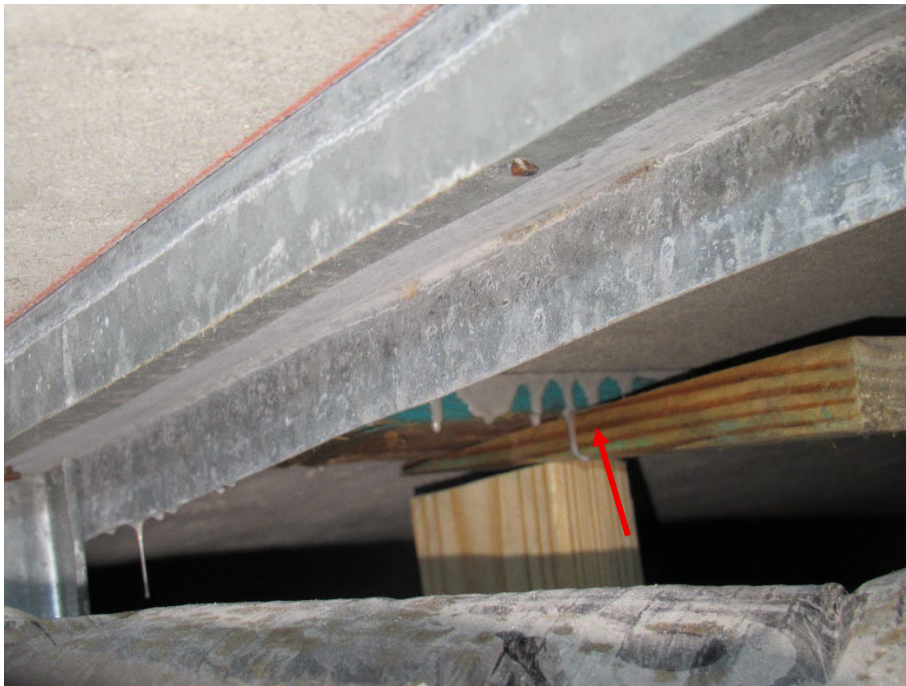
Socotec conducted a field inspection of the ongoing structural crack repair at Unit E301. During the structural epoxy injection process, significant deficiencies were identified in the formwork installed by Dietz of Naples that prevents proper containment of the structural epoxy during injection. The formwork beneath the crack has been installed improperly and incompletely. The form does not seem to extend throughout the entire length of the crack. Structural epoxy was observed leaking from the ends of the formwork and additional leakage was noted at unsealed seams/joints of the formwork. It is important to note that this crack is a structural crack that extends completely through the depth of the concrete slab. This full-penetration crack represents a discontinuity in the structural element. Due to the full-depth structural nature of this crack, restoration of the slab's original load-carrying capacity requires the use of a high-modulus, high-strength epoxy. The repair must achieve 100% penetration and sealing of the entire crack throughout its full depth and length. Complete removal and reinstallation of the formwork is necessary to ensure full coverage along the entire crack length and proper sealing at all seams/joints to prevent epoxy migration. All formwork must be inspected and approved by Socotec prior to the continuation of the repair work and injection operations.

Observed epoxy leakage at unsealed formwork seams.

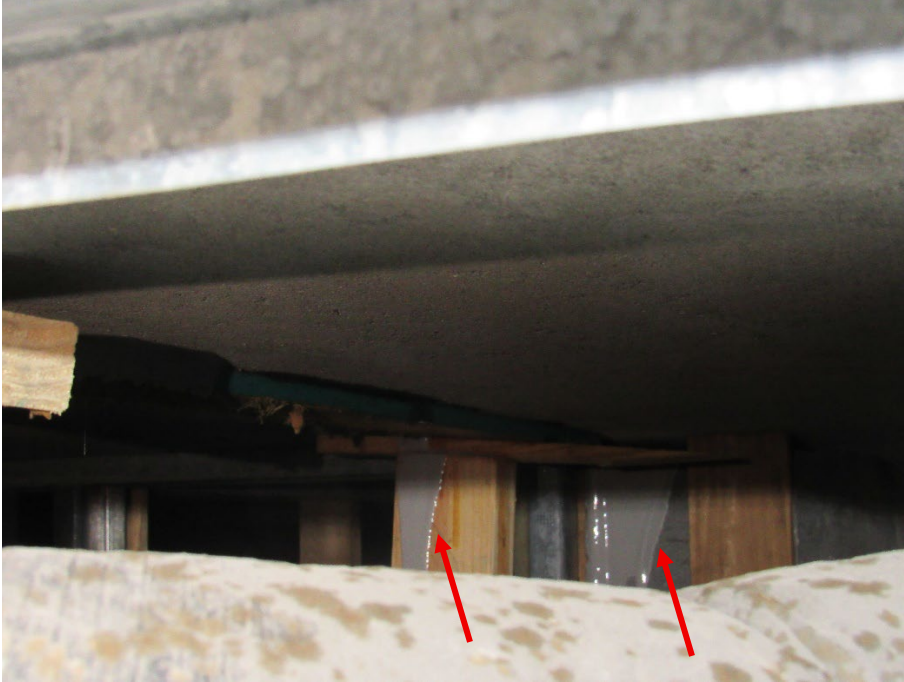
Observed epoxy leakage at formwork end point.
