**From:** Dyani Colon <dyani.colon@socotec.us>  
**Sent:** Friday, May 2, 2025 1:43 PM  
**To:** Rich Meyer  
**Cc:** Joe DiRienzi Sr.; Chris DiRienzi; Aaron Faust  
**Subject:** Calais at Pelican Bay Unit 103 Building D  
**Attachments:** IMG\_9072.JPG; IMG\_9039.JPG; IMG\_9046.JPG; IMG\_9055.JPG; IMG\_9059.JPG; IMG\_9056.JPG

I hope this email finds you well, below is a summary of my observations at unit 103 from my site visit today.

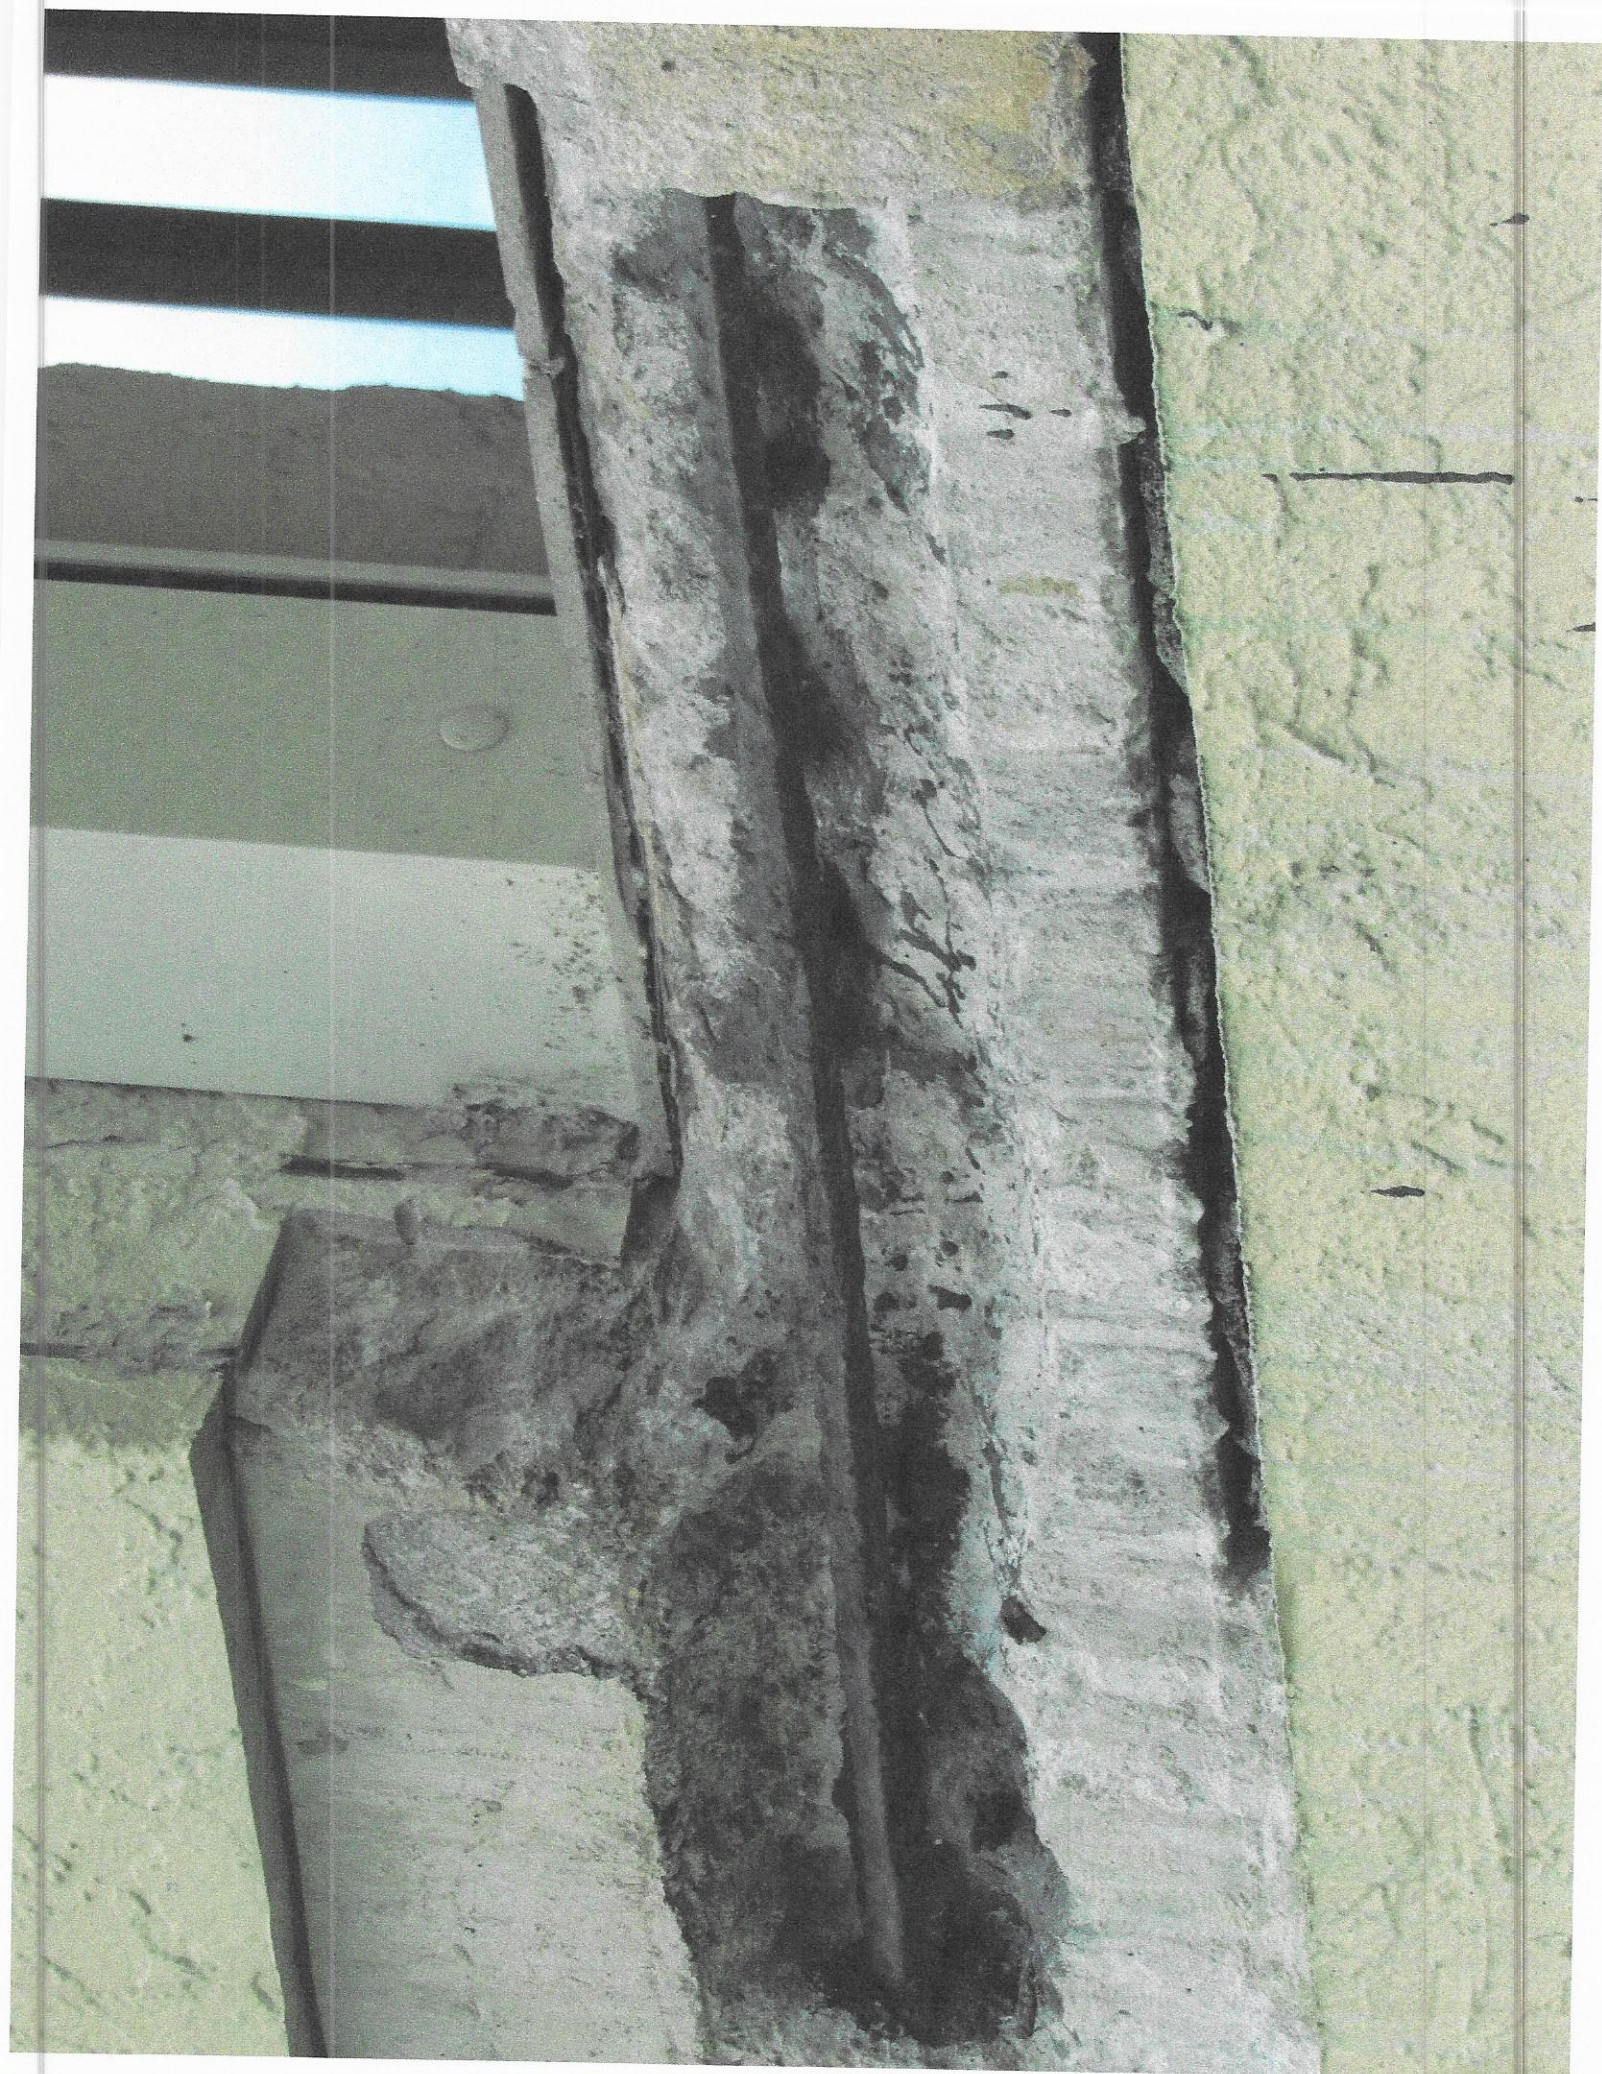
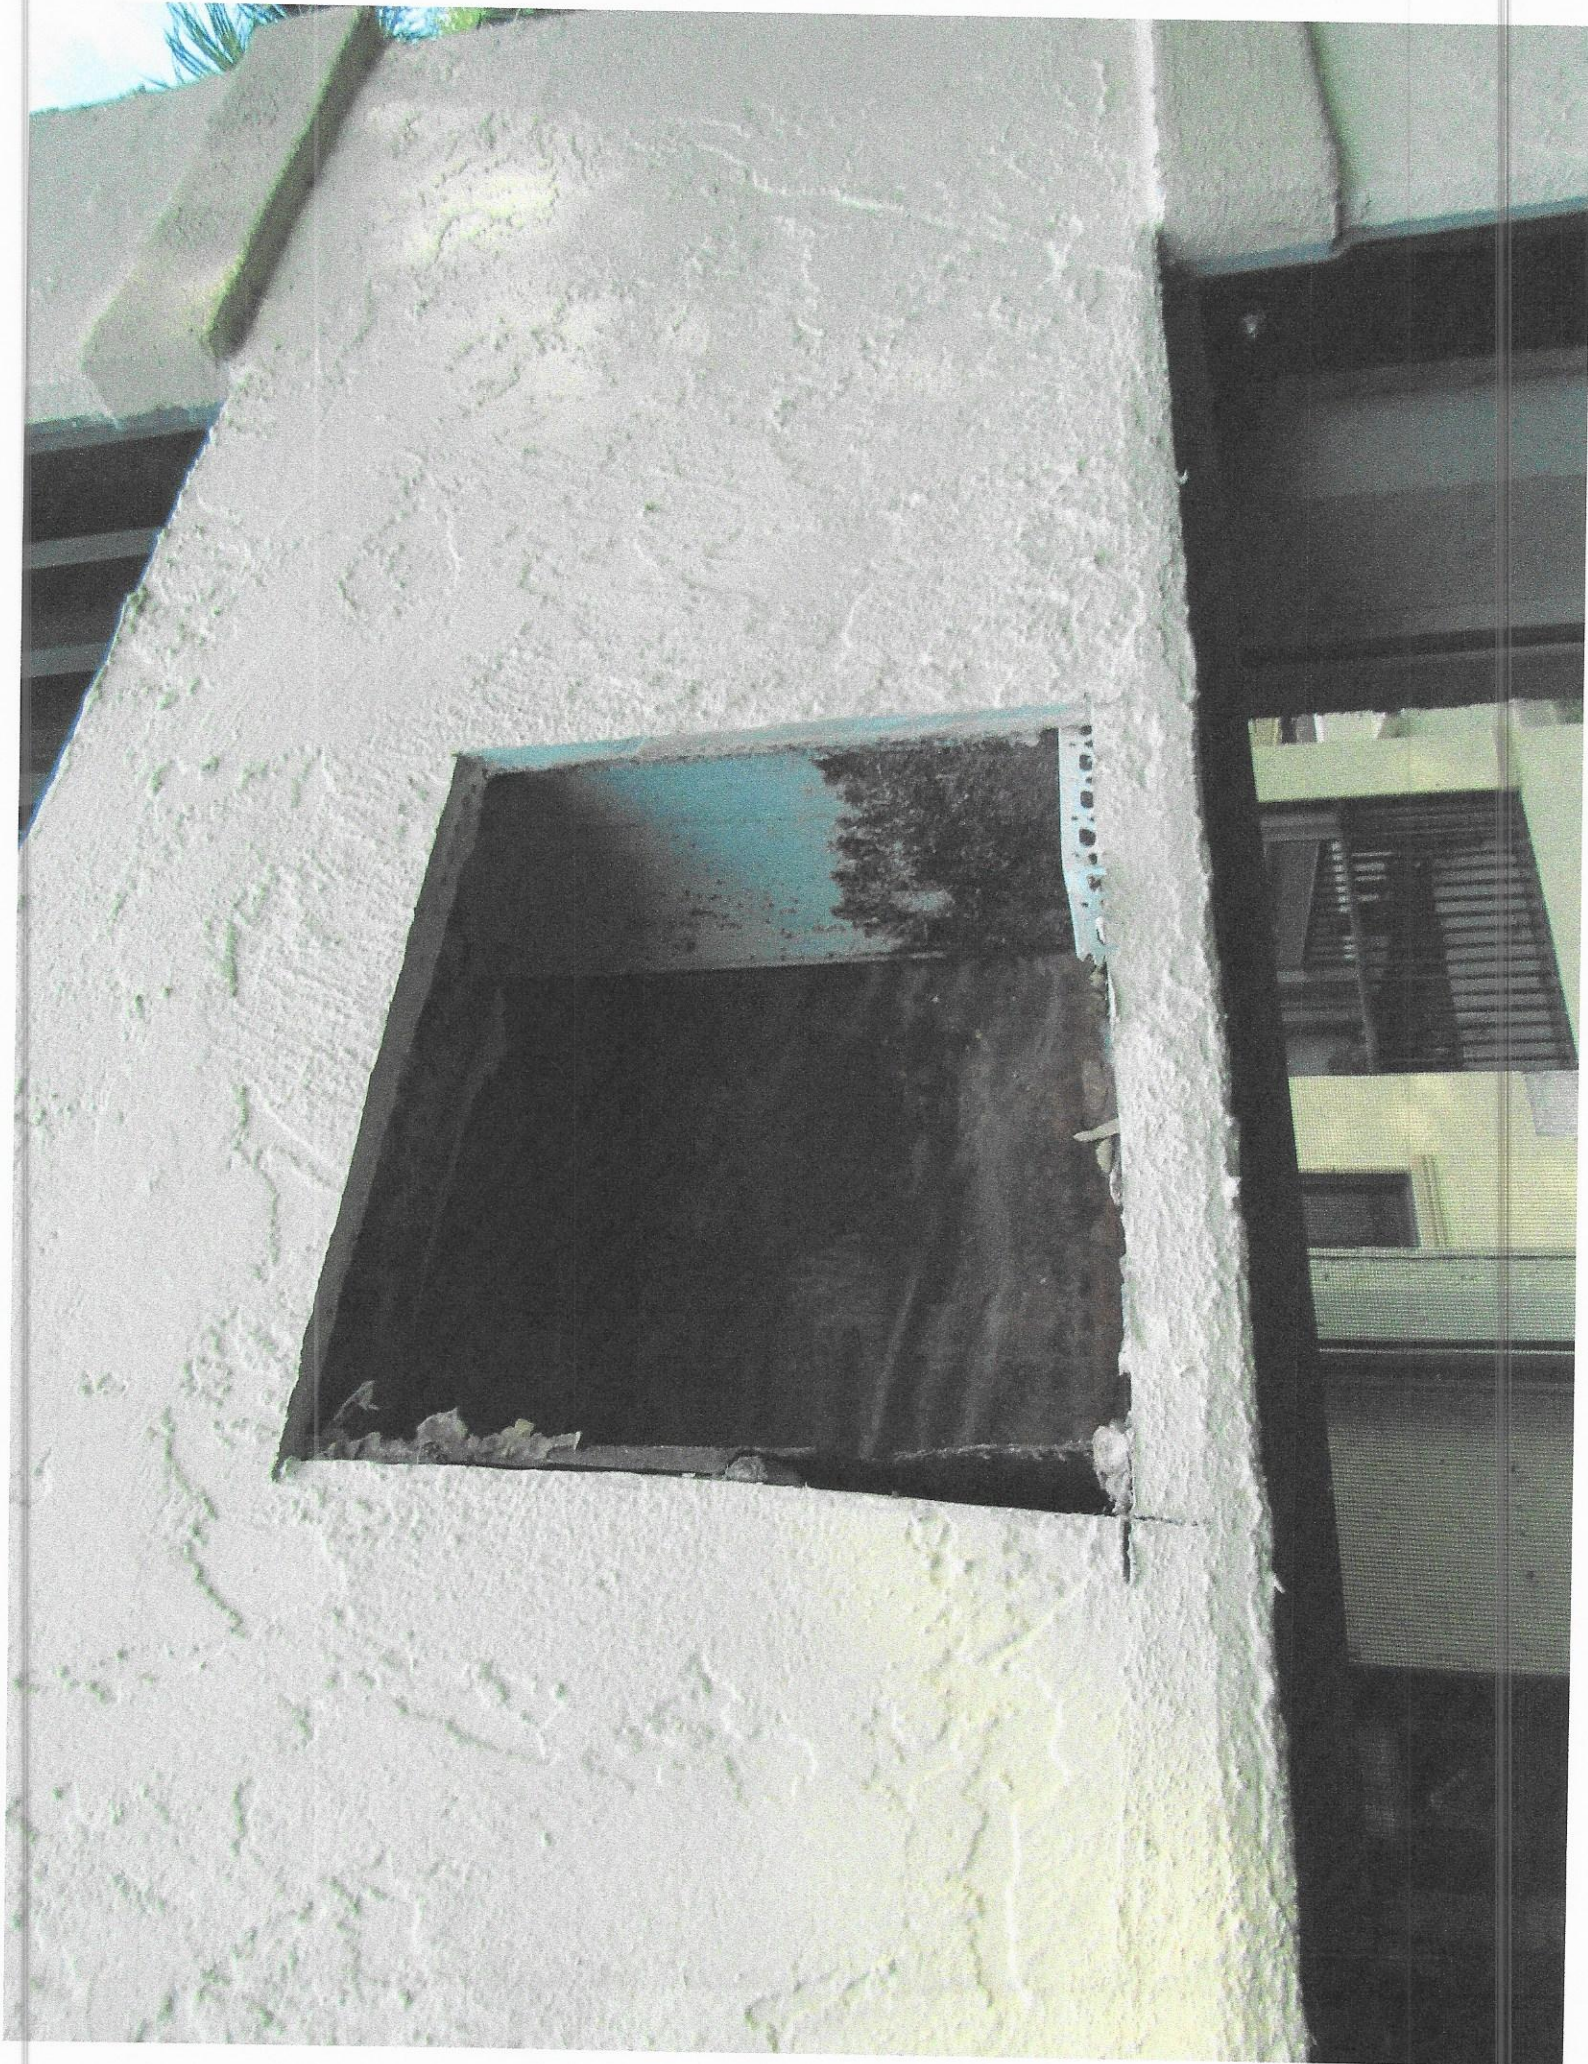
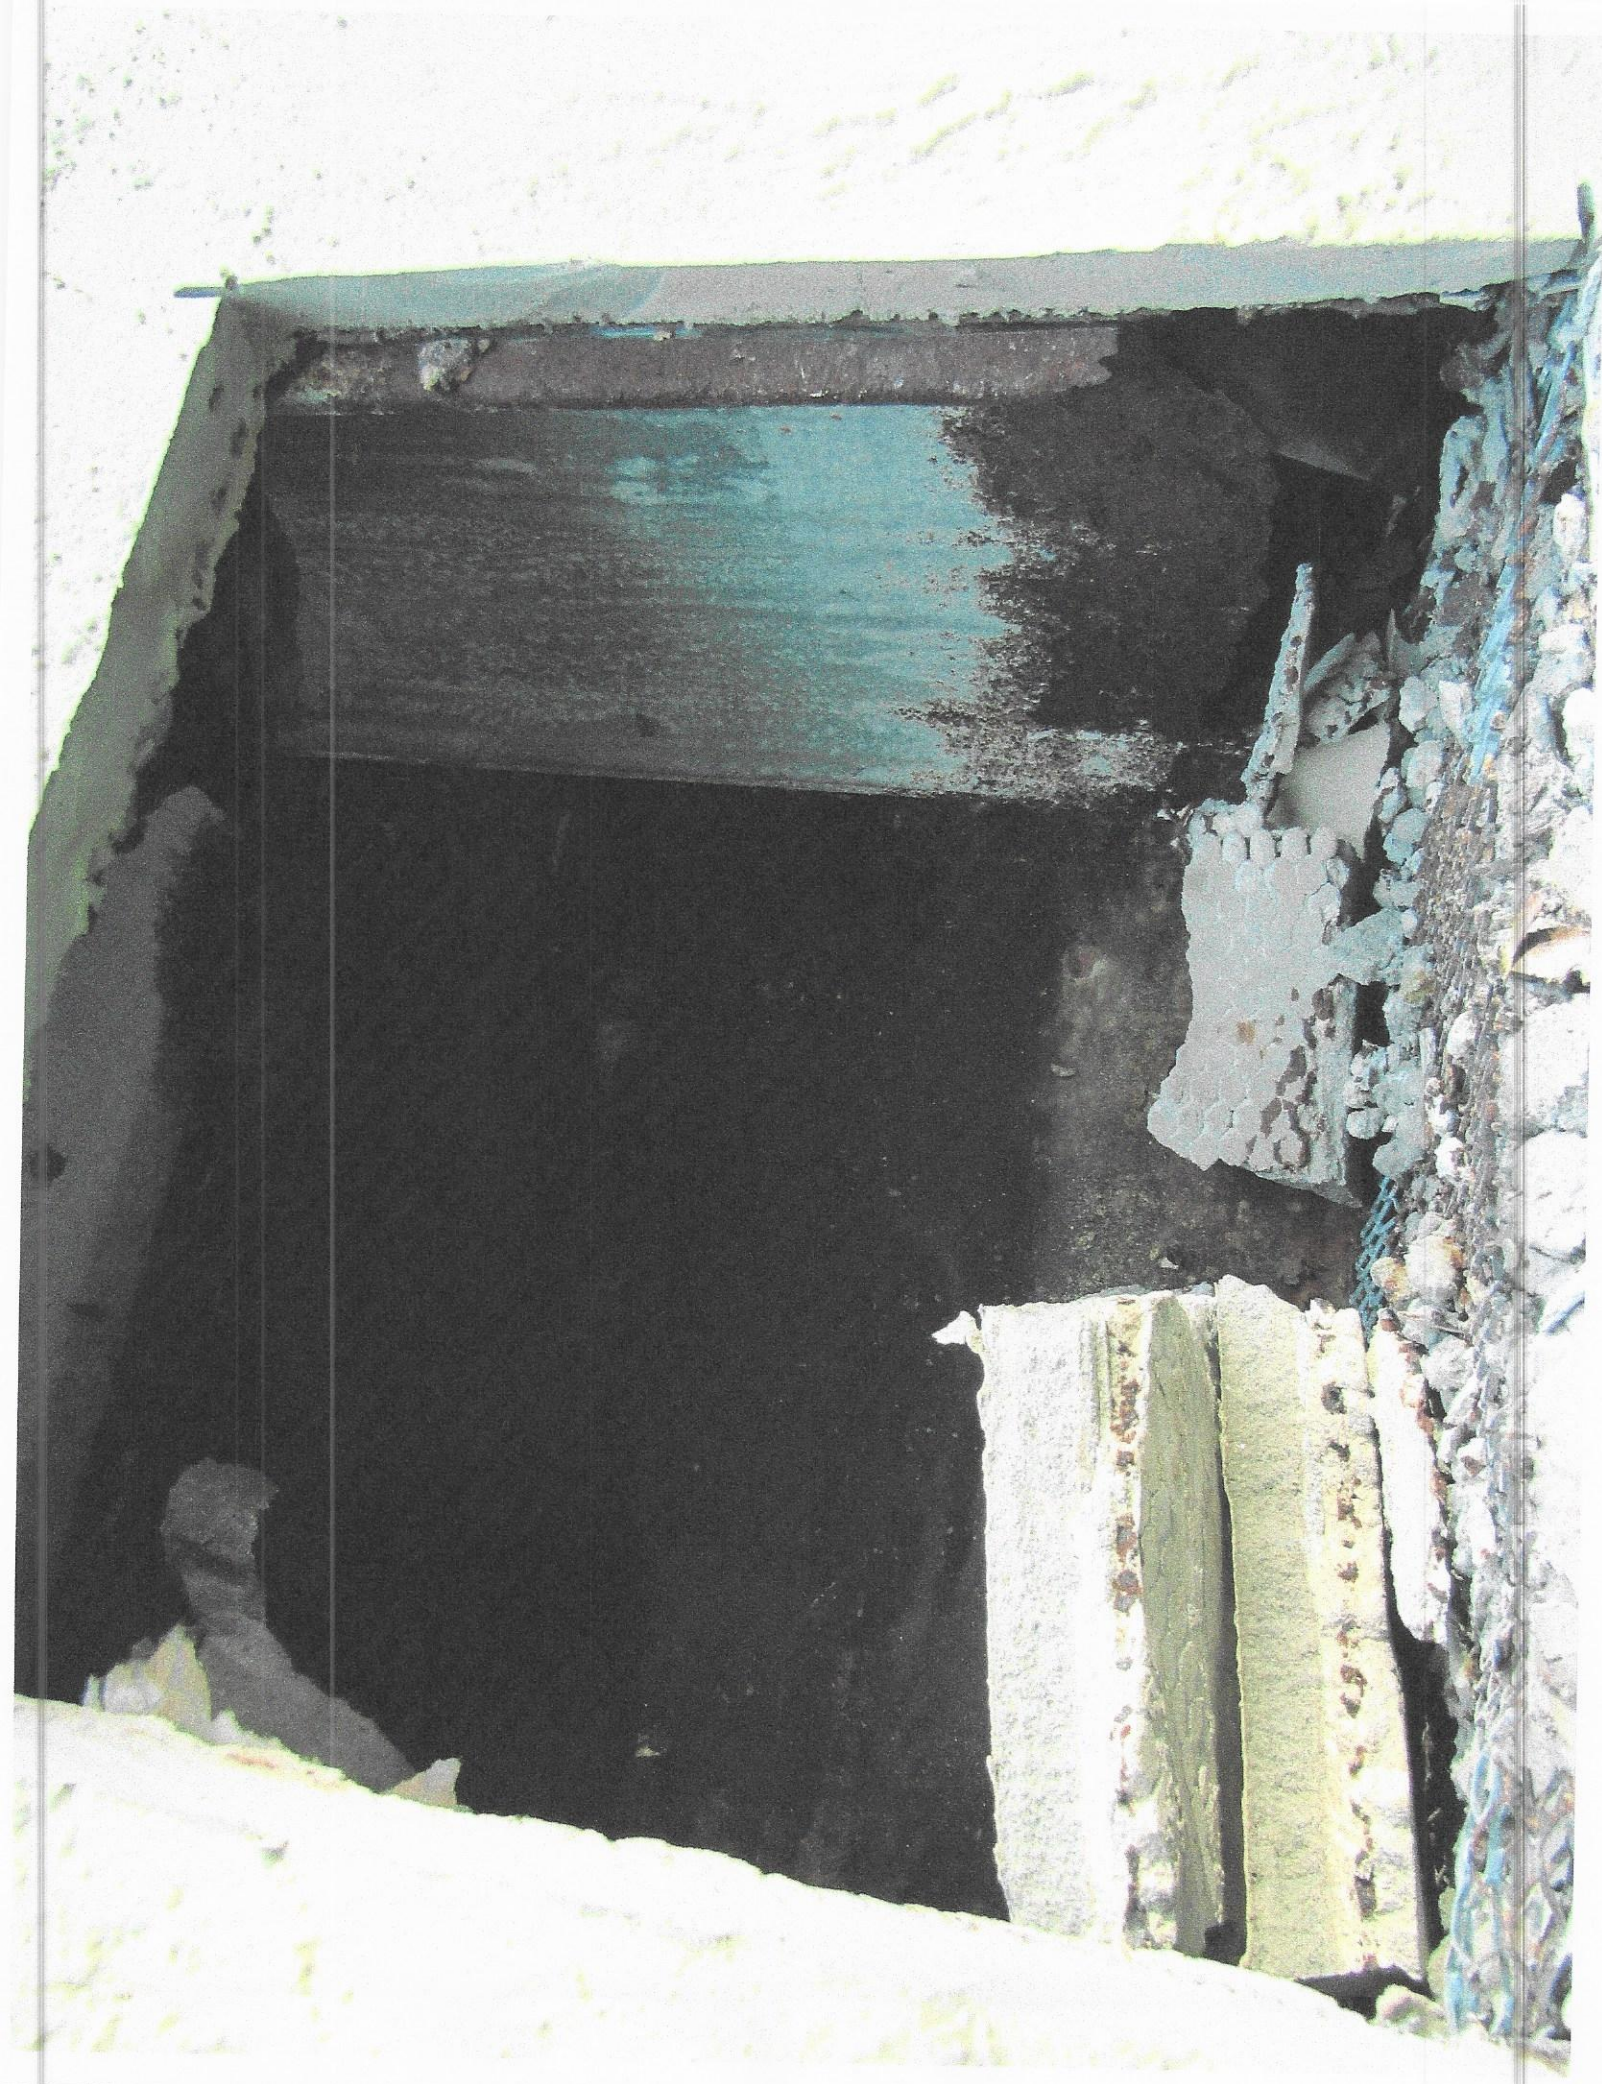
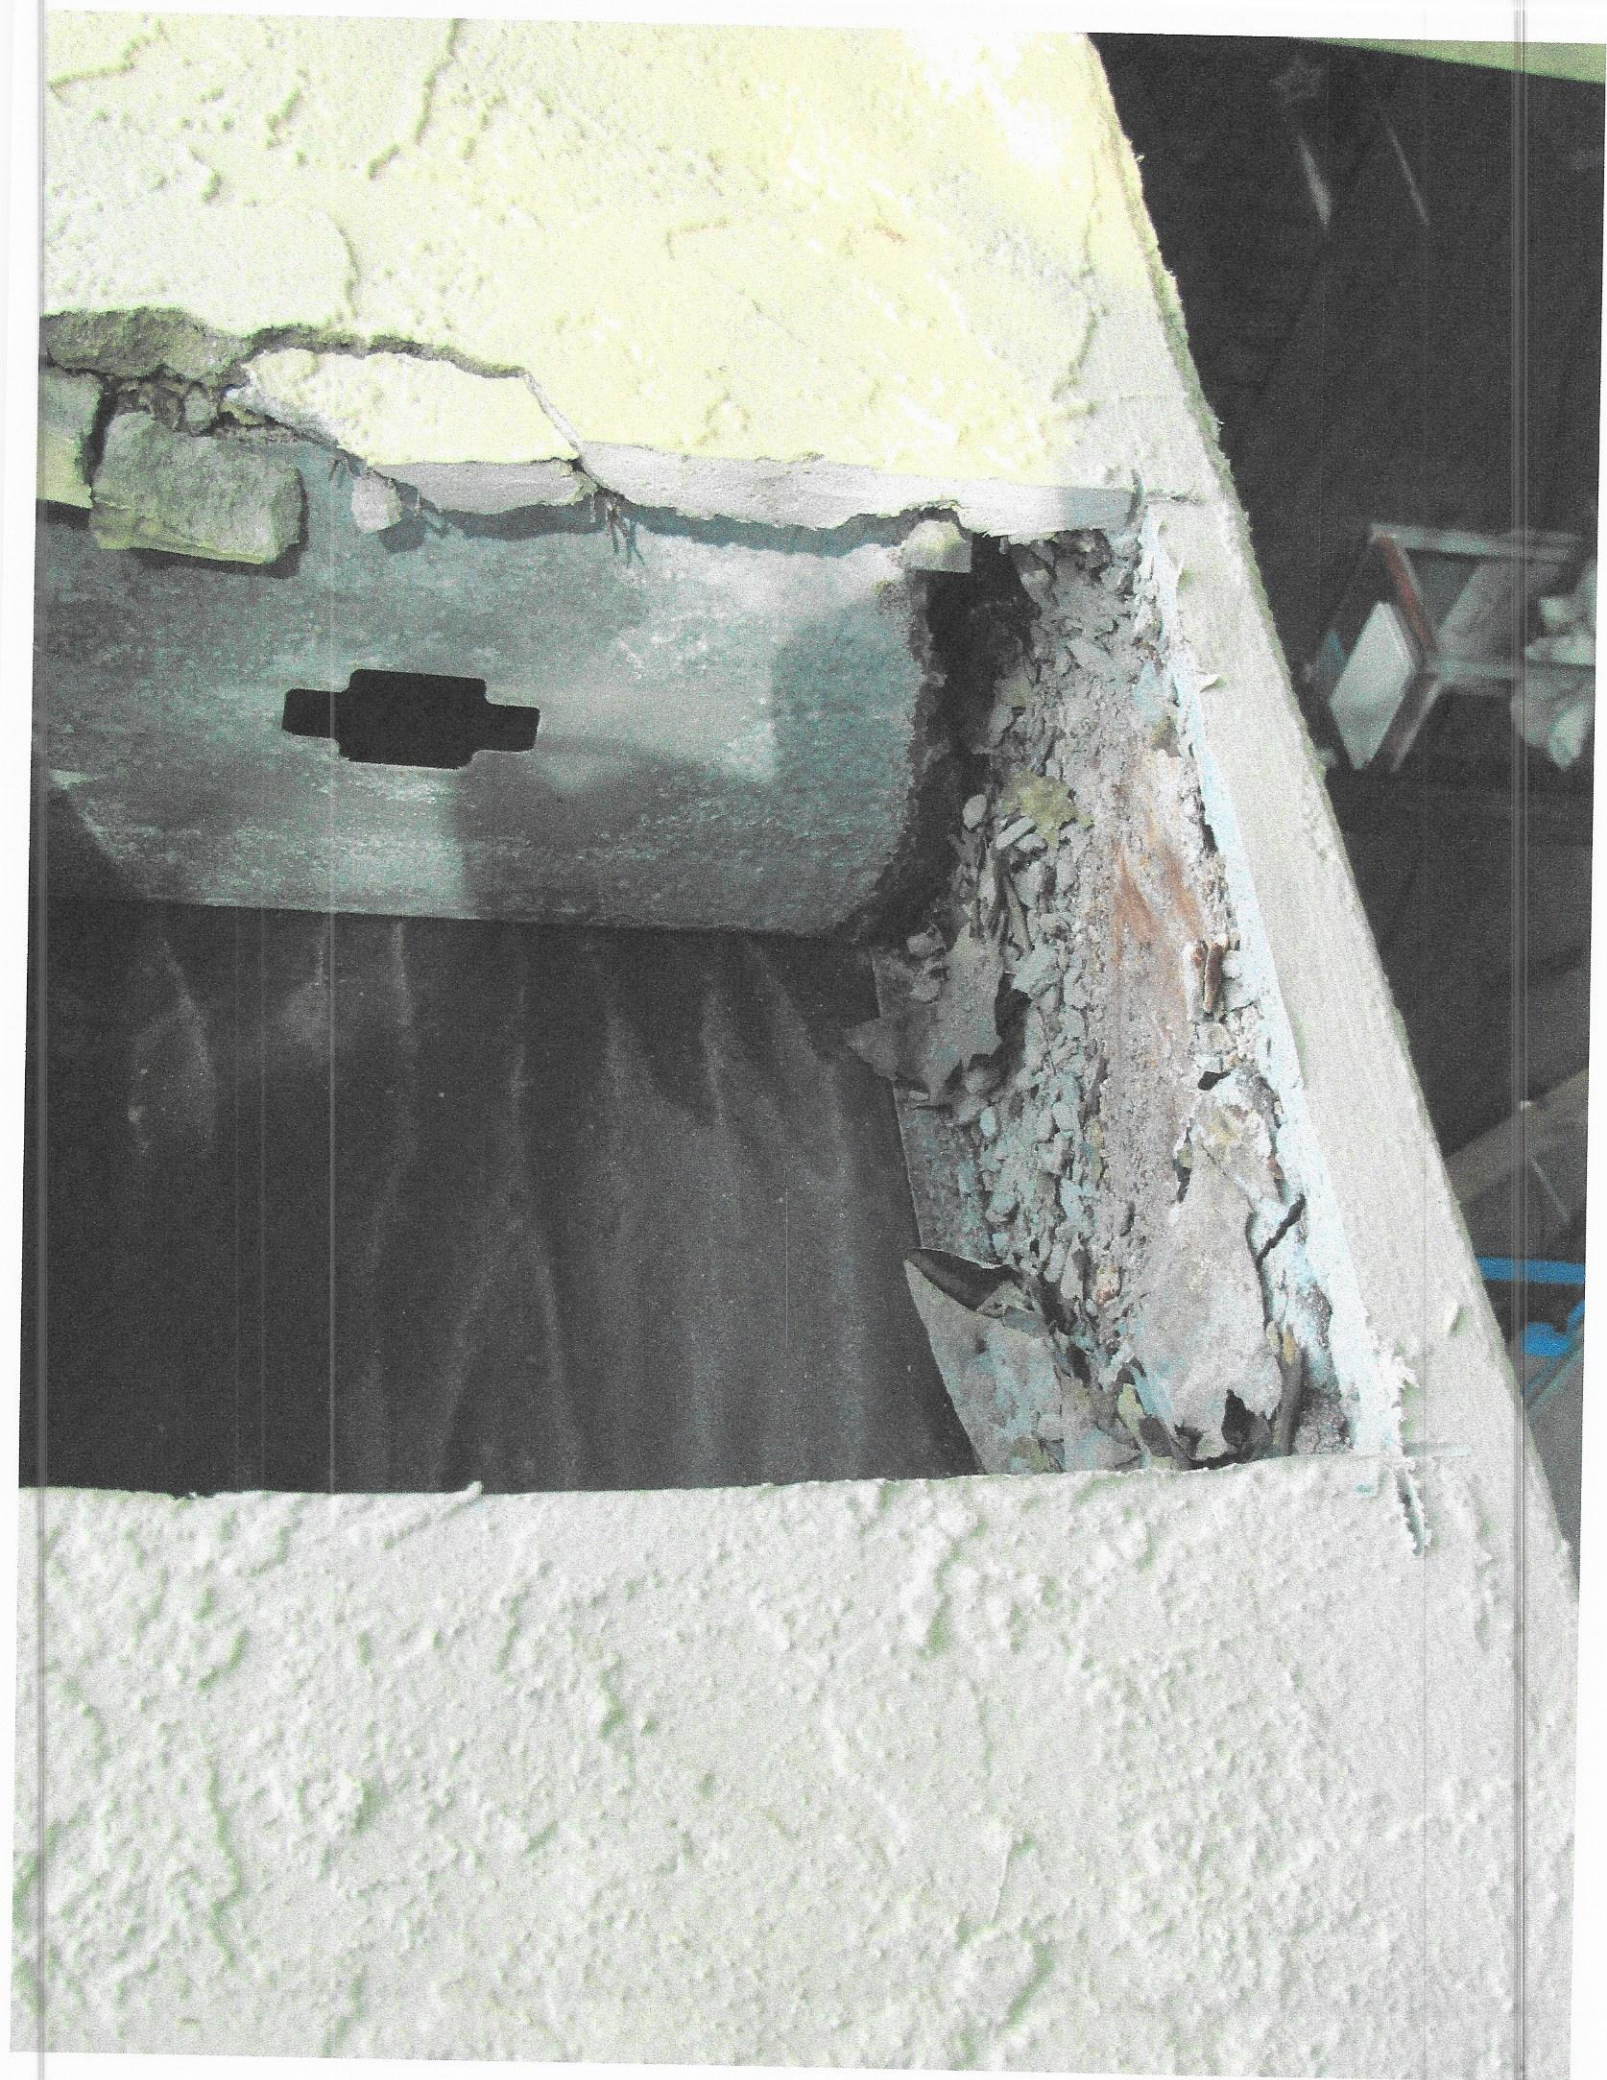
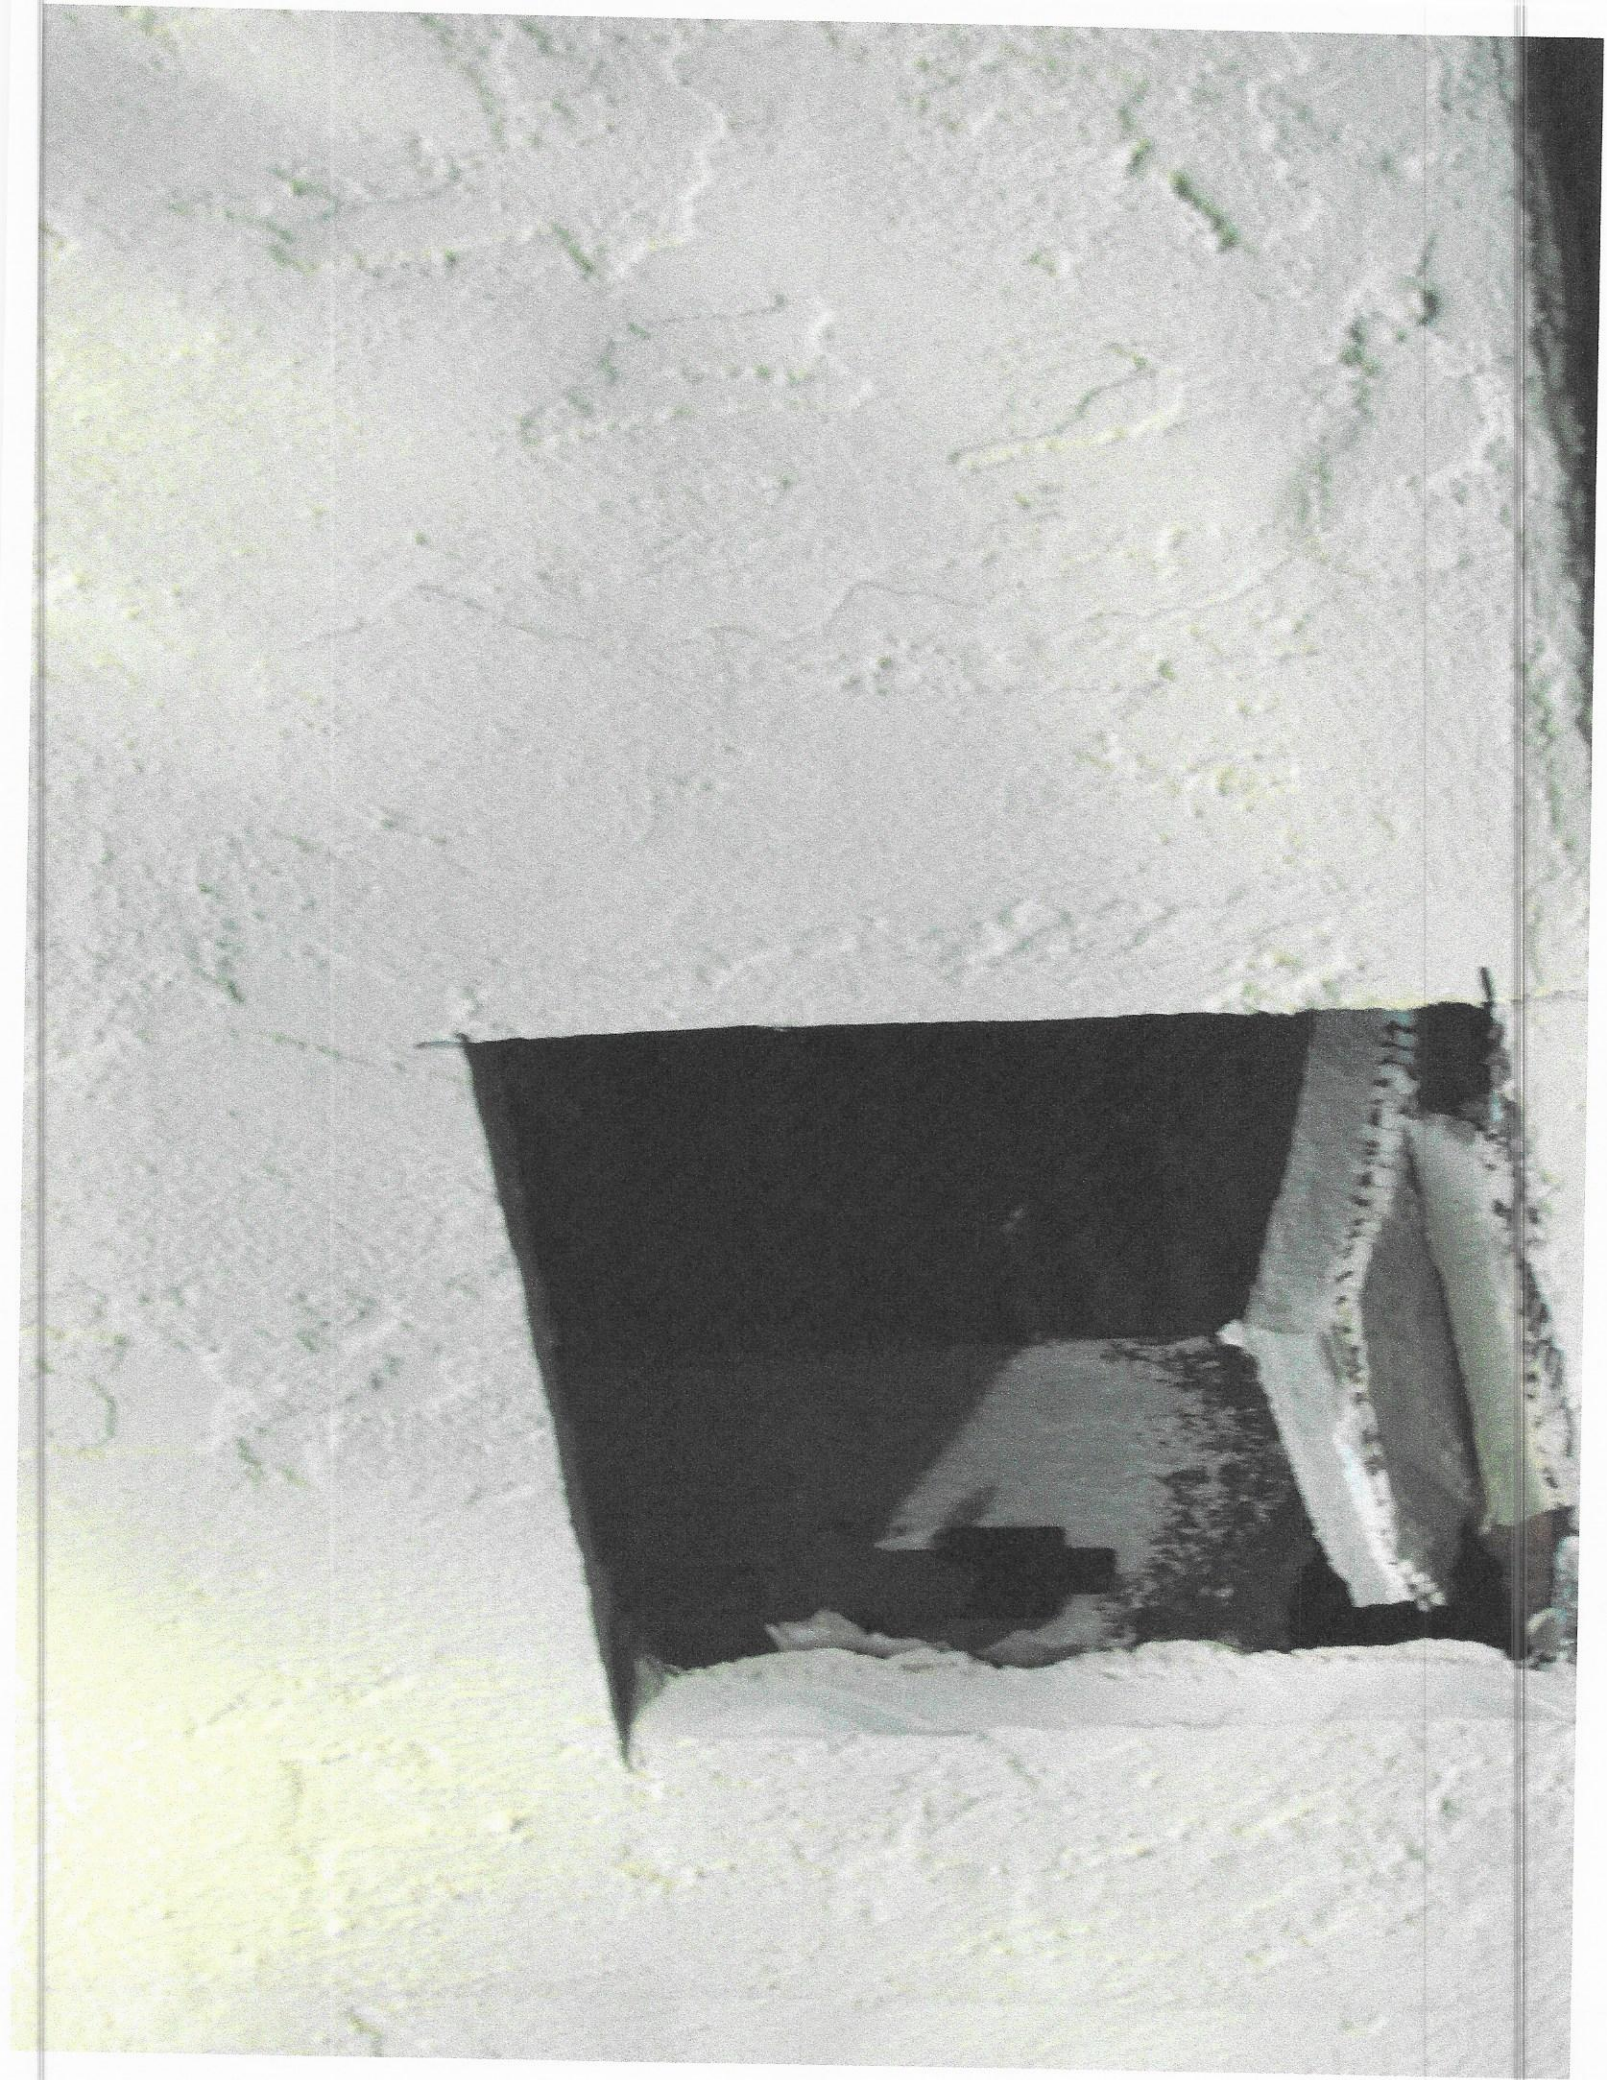
1. Concrete restoration work is in progress in building D, a balcony deck edge location at unit 103 was inspected by Socotec and instructions for repair were given onsite. Fortunately, no damage to the post-tension tendons has been yet observed.
2. Cracked stucco at the headers on the screened lanais was observed. After further investigation we found the light gauge metal framing is badly corroded. It is in Socotec's opinion that all three headers will need to be removed and replaced in accordance with the details provided.
