Windstorm Mitigation Report (OIR-B1-1802)

Calais at Pelican Bay Condominium Association, Inc.

7000 Pelican Bay Blvd, Bldg A

As of 4/5/2022 | FPAT File# MIT2217414

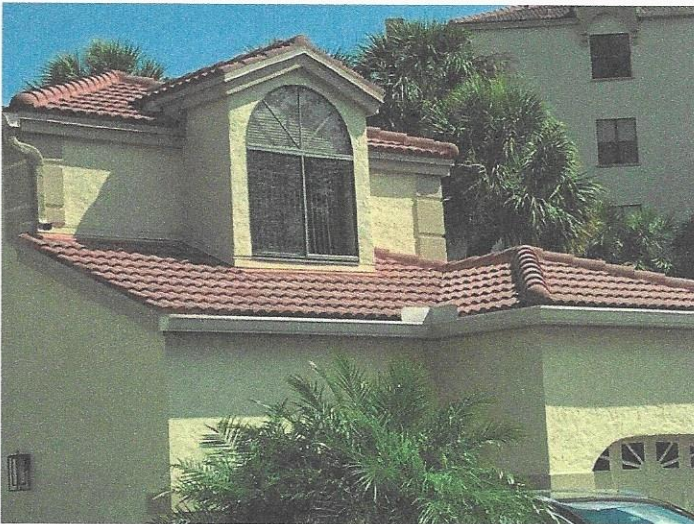
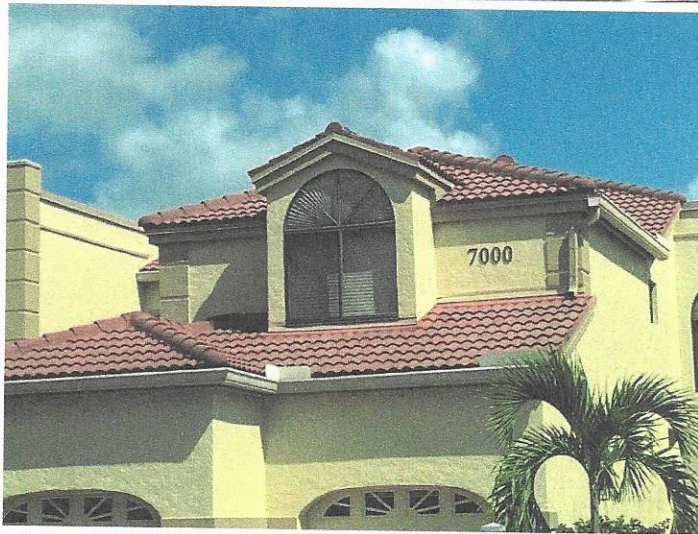
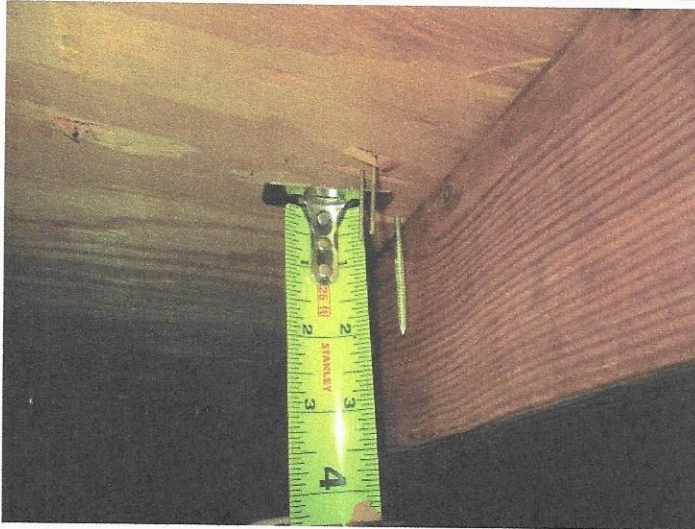
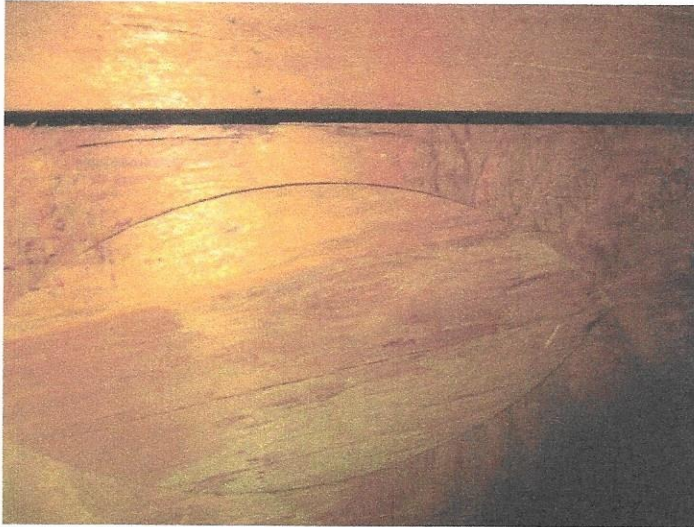
Roof Construction

- 3. Roof Deck Attachment:** **Level C**
Comments: Inspection verified 1/2" plywood roof deck attached with 8d nails at a minimum 6" on the edge & 6" in the field.

- 4. Roof to Wall Attachment:** **Clips**
Comments: Inspection verified embedded straps fastened with a minimum of three nails.
- 5. Roof Geometry:** **Other Roof**
Comments: The roof shape is made up of a combination of flat and pitched sections. The flat area of the roof comprises approximately 21% of the total roof area. The hip portion of the roof comprises approximately 77% of the total roof perimeter. According to the wind mitigation affidavit this roof is rated as "Other".

- 6. SWR:** **Yes**
Comments: SWR was verified at time of inspection. The Secondary Water Resistance verified is a self-adhering peel and stick.
- 7. Opening Protection:** **None or Some Glazed Openings**
Comments: Inspection verified some metal shutter opening protection. Not all glazed openings were protected with impact resistant coverings.
