## Windstorm Mitigation Report (OIR-B1-1802)

Calais at Pelican Bay Condominium Association, Inc.

7056 Pelican Bay Blvd, Bldg B

As of 4/5/2022 | FPAT File# MIT2217414

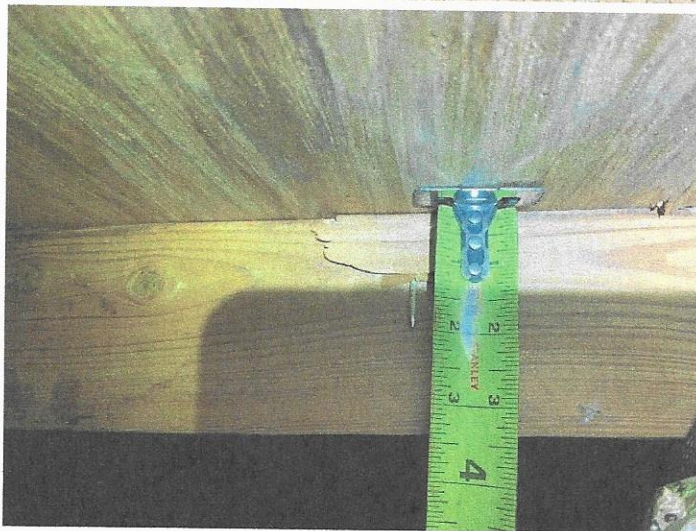
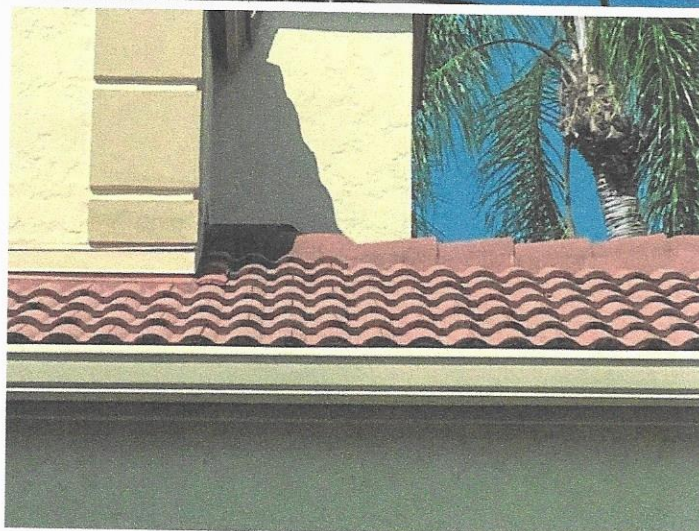
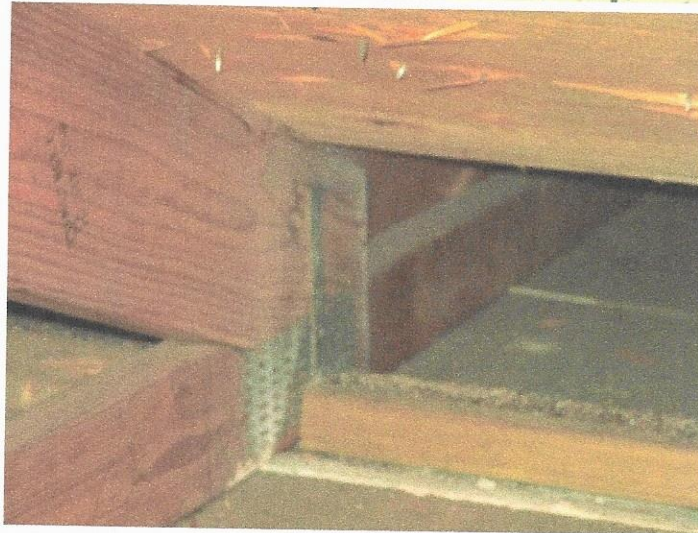
Roof Construction

- 3. Roof Deck Attachment:** **Level C**  
Comments: Inspection verified 1/2" plywood roof deck attached with 8d nails at a minimum 6" on the edge & 6" in the field.

- 4. Roof to Wall Attachment:** **Clips**  
Comments: Inspection verified embedded straps fastened with a minimum of three nails.
- 5. Roof Geometry:** **Other Roof**  
Comments: The roof shape is made up of a combination of flat and pitched sections. The flat area of the roof comprises approximately 21% of the total roof area. The hip portion of the roof comprises approximately 77% of the total roof perimeter. According to the wind mitigation affidavit this roof is rated as "Other".

- 6. SWR:** **Yes**  
Comments: SWR was verified at time of inspection. The Secondary Water Resistance verified is a self-adhering peel and stick.
- 7. Opening Protection:** **None or Some Glazed Openings**  
Comments: Inspection verified some metal shutter opening protection. Not all glazed openings were protected with impact resistant coverings.
