Windstorm Mitigation Report (OIR-B1-1802)

Calais at Pelican Bay Condominium Association, Inc.

7048 Pelican Bay Blvd, Bldg C

As of 4/5/2022 | FPAT File# MIT2217414

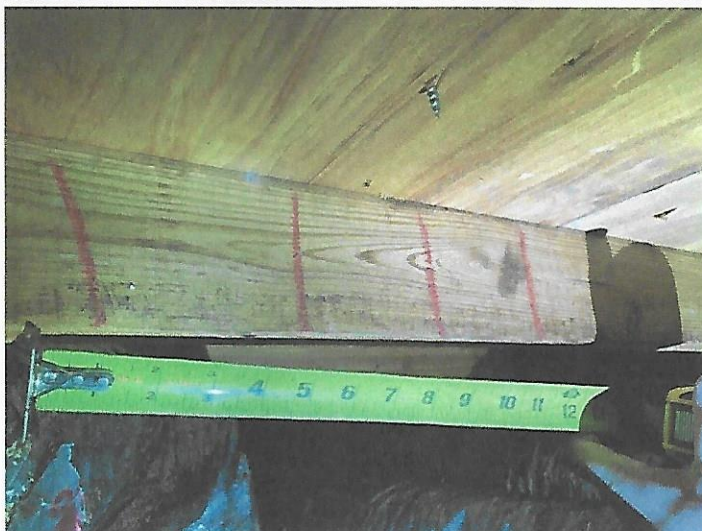
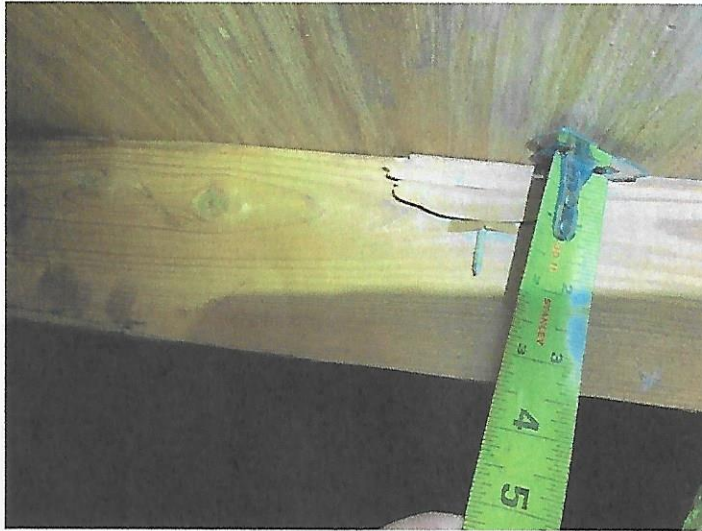
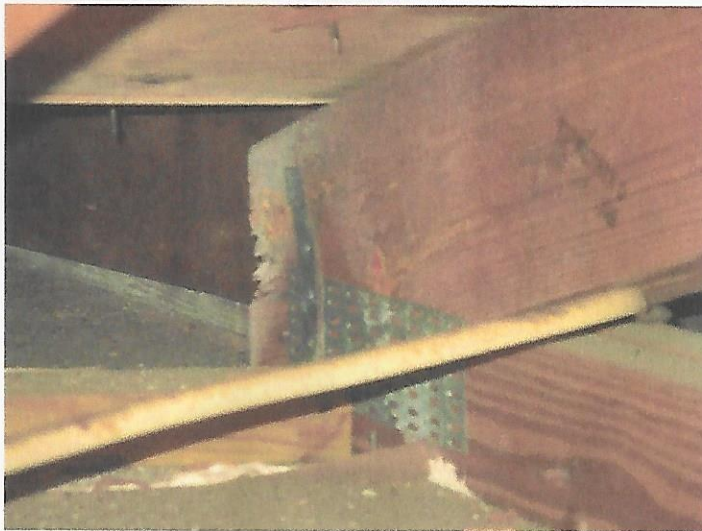
Roof Construction

- 3. Roof Deck Attachment:** **Level C**
Comments: Inspection verified 1/2" plywood roof deck attached with 8d nails at a minimum 6" on the edge & 6" in the field.

- 4. Roof to Wall Attachment:** **Clips**
Comments: Inspection verified embedded straps fastened with a minimum of three nails.
- 5. Roof Geometry:** **Other Roof**
Comments: The roof shape is made up of a combination of flat and pitched sections. The flat area of the roof comprises approximately 21% of the total roof area. The hip portion of the roof comprises approximately 77% of the total roof perimeter. According to the wind mitigation affidavit this roof is rated as "Other".

- 6. SWR:** **Yes**
Comments: SWR was verified at time of inspection. The Secondary Water Resistance verified is a self-adhering peel and stick.
- 7. Opening Protection:** **None or Some Glazed Openings**
Comments: Inspection verified some metal shutter opening protection. Not all glazed openings were protected with impact resistant coverings.
