Windstorm Mitigation Report (OIR-B1-1802)

Calais at Pelican Bay Condominium Association, Inc.

7040 Pelican Bay Blvd, Bldg D

As of 4/5/2022 | FPAT File# MIT2217414

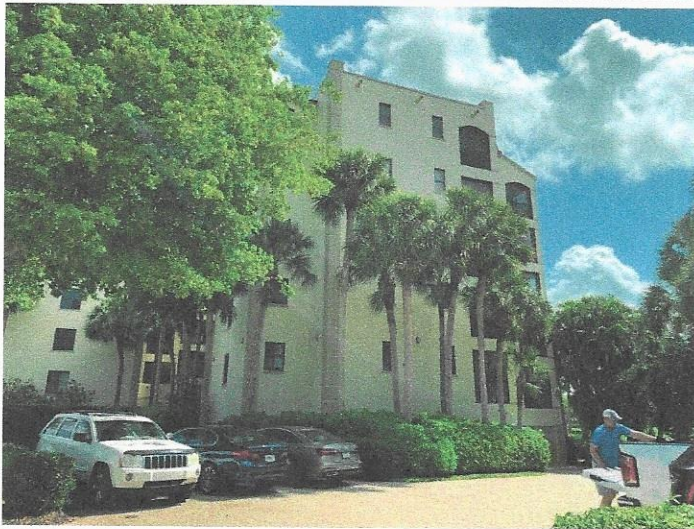
Exterior Elevation

- 5. Roof Geometry:**
Comments: **Hip Roof**
Inspection verified a hip roof shape.
- 6. SWR:**
Comments: **No**
SWR does not apply to reinforced concrete roof decks.
