Windstorm Mitigation Report (OIR-B1-1802)

Calais at Pelican Bay Condominium Association, Inc.

7032 Pelican Bay Blvd, Bldg E

As of 4/5/2022 | FPAT File# MIT2217414

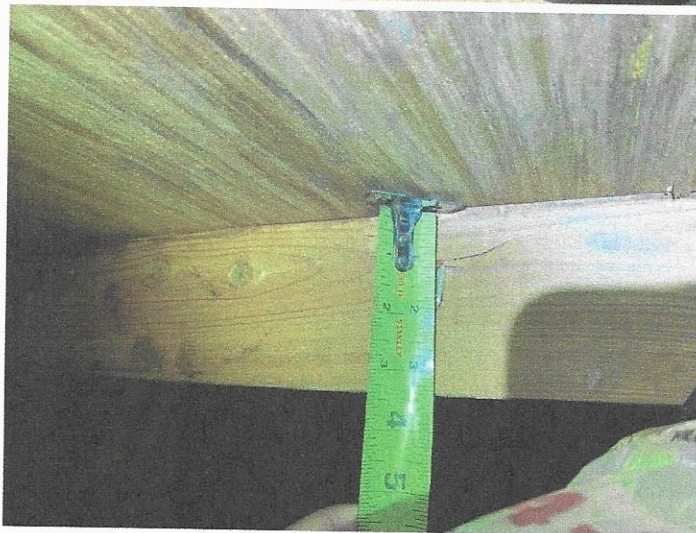
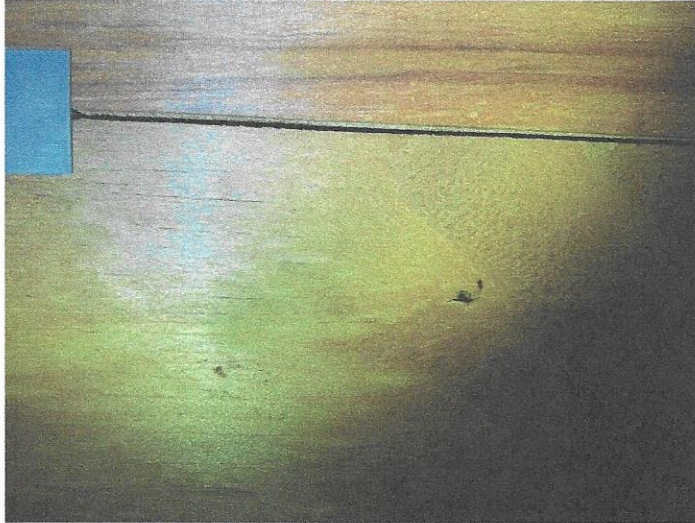
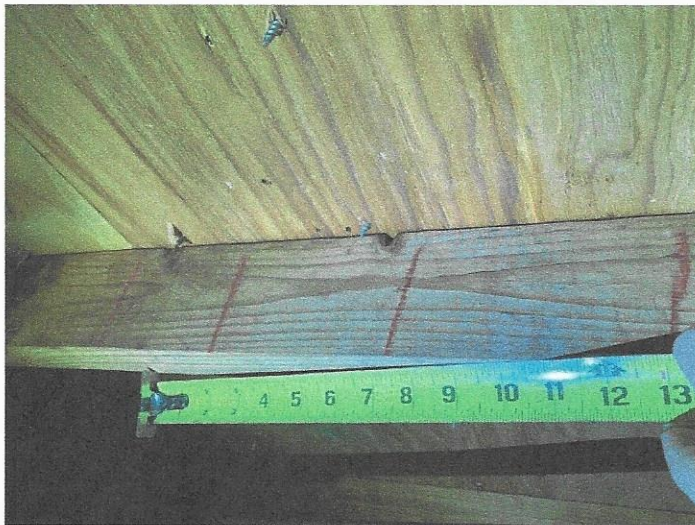
Roof Construction

- 3. Roof Deck Attachment:**
Comments: **Level C**
Inspection verified 1/2" plywood roof deck attached with 8d nails at a minimum 6" on the edge & 6" in the field.

- 4. Roof to Wall Attachment:**
Comments: **Clips**
Inspection verified embedded straps fastened with a minimum of three nails.
- 5. Roof Geometry:**
Comments: **Other Roof**
The roof shape is made up of a combination of flat and pitched sections. The flat area of the roof comprises approximately 21% of the total roof area. The hip portion of the roof comprises approximately 77% of the total roof perimeter. According to the wind mitigation affidavit this roof is rated as "Other".
