Windstorm Mitigation Report (OIR-B1-1802)

Calais at Pelican Bay Condominium Association, Inc.

7016 Pelican Bay Blvd, Bldg G

As of 4/5/2022 | FPAT File# MIT2217414

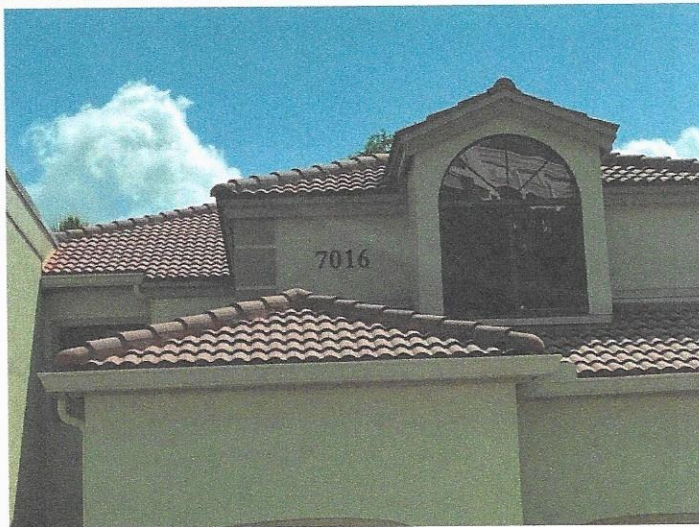
Roof Construction

- 3. Roof Deck Attachment:** **Level C**
Comments: Inspection verified 1/2" plywood roof deck attached with 8d nails at a minimum 6" on the edge & 6" in the field.

- 4. Roof to Wall Attachment:** **Clips**
Comments: Inspection verified embedded straps fastened with a minimum of three nails.
- 5. Roof Geometry:** **Other Roof**
Comments: The roof shape is made up of a combination of flat and pitched sections. The flat area of the roof comprises approximately 21% of the total roof area. The hip portion of the roof comprises approximately 77% of the total roof perimeter. According to the wind mitigation affidavit this roof is rated as "Other".

- 6. SWR:** **Yes**
Comments: SWR was verified at time of inspection. The Secondary Water Resistance verified is a self-adhering peel and stick.
- 7. Opening Protection:** **None or Some Glazed Openings**
Comments: Inspection verified some metal shutter opening protection. Not all glazed openings were protected with impact resistant coverings.
