**Windstorm Mitigation Report (OIR-B1-1802)**

Calais at Pelican Bay Condominium Association, Inc.

7008 Pelican Bay Blvd, Bldg H

As of 4/5/2022 | FPAT File# MIT2217414

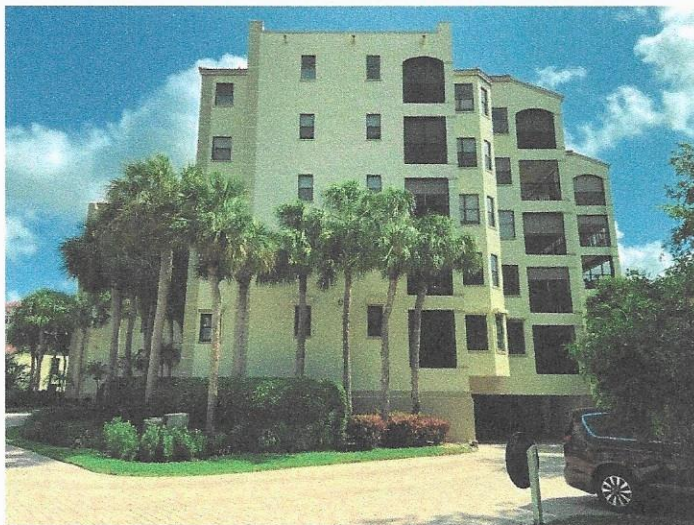
Exterior Elevation

- 5. Roof Geometry:** **Hip Roof**  
Comments: Inspection verified a hip roof shape.
- 6. SWR:** **No**  
Comments: SWR does not apply to reinforced concrete roof decks.

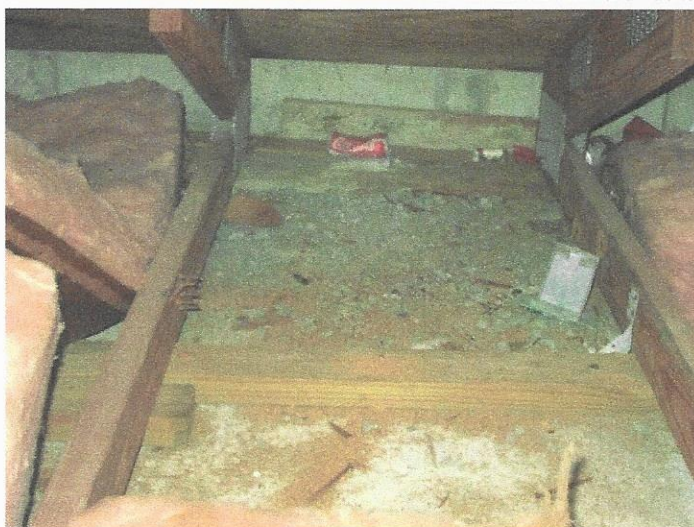
Roof Construction

- 3. Roof Deck Attachment:** **Reinforced Concrete Roof Deck**  
Comments: Inspection verified a roof structure composed of cast-in-place or pre-cast structural concrete designed to be self-supporting and integrally attached to the wall / support system.

- 4. Roof to Wall Attachment:** **Structural**  
Comments: Inspection verified a roof structure composed of cast-in-place or pre-cast structural concrete designed to be self-supporting and integrally attached to the wall / support system.
