# Calais at Pelican Bay

## Project Management Report 20 – Building F

**RE:** Scope of Work Updates and Revisions – Unit F-303, Building F Post-Tension Cable Repairs/Replacement

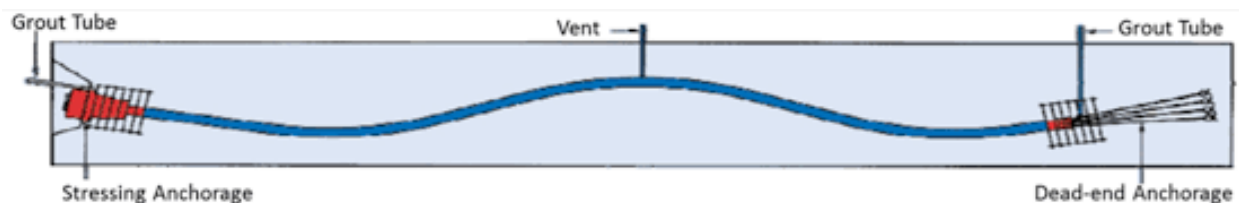
Based on the structural plans originally provided, the three uniform cables emanating from the column in Unit F-303 were assumed to have their live end (where stressing occurs) at the balcony slab edge of Unit F-303 and their dead end (anchored end) between the interior of Units F-303 and F-304.

However, during the repair process and subsequent investigation by the PT Specialist, it was discovered that these cables may run across the full length of the building from Unit F-303 to Unit F-305 rather than terminating between F-303 and F-304 as shown on the plans. When stressing was attempted during the typical repair procedure (locking off, splicing,

and re-stressing), at least one cable is confirmed to have failed and released, with the resulting damage observed at the balcony slab edge of Unit F-305.

Due to the cable failures and the unknown location of the break point, full cable replacement has been recommended by the PT Specialist as the only viable course of action for the affected cables.
