## Calais at Pelican Bay

### Phase II Work Scope

#### Project Management Report No 8

Site visit, Date 2.17.2025 Building D

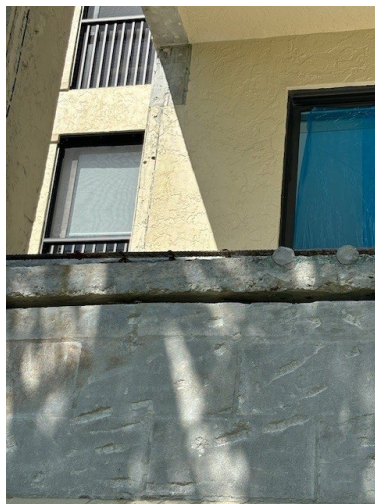
Picture 1

1. Permitting for building D continues with the County.
2. Permitting for building F has been secured with the County.
3. Concrete restoration work is in progress in building D, a balcony deck edge location at unit 502 (please see picture 1) was inspected by Socotec and instructions for repair were given onsite to the field supervisor.
