## Calais at Pelican Bay

### Phase II Work Scope

#### Project Management Report – Week 4-6

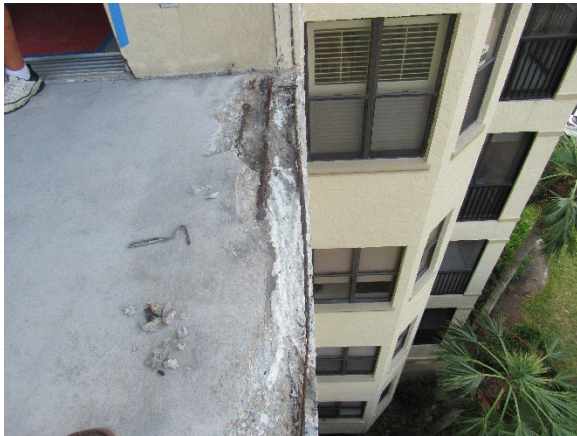
504 PT cables & corroded steel

2. Following the storm work picked up again on 504, 404, 502, 104 and 204. Parts of this work are more complex in that post-tensioning cables are exposed and will need a specialty contractor to assist with the repairs. The work included on going column repairs, stucco repairs and deck edge work.

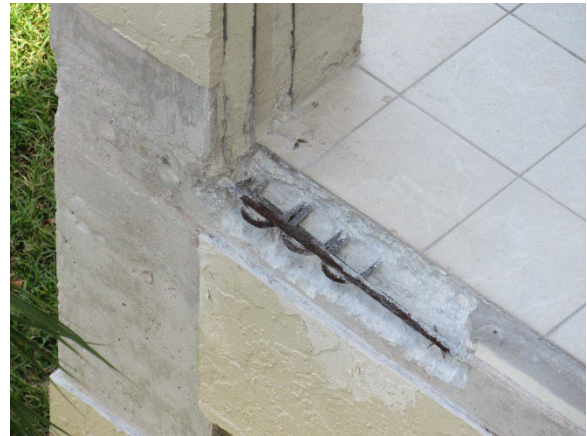
404 deck edge repairs

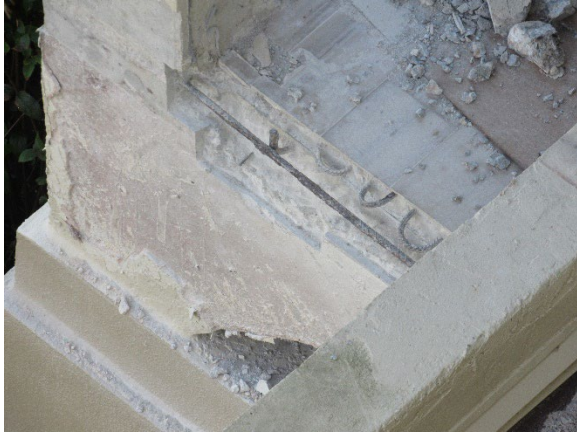
104 deck edge repairs

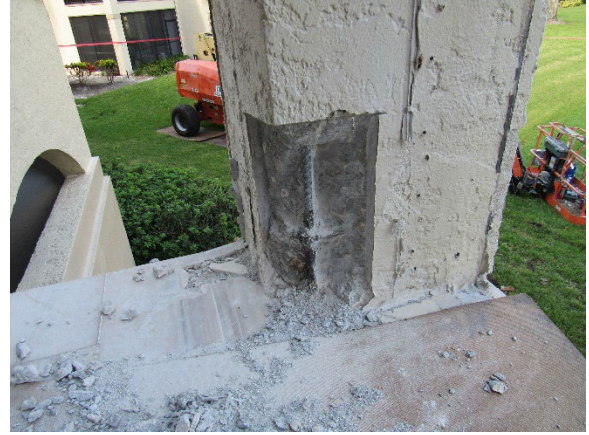
104 column repairs
